ACCIDENT

Aircraft Type and Registration:	Zivko Aeronautics Inc Edge 540, N540BW	
No & Type of Engines:	1 Lycoming AEIO-540 piston engine	
Year of Manufacture:	1998	
Date & Time (UTC):	22 August 2009 at 1057 hrs	
Location:	Silverstone Circuit, Towcester, Northamptonshire	
Type of Flight:	Competition	
Persons on Board:	Crew - 1	Passengers - None
Injuries:	Crew - 1 (Fatal)	Passengers -N/A
Nature of Damage:	Aircraft destroyed	
Commander's Licence:	FAA Commercial Pilot's Licence	
Commander's Age:	41 years	
Commander's Flying Experience:	2,500 hours (of which 1,400 were on type) Last 90 days - 50 hours Last 28 days - 11 hours	
Information Source:	AAIB Field Investigation

Synopsis

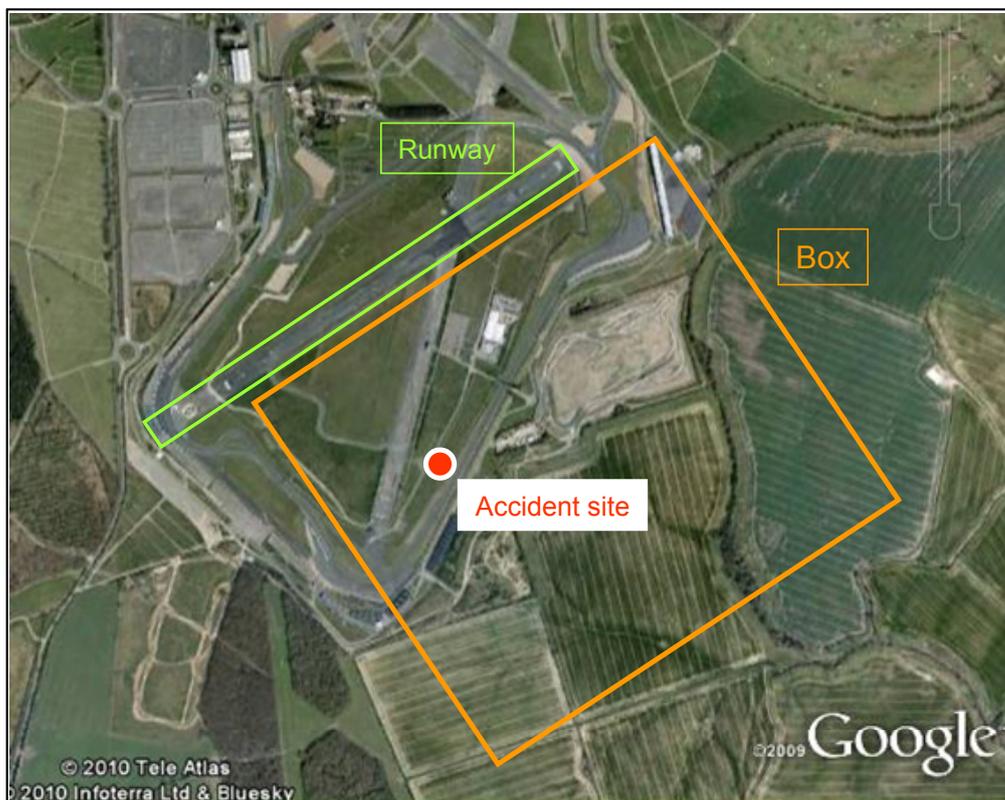
Figure 1

Part of Silverstone circuit showing runway, aerobatic box and accident site

The wreckage was located within the race track (Figure 1). The wing tips and the engine had struck the ground at an angle of approximately 45°, with the aircraft in a nose down attitude and the left wing being more damaged than the right. The aft fuselage and attached empennage had separated from the wings and forward fuselage, and these two major items of

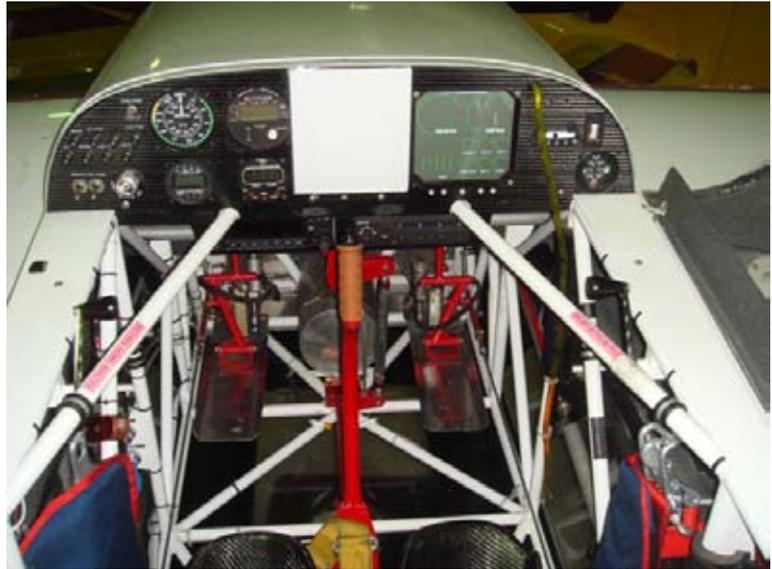
Figure 3
Cockpit layout

Figure 3 is a photograph of the cockpit layout. The control column was connected to the ailerons and elevators by a series of conventional pushrods and bell cranks. The rudder pedals were mounted on light alloy footplates which were attached to horizontal tubular steel fuselage cross-members. On the outer side of each pedal was a connection to a cable that ran rearwards to the respective rudder control horn. Also connected to the side of each pedal was a light spring that ran forwards and was attached to the fuselage structure. These springs prevented the rudder pedals from falling rearwards when no foot pressure was applied. The rudder pedals were operated with the pilot's heels on the foot plates and the balls of their feet pushing against horizontal tubes on each pedal. The aircraft was fitted with adjustable foot straps which passed through these horizontal tubes. When used, they ensure that the pilot's feet remain in contact with the rudder pedals; they also allow the opposing foot to pull at the same time as the other foot pushes. The range of movement of the rudder cables was ± 45 mm, producing rudder deflections of $\pm 30^\circ$.

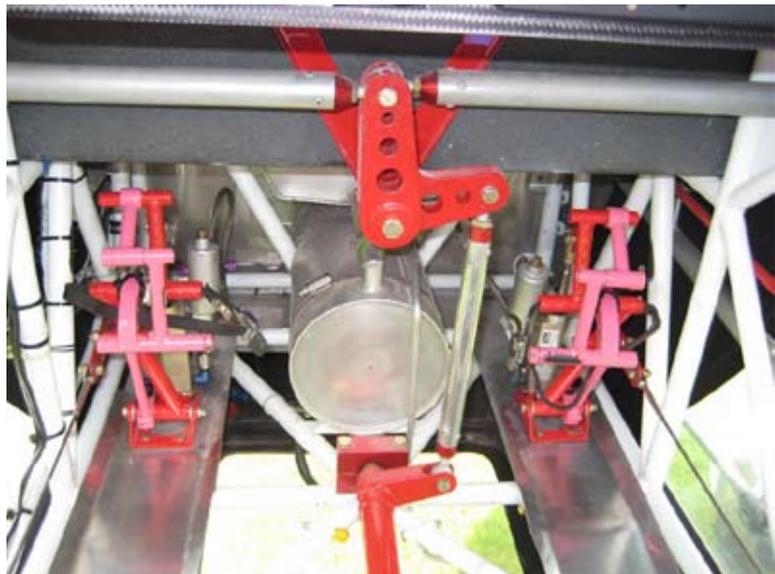
Figure 4
Rudder pedals with pedal extensions (pink) fitted

her right foot had bent the right foot plate downwards, deforming it. The footplate was straightened after the flight. The team engineer prepared a pair of longer, stiffer footplates but these had not been fitted at the time of the accident.

According to information posted by the pilot on her internet site, another pilot had also bent the footplate, whilst getting into the aircraft, and had bent it back. The photograph at Figure 4 shows the right footplate with evidence of the deformation. It is not known if this was taken after the ground or the airborne incident.

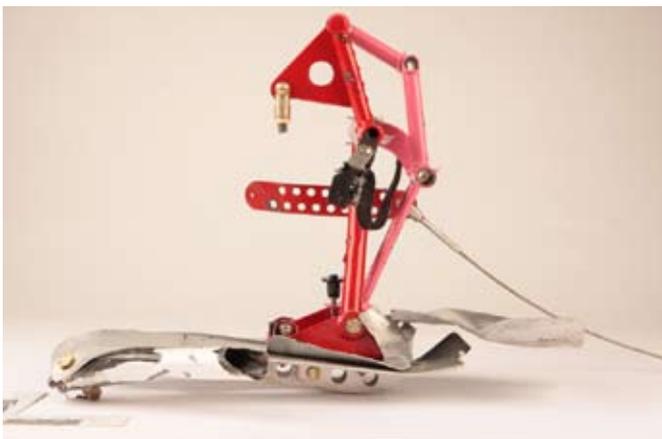
Figure 5

Right rudder pedal with extension

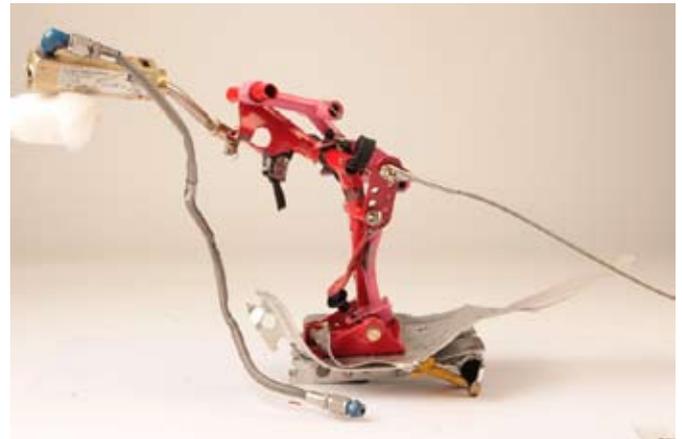
Figure 6

Left rudder pedal with extension

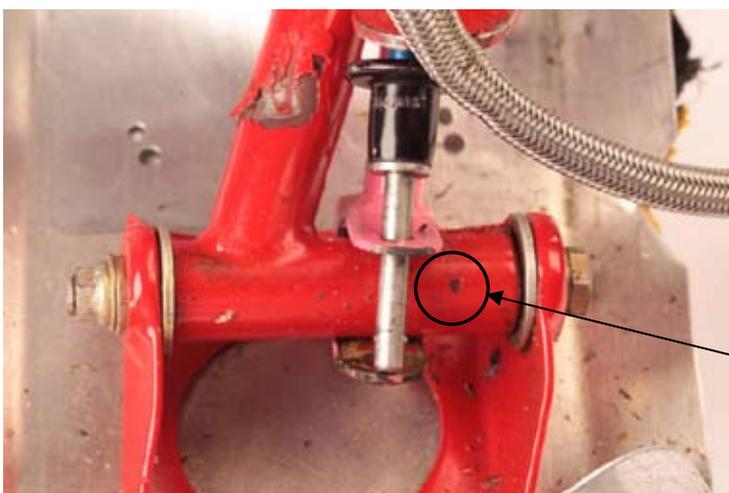
Figure 7

- a) The lower attachment of the rudder pedal extensions could be moved in a spanwise direction along the rudder pedal pivot tubes (see Figure 7).
- b) In the case of the non-extended rudder pedals, the force applied by a foot acts directly above the point at which the vertical element of

- c) There was wear damage on both the left and right pivot tubes consistent with the lower attachment of the rudder extensions moving laterally.
- d) There were witness marks on both pivot tubes. The evidence indicated that these were made by the pip-pins, which were positioned approximately 10 mm from the outboard vertical flange on the pedal base plate (Figure 7). These witness marks were probably made when the aircraft struck the ground, and might be indicative of the position of the lower attachments in the later stages of the flight.

Note the witness mark on the pivot tube probably made by the pip-pin.

Front (and above) view of the left rudder pedal pivot tube
(Note that the lower attachment for the pedal extension, painted pink, can move relatively freely from left to right)

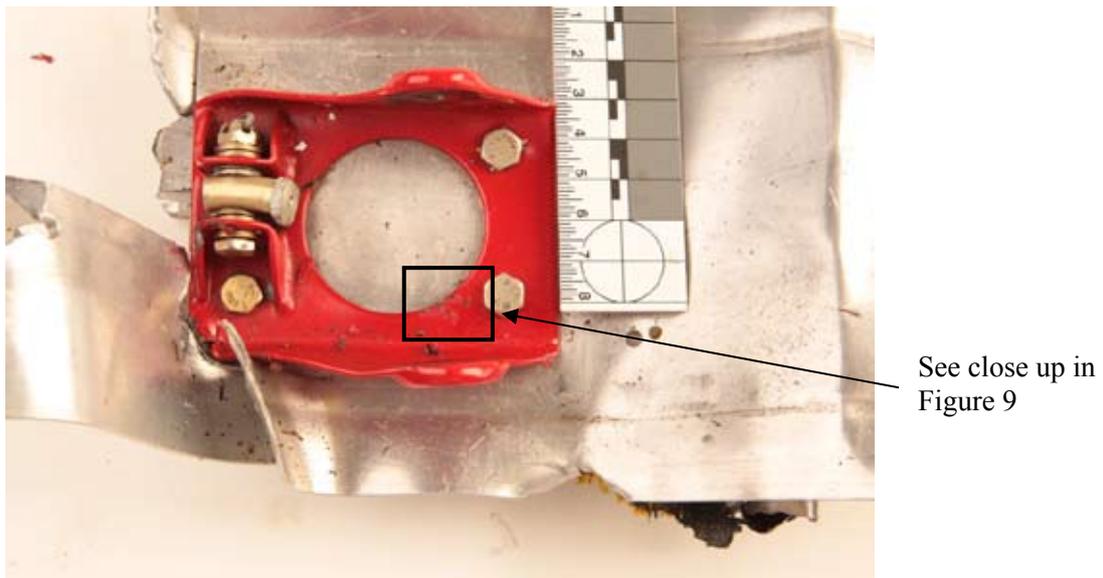
Figure 8

- e) Using a microscope, red traces were found on the tip of the pip-pin on the left pedal extension. However, there was insufficient material to carry out any detailed chemical analysis of the red traces.
- f) There were several witness marks on the base plate of the left rudder pedal. These were approximately 10 mm from the outboard vertical flange on the pedal base plate (see Figures 8 and 9). The two most significant witness marks were made by an object approximately 2.5 mm in radius which is similar to the radius of the pip-pin. There was plastic deformation of the paint on both of these witness marks, consistent with the pip-pin gouging the paint as the rudder moved from a deflection to the left towards the neutral position.

Base plate for left rudder pedal

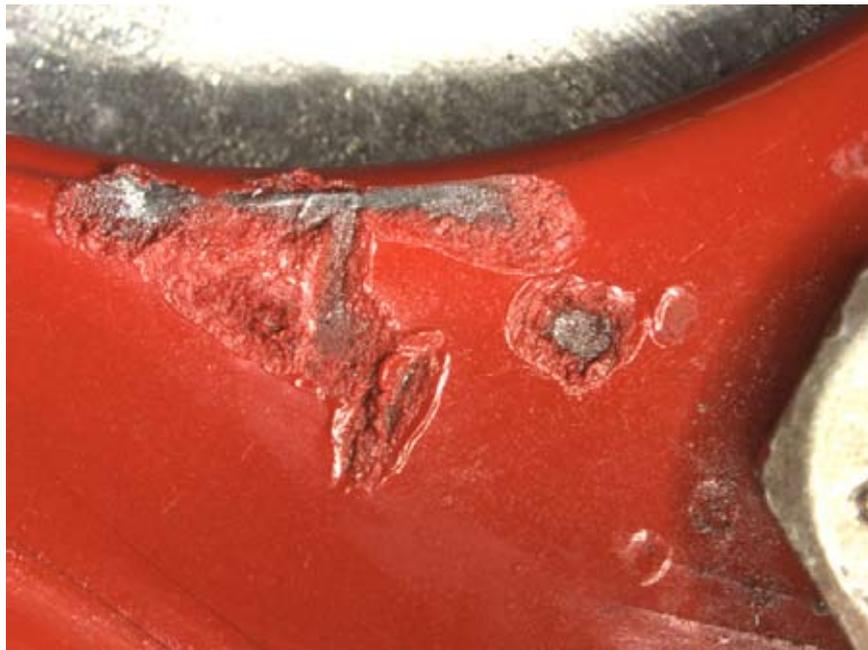
Figure 9

Close up of Figure 8 showing witness marks probably made by the end of the pip-pin

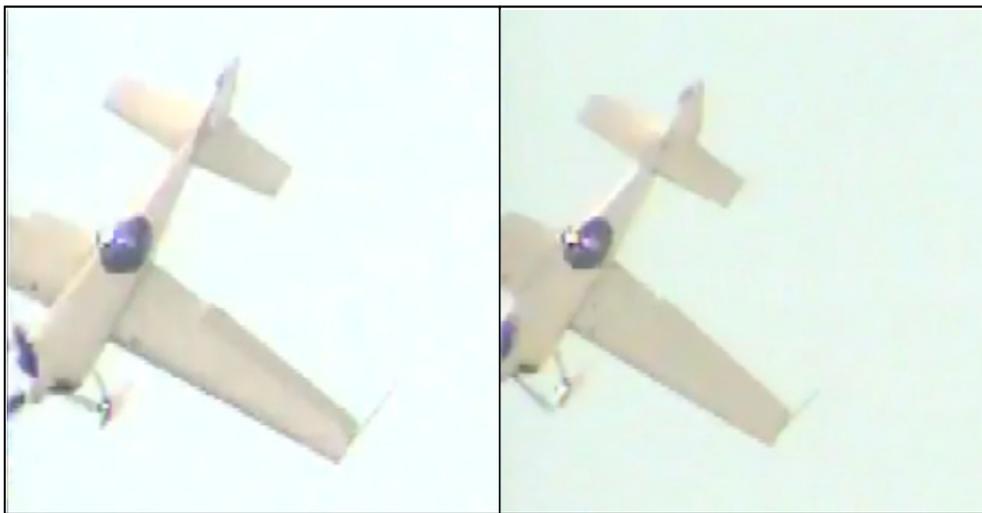
Figure 10 shows comparative video images from the practice and accident manoeuvres, from a point just after

initiation of the snap roll; the aircraft has rolled through about 120° at this point.

Shortly after initiation of the snap roll – the practice manoeuvre is on the left

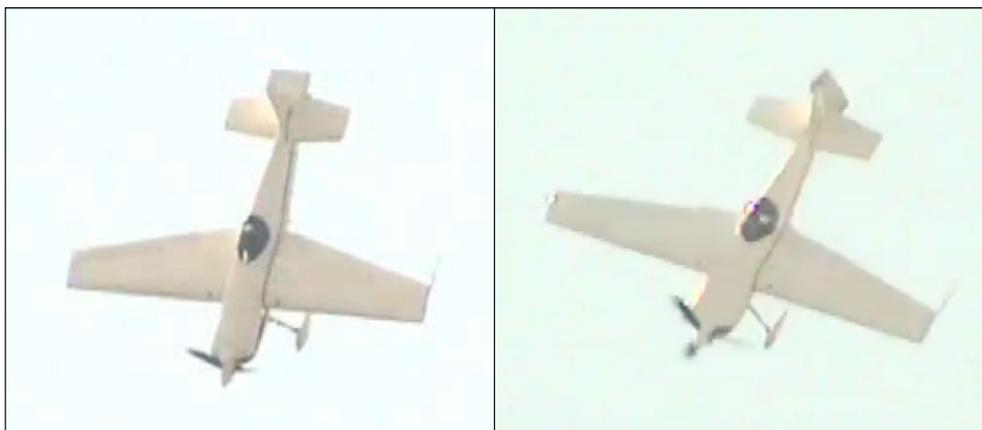
Figure 11 again shows images from the practice and accident manoeuvre, advanced nearly a full turn from the previous images, at about the point of recovery. Significant differences can be seen in terms of rudder angle and pilot's head position (the pilot was wearing a white helmet).

The point of recovery in practice manoeuvre (left) compared to the equivalent point during the accident manoeuvre

Elevator position could not be measured with accuracy, but it was noted that, approaching the point of recovery from the snap roll, the aircraft’s body pitch angle was 14° less nose-down than at the equivalent position in the practice manoeuvre (this is visible at Figure 11). For the first two turns after the expected recovery point, the elevator appeared approximately neutral, and the nose-down pitch angle increased to approximately 5° from vertical. During the next three turns there was noticeable ‘up’ elevator applied, and the nose-down pitch angle reduced to about 18° from vertical. The ‘up’ elevator remained applied until the aircraft disappeared from view a turn later.

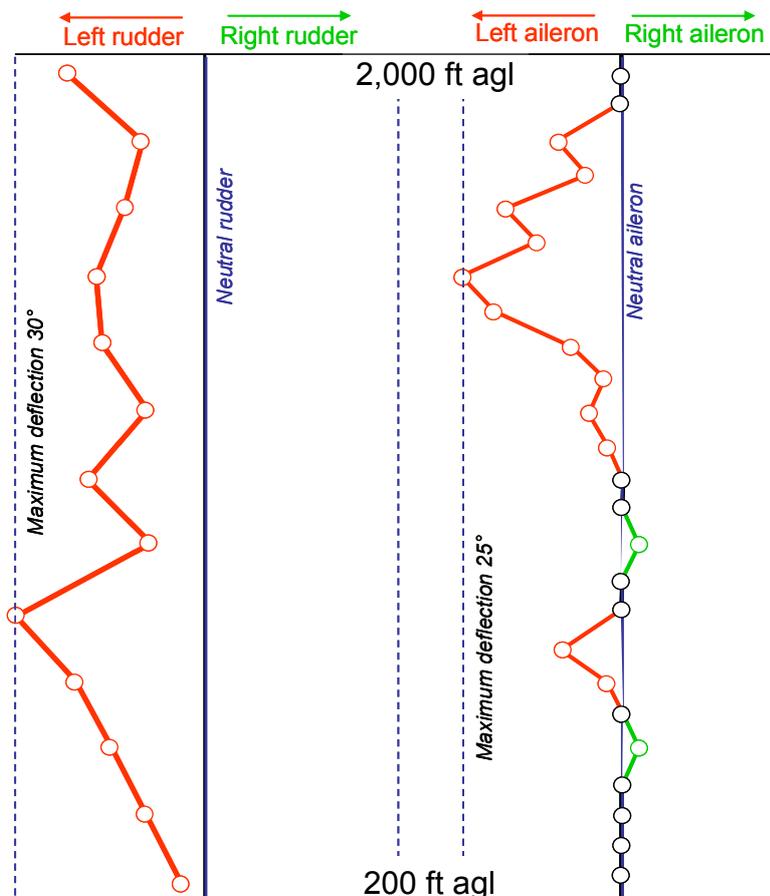
The radar-slaved video allowed a limited assessment of control surface positions. Figure 12 shows a graphical representation of rudder and aileron positions as the aircraft descended. The data begins at the point of intended recovery (1¼ turns after initiation of the snap roll) and ends when the aircraft descended out of view behind trees. Rudder position could only be accurately assessed when the aircraft presented a plan form to the camera, so the data points are plotted for every half turn. Increased data points are presented for aileron deflections; one per quarter turn. This was possible due to movement of the aileron spades under the wing, which allowed an assessment of their position when viewing the aircraft underside. Also, generally better views of aileron deflection allowed a degree of

Rudder and aileron deflections

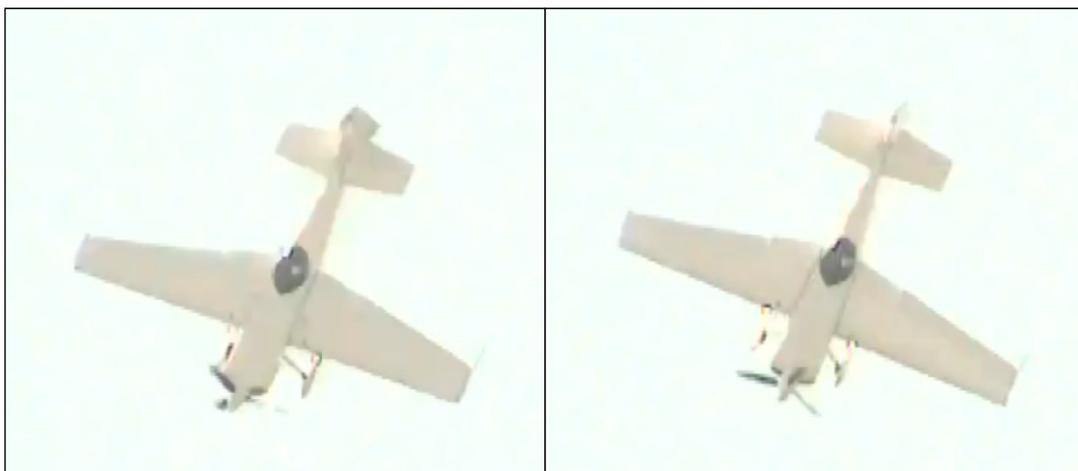
Figure 13 shows two consecutive images taken during the accident sequence. They are separated by a fraction of a second, at a point about two turns advanced from the images in Figure 11. Despite the very short time interval, significant changes to rudder angle can be seen. The pilot's head position is also still considerably displaced to the left.

Two turns after the point of expected recovery, the two images are taken from the accident sequence and only a fraction of a second apart. Note change in rudder position
