AAIB Bulletin No: 11/94

Ref: EW/G94/07/12

Aircraft Type and Registration: Cessna 150J, G-BOWC

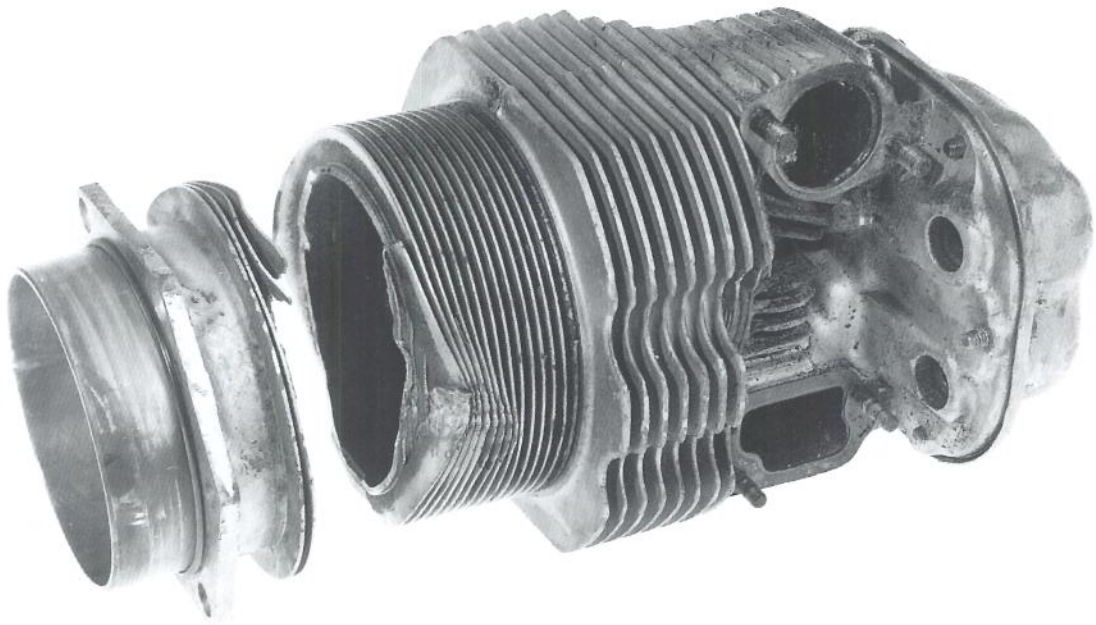
Investigation quickly showed that the front left (No 4) cylinder barrel had failed circumferentially around approximately the second/third cooling fin from the bottom, releasing the major portion of the barrel (see photograph). Subsequent metallurgical examination by the AAIB showed that the failure had been due to metal fatigue initiated by corrosion pits on the outside surface of the cylinder at the base of the cooling fins.

G-BOWC failed cylinder

A regular flight safety publication issued by Transport Canada Aviation called 'Flight Safety Maintainer' featured the problem of cylinder and head cracking in its issue 3/94. In addition to discussing the relative merits of renewing or overhauling cylinders, it advocated regular checks, including visual, borescope, compressed air and compression checks. The same publication, in its 4/93 issue, gave details of a Continental O-200A engine from a Cessna 150L which force landed following a separated cylinder. Cause of the failure was attributed to fatigue initiated by corrosion pits, the engine having run 3,170 hours since new and 1,371 hours since last overhaul. The calendar age of the engine was not stated. The photograph accompanying the article appears strikingly similar to the photograph which accompanies this bulletin and suggests that the origin of the fatigue occurred in the same location.
