**ACCIDENT**

<b>Aircraft Type and Registration:</b>	Piper PA-28R-201T Turbo Cherokee Arrow III, G-BFLI	
<b>No &amp; Type of Engines:</b>	1 Teledyne Continental Motors TSIO-360-FB piston engine	
<b>Year of Manufacture:</b>	1977	
<b>Date &amp; Time (UTC):</b>	25 June 2008 at 1748 hrs	
<b>Location:</b>	Bradford Leigh, Bradford-on-Avon, Wiltshire	
<b>Type of Flight:</b>	Private	
<b>Persons on Board:</b>	Crew - 1	Passengers - None
<b>Injuries:</b>	Crew - 1 (Minor)	Passengers - N/A
<b>Nature of Damage:</b>	Aircraft damaged beyond economic repair	
<b>Commander's Licence:</b>	Private Pilot's Licence	
<b>Commander's Age:</b>	59 years	
<b>Commander's Flying Experience:</b>	1,273 hours (of which 1,098 were on type) Last 90 days - 14 hours Last 28 days - 6 hours	
<b>Information Source:</b>	Aircraft Accident Report Form submitted by the pilot and subsequent AAIB investigation

**Synopsis**

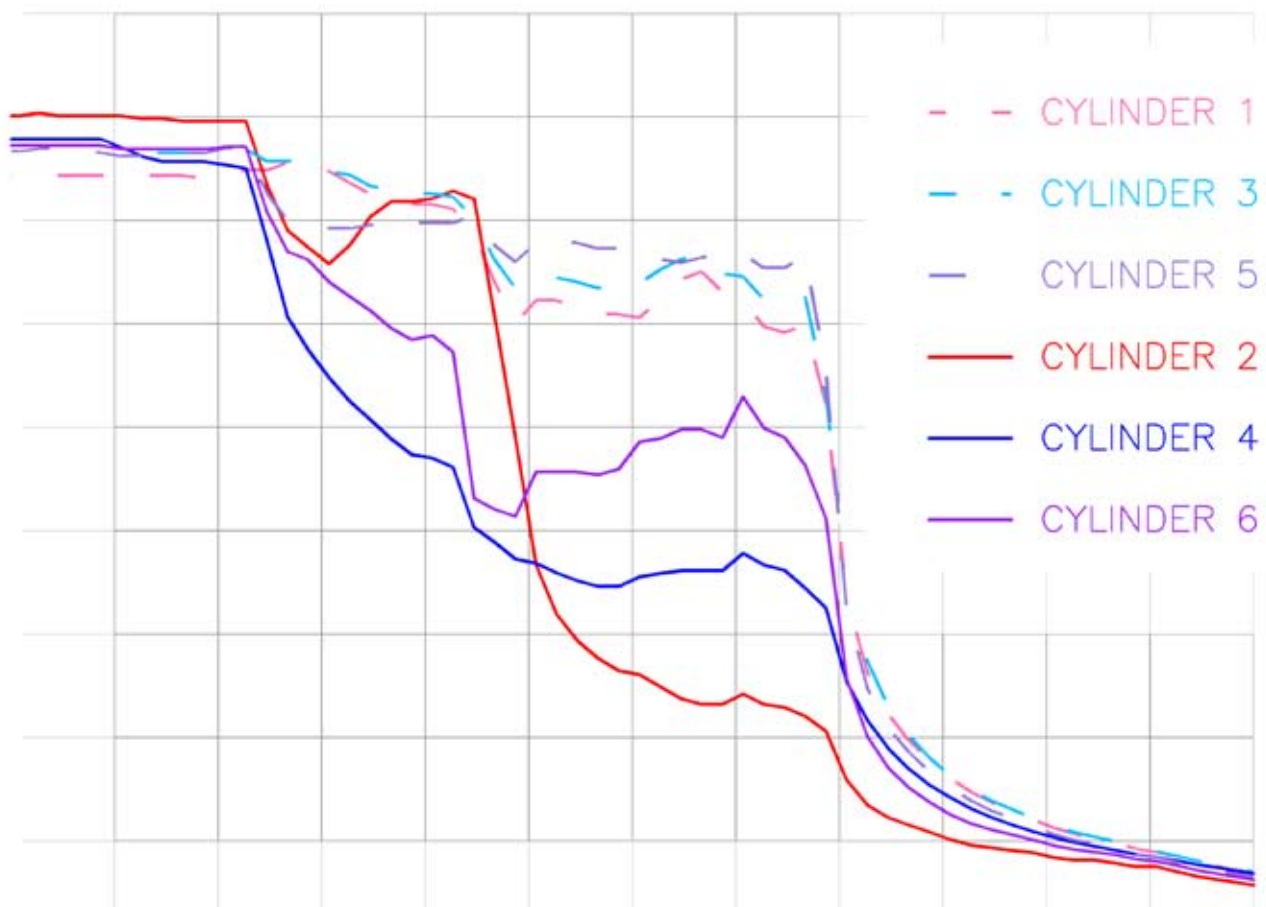
The JPI system and engine were recovered to AAIB headquarters. The JPI unit was dried slowly and the data downloaded. Figure 1 shows the EGT for all six cylinders at the time of the engine problem; it can be seen that the EGT for the No 4 cylinder dropped markedly, with the EGTs for the No 2 and 6 cylinders following shortly afterwards. Several seconds later the EGTs for the remaining cylinders decreased rapidly, consistent with the engine being shut down.

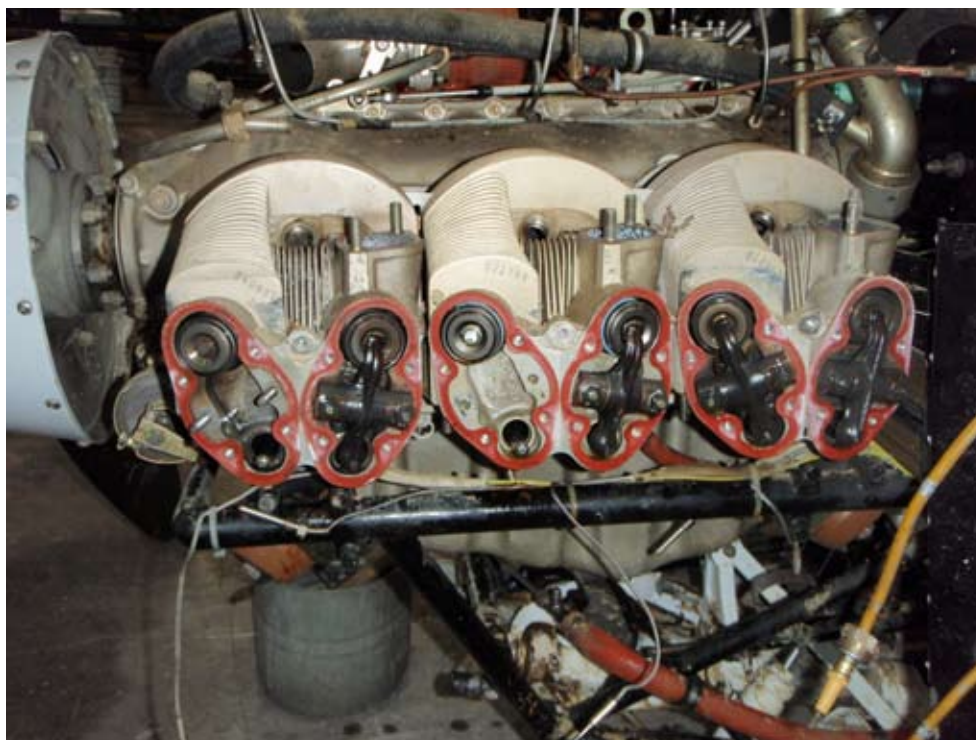
Figure 2

The engine was strip-examined with a representative from the manufacturer present. The two stud bolts that attached the inlet valve rocker assembly to the No 4 cylinder head were found to have failed (Figures 2 and 3), leaving the inlet valve closed. The valve opened satisfactorily when tested. Witness marks were present inside the rocker cover which appeared to have been made by the tie-down nuts from the failed stud bolts.

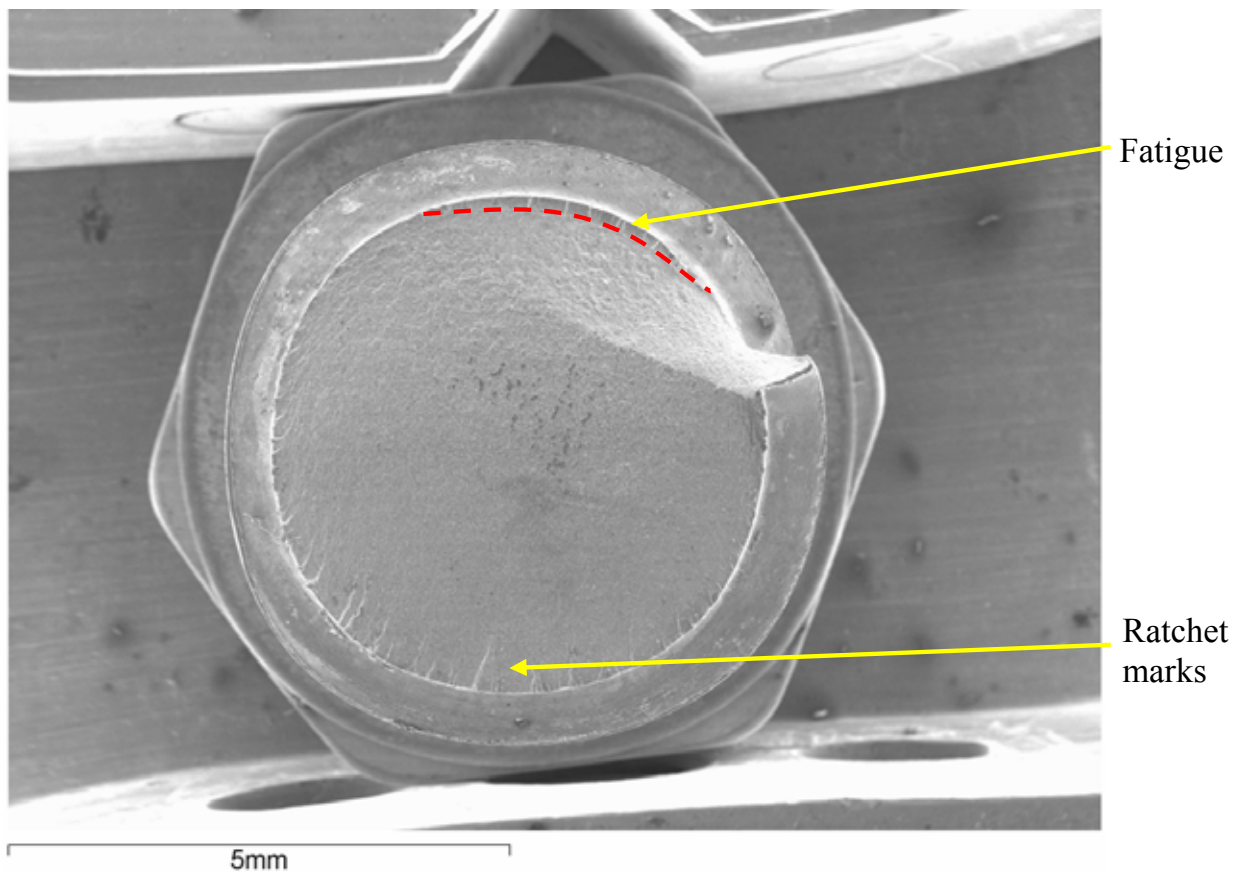
The two failed stud bolts (bolt 'A', Figure 4 and bolt 'B', Figure 5) were sent to a metallurgist for detailed

examination. Both showed evidence of fatigue, although no material defect that could have initiated the fatigue was found in either bolt. The hardness value of each bolt was checked; one was found to be 33 and the other 35 on the Rockwell 'C' hardness scale (HRC) the specified hardness range for this type of bolt being 28-32 HRC. The slightly high hardness values were not considered to be significant.

**Figure 4**  
Fracture surface of bolt A

No material defects were found in the failed stud bolts that could account for their failure. Given the recent replacement of the No 2 and No 4 cylinders, the possibility that the No 4 cylinder inlet valve rocker tie-down nuts had been incorrectly torqued on reinstallation could not be ruled out, but this could not be concluded with any degree of certainty.

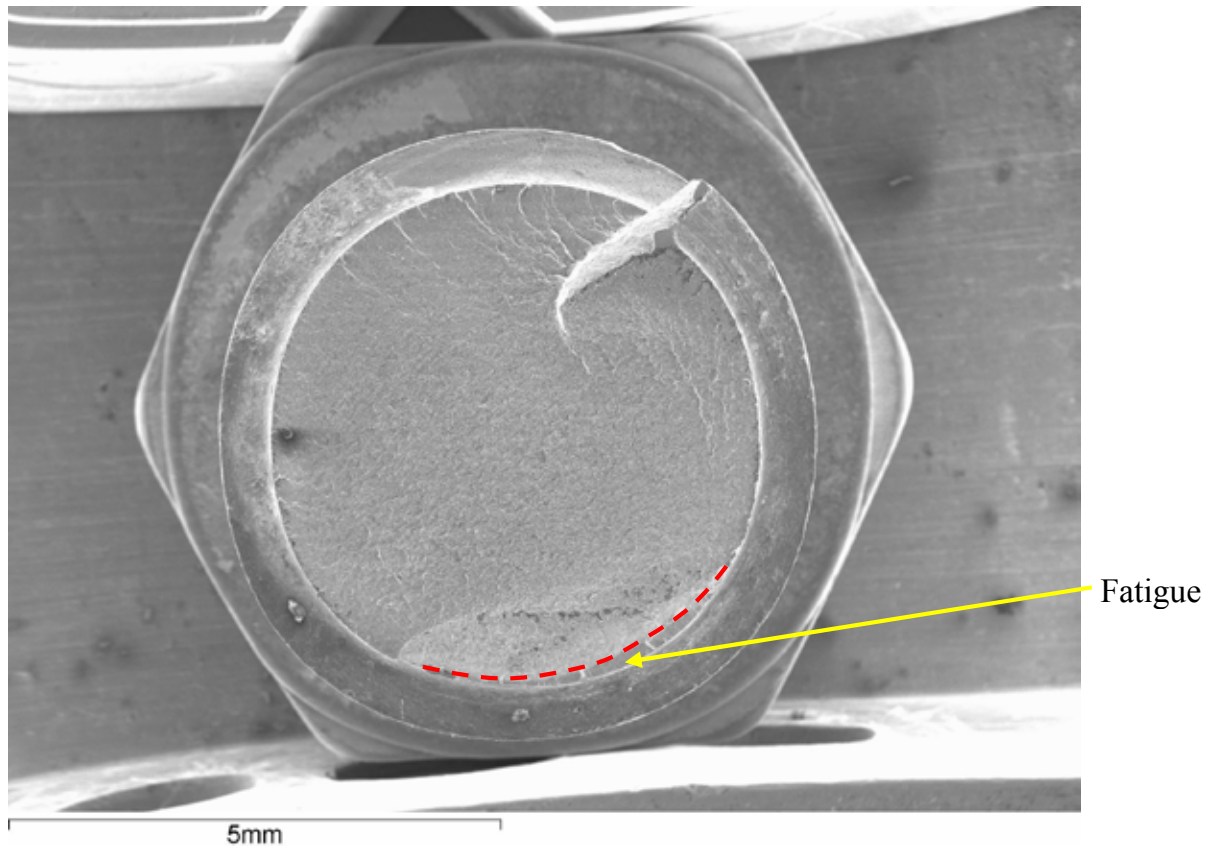
**Figure 5**

Fracture surface of bolt B
