Aircraft type and registration: Bell 222 G-DMAF (twin engined helicopter)

Date and time (GMT): 10 July 1985 at 1710 hrs

Location: Oxted, Surrey

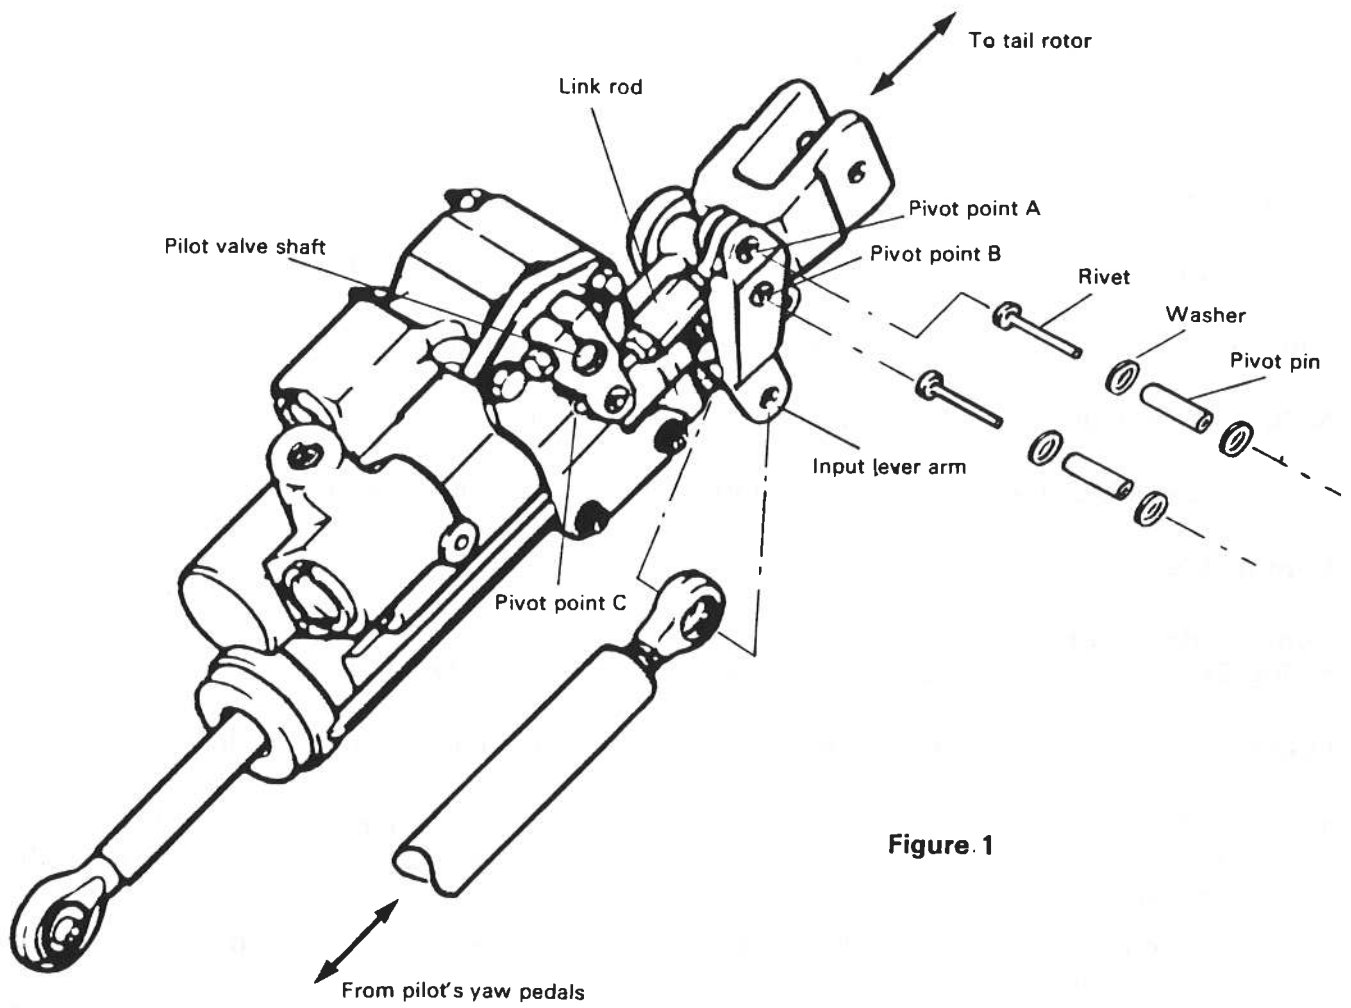
Figure 1

Yaw pedal movement on the Bell 222 is transmitted to the pitch change arms of the tail rotor blades via a rod and bellcrank lever linkage. A hydraulic servo jack is interposed in series in the linkage part way along the run to provide reduced pedal forces and prevent transient tail rotor loads feeding back to the pedals. An input lever arm pivoted on the jack body transmits yaw pedal demands to the jack pilot valve via a link rod. The arm and rod are connected (Point A, Fig 1) by a pivot pin which is retained axially by a rivet fitted through the pin bore and carrying a washer at either end. Inspection of the aircraft revealed that the arm was disconnected from the rod.

The ram of the servo jack is earthed to structure and the jack body moves to provide position feedback and thus cancel an input demand when it has been matched by jack displacement. In the event of an input disconnection position feedback is lost, and any displacement of the pilot valve from its null position will cause the jack to drive to full travel. The pilot valve is not self-centering.

A search at the accident site located the missing pivot pin beneath the aircraft, but in spite of a

search with metal detectors the associated rivet and washers were not found. There were no signs that the rivet had been forcibly removed from the pivot pin. It was not possible to ascertain whether the rivet had been inadequately formed and had fallen out, or had never been installed.

It was also found that no rivet was fitted in the pivot pin connecting the lever arm to the jack body (Fig 1, Point B). The maintenance organisation involved checked two other Bell 222's in their care and found that the rivet at Point C on one aircraft appeared inadequately formed with little spread of the tail. This rivet was fitted with the tail on the jack body side of the link and inspection with the actuator in situ was considered extremely difficult.

An Alert Service Bulletin issued by the manufacturer shortly after the accident and an Emergency Airworthiness Directive issued by the Federal Aviation Authority required inspection of the rivets at the above three points.
