INCIDENT

Aircraft Type and Registration:	Avro RJ85, D-AVRJ
No & Type of Engines:	4 Avco Lycoming LF 507-1H turbofan engines
Year of Manufacture:	1996
Date & Time (UTC):	21 April 2008 at 0650 hrs
Location:	London City Airport
Type of Flight:	Commercial Air Transport (Passenger)
Persons on Board:	Crew - 4 Passengers - 37
Injuries:	Crew - None Passengers - None
Nature of Damage:	Minor damage
Commander's Licence:	Airline Transport Pilot's Licence
Commander's Age:	45 years
Commander's Flying Experience:	10,000 hours (of which 7,000 were on type) Last 90 days - 150 hours Last 28 days - 50 hours
Information Source:	AAIB Field Investigation

Synopsis

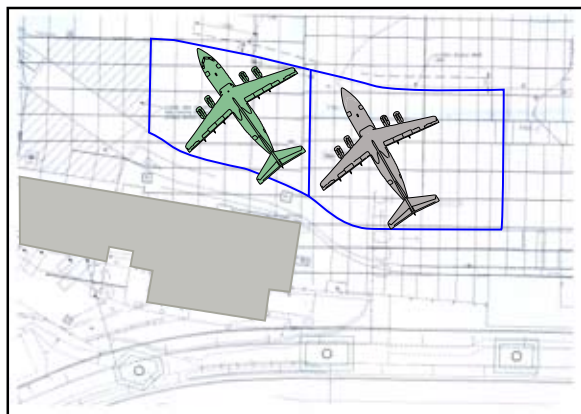
The RJ100 on Stand 11 had been parked 1 m to the right of the stand centreline but parallel to it, thus reducing the clearance from the RJ85, D-AVRJ, on Stand 10 by the same amount. D-AVRJ was initially parked on the stand centreline.

Location of the two parked aircraft.
D-AVRJ is the aircraft on the right and is about to taxi off the stand

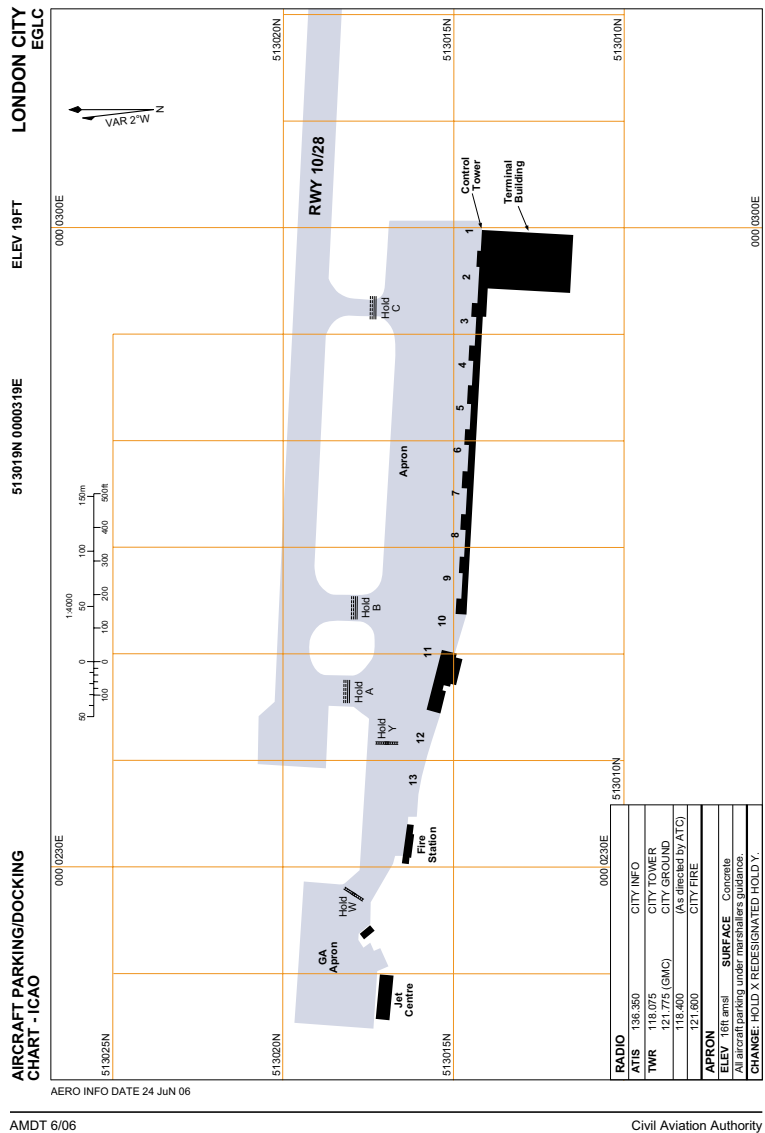
Figure 3
ICAO Parking/Docking Chart for London City Airport
(current at time of accident)
as published in UK AIP

At the time of the incident there were 13 stands at London City (Figure 3). Stands 10 and 11 are smaller and non-uniform in shape when compared with Stands 1 to 9.

Stands 10 and 11 are approximately 38 m and 31 m wide respectively.
