INCIDENT

Aircraft Type and Registration:	Airbus A320-214, G-BXKD
No & Type of Engines:	2 CFM56-5B4/P turbofan engines
Category:	1.1
Year of Manufacture:	1997
Date & Time (UTC):	15 January 2005 at 1635 hrs
Location:	London Gatwick Airport, West Sussex
Type of Flight:	Public Transport (Passenger)
Persons on Board:	Crew - 7 Passengers - 177
Injuries:	Crew - None Passengers - None
Nature of Damage:	Left nose wheel detached from aircraft
Commander's Licence:	Airline Transport Pilot's Licence
Commander's Age:	40 years
Commander's Flying Experience:	6,200 hours (of which 4,400 were on type) Last 90 days - 113 hours Last 28 days - 55 hours
First Officer's Flying Experience	4,392 hours (of which 2,566 were on type) Last 90 days - 82 hours Last 28 days - 36 hours
Information Source:	AAIB Field Investigation

Synopsis

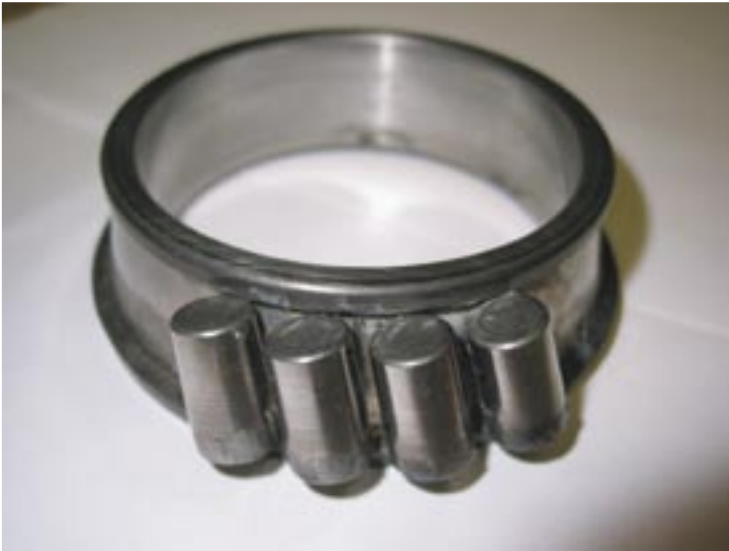
The cage, which was distorted, was cut open to allow the bearing to be inspected. (Figures 6 and 7) The cage pockets were skewed and metal transfer had occurred between the cage and cup, approximately 5 to 10 mm from the roller large end. Four of the rollers were welded to the race at an angle of approximately 16° and there were marks around the remainder of the circumference indicating that the remaining rollers had

been spot welded to the cone race. The roller large ends were slightly deformed with metal smearing and signs of bluing, which indicates temperatures above 815°C. A number of the rollers also exhibited metal smearing and a flat spot within 10 mm of the roller large end, which indicates that the rollers had skidded for a short period. The cone large rib face exhibited signs of plastic deformation and bluing around its circumference. The cup displayed evidence of light straw discolouration, indicating temperatures of approximately 238°C, and metal smearing 5 mm deep around the circumference of the race, which matched the metal smearing on the cage.

Figure 6 (left)
Rollers welded to cone

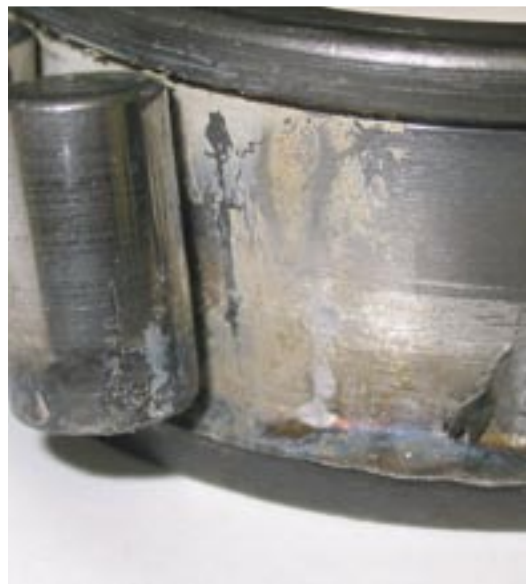
Figure 7 (right)
Distortion of cone large rib
face

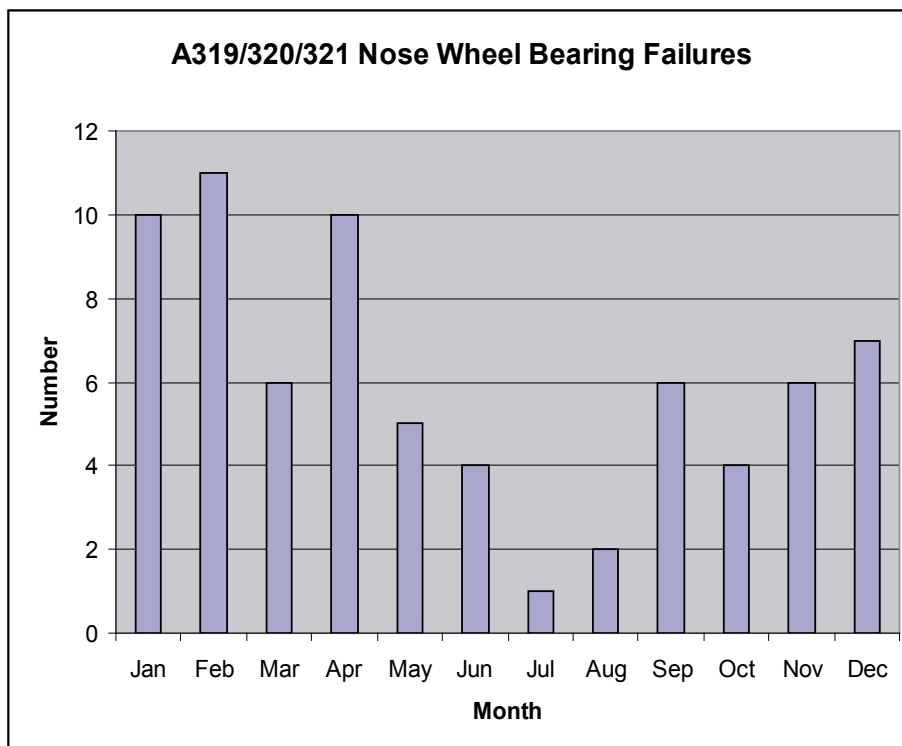
Graph 1

a seasonal connection. However, given the size of the fleet and the number of cycles flown since 1989 care must be taken in how this relatively small number of occurrences is interpreted. (See Graph 1.)

Following the early failures an investigation was undertaken by the aircraft, wheel and bearing manufacturers who determined that the failure mode of the bearing was roller end scoring, resulting from excessive rib stress. In the subsequent years a number of measures were introduced such as increasing the bearing preload and reducing the aircraft speed when undertaking

Data provided by the aircraft manufacturer indicated that there had been 74 reported occurrences of problems with the nose wheel bearings on the A319/320/321 family of aircraft since 1989, which resulted in seven nose wheels coming off aircraft operated by six different airlines. Four of the incidents involved the left wheel. Approximately 44% of the occurrences involved the new wheel assembly (3-1531), of which 28% involved the outer bearing. The majority of the airlines that have reported problems operate in the Northern Hemisphere and it would appear from the data that there might be
