INCIDENT

Aircraft Type and Registration: Boeing 737-4Y0, G-OBMM

Location: Tenerife

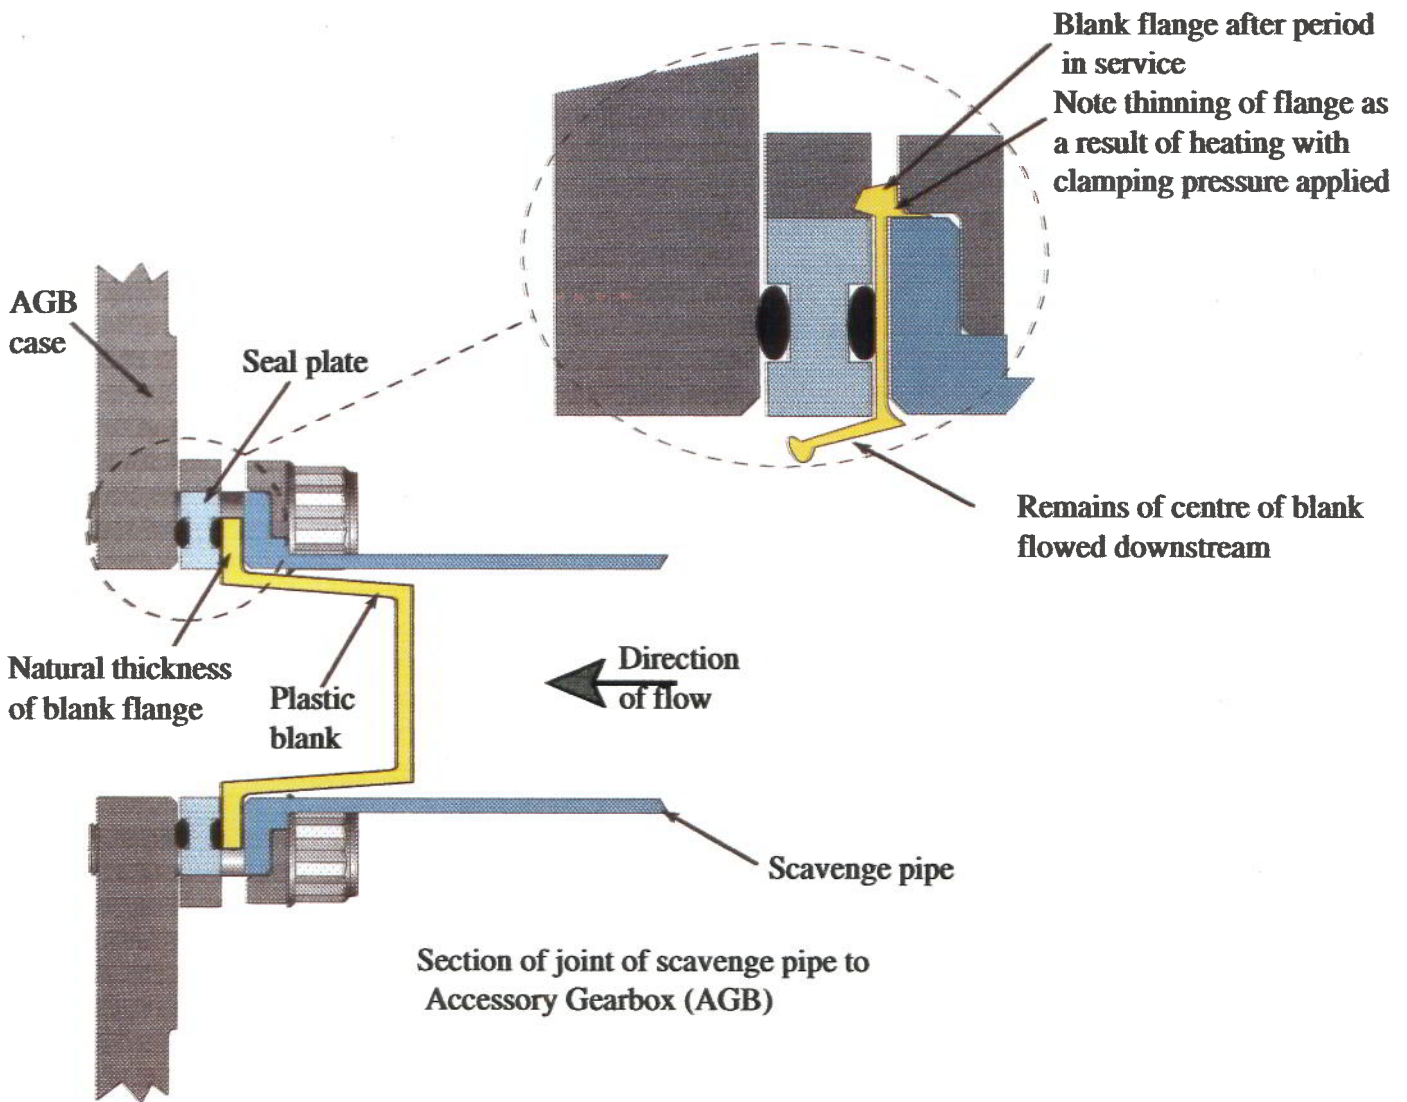
There were several possible ways considered in which the plug could have been left in, or be placed within the pipe. Examination of the softened plastic showed that it was contoured to match the pipe flange and securing plate, rather than the completely flat flange of the AGB. This indicated that the flange had been on the pipe side, which appeared consistent with failure to remove the plug from the pipe before assembly. Another type of plastic plug, usually coloured red, is used to blank the AGB and this is rather larger and blocks the bolt holes. This had been removed. The accompanying diagram shows the general arrangement of the pipe, seal assembly and the position at which the blank had been located. The associated photograph shows the appearance of the parts during assembly; note that the yellow blank, which is in place within the scavenge pipe, is not clearly visible.

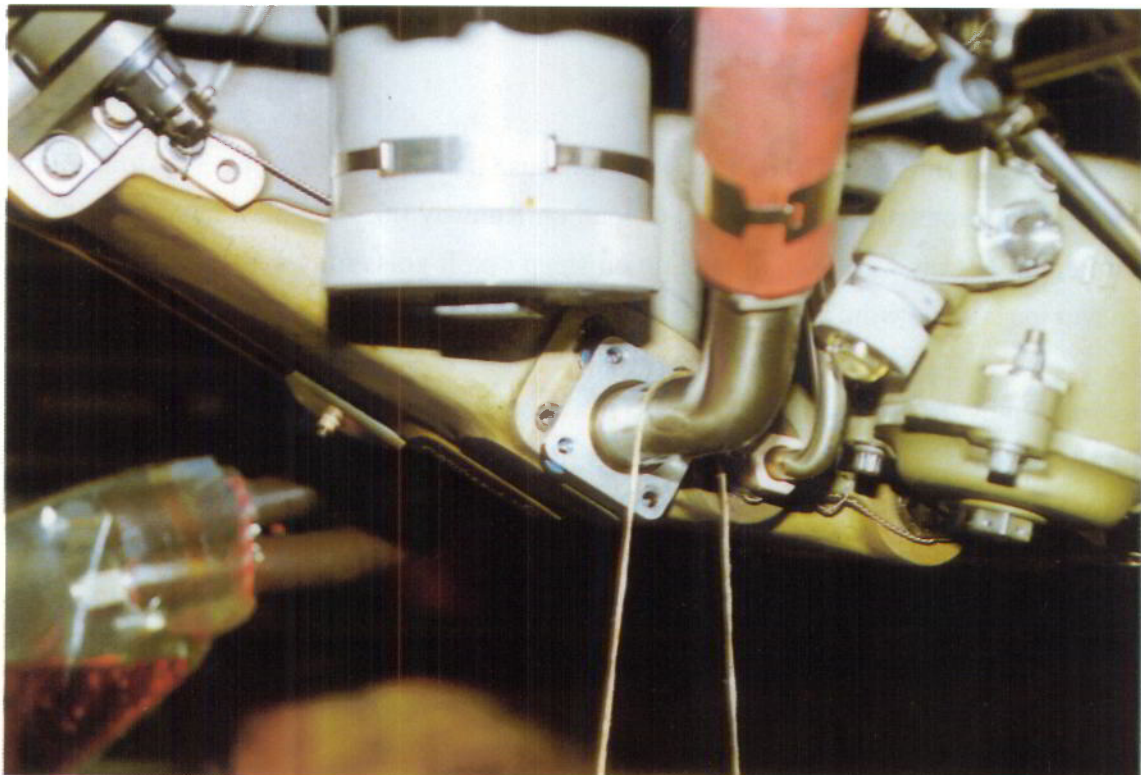
Following this incident the overhaul agency determined that the yellow plastic debris found was the remains of the type of blanking plug normally used to blank off the scavenge pipe during overhaul. Tests showed that this type of plug lost all mechanical strength at around 80 - 90°C, whereas the oil normally operates at some 100 - 110°C. During initial running, before the oil temperature increased, the plug would have obstructed oil flow from the TGB to the AGB, however this would have caused the oil to 'back-up' in the pipe until the level in the TGB was such that oil could flow into the transfer drive shaft duct. This duct runs between the TGB and the top of the AGB and therefore oil would flow back into the AGB via the duct until the plug softened sufficiently to rupture under the head of oil. This sequence accounted for the apparently normal oil system operation in the test cell and in the subsequent flights. The oil leak was then caused by progressive deterioration and breakup of the flange of the blanking plug and the seal plate 'O' ring.

View on end of assembly with yellow plastic blank in scavenge pipe
