Aircraft Type and Registration: Yak 18T, RA-44481

Date & Time (UTC): 7 August 1994 at 1425 hrs

Location: White Waltham Airfield, Berkshire

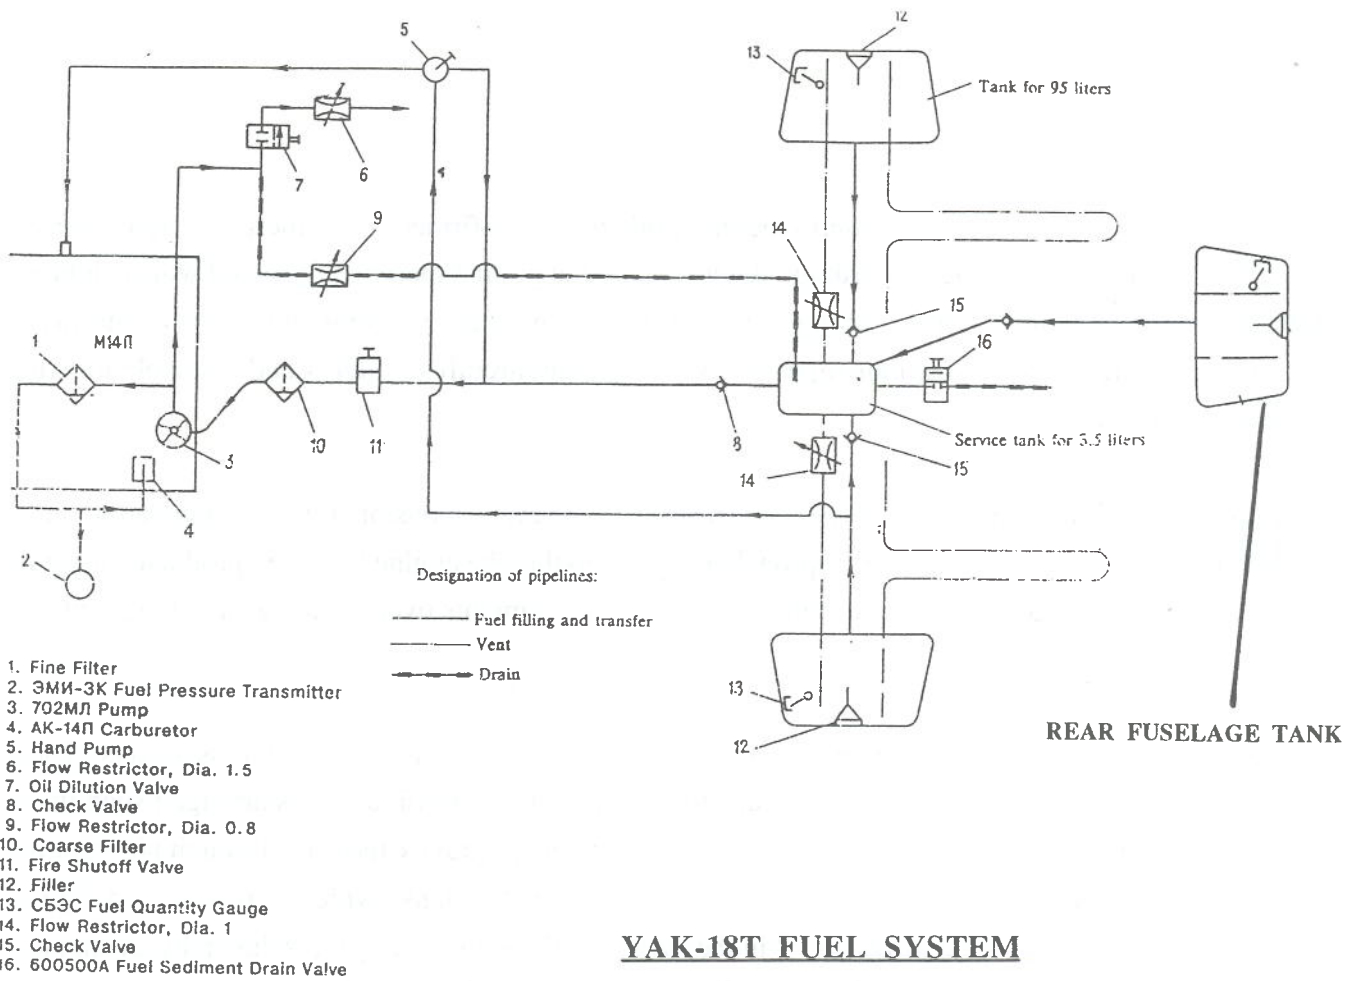
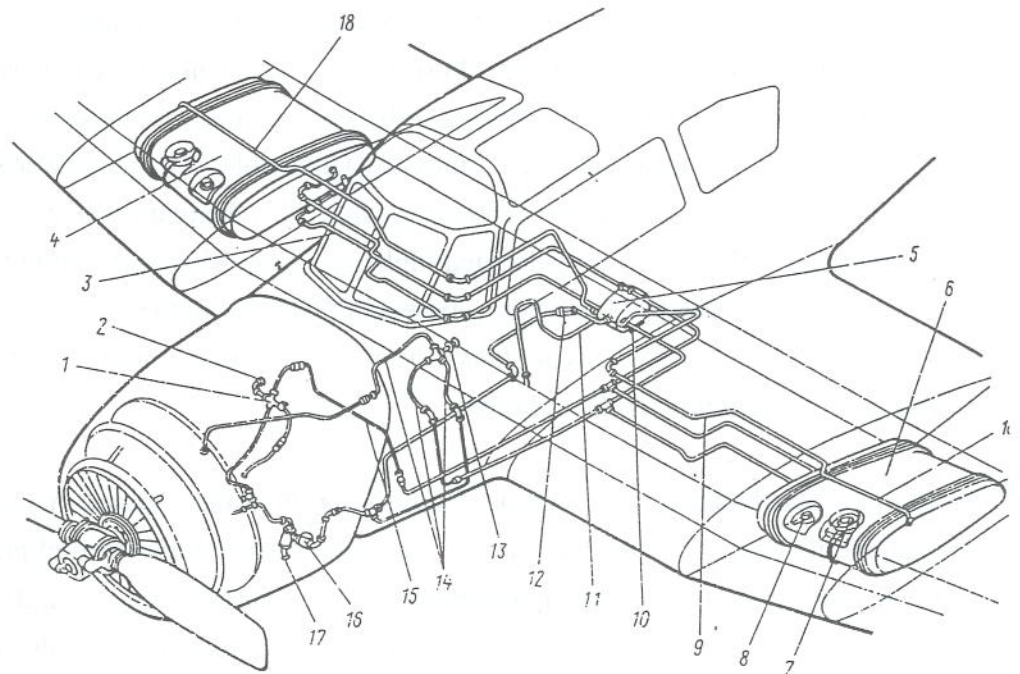
Figure 1

The aircraft's fuel system was examined and found to be clean and free from any obvious defects. The basic Yak 18T fuel system, shown diagrammatically and pictorially in Figure 1, is arranged such that two main tanks (each of 95 litres capacity, with one in each wing) gravity feed fuel through non-return valves into a service tank in the centre fuselage. Fuel from this tank, which is of only 3.5 litres capacity and is designed as the lowest point in the system with the aircraft erect, is drawn by an engine driven pump and delivered to the carburettor. To ensure that a supply of fuel is available to the engine under negative g conditions, the internal fuel outlet pipe from this tank is flexible and weighted at its open end so that it will always fall to the lowest point in the tank and remain submerged in fuel until the tank contents become depleted. With a full service tank the engine will run at full power for approximately 30 seconds, but longer times are achievable at lower power settings. RA-44481 was fitted with an additional fuel tank of 130 litres capacity in the rear fuselage, which was also connected into the service tank. This tank is located higher than the wing tanks and produces, under positive g conditions, a greater head of fuel with a consequent increase in the rate of fuel transfer into the service tank than that provided by the wing tanks. It was reported that approximately 15 to 20 litres of fuel was present in this tank after the accident.

The pilot reported that in his experience of this aircraft all the inverted manoeuvres that he had flown during practice and previous displays were possible without loss of fuel pressure. On the accident flight the engine lost power after approximately 50 seconds of inverted flight. The pilot believed that this had resulted from his use of a higher than intended power setting for the manoeuvre and, possibly, not starting the inverted run with a full service tank as a result of insufficient time having elapsed for it to have refilled following his previous negative g manoeuvres during the flying display. Fuel quantity in the service tank is not separately indicated to the pilot in the Yak 18T.
