Aircraft type and registration:	Enstrom F28A G-BAWI (single engined light helicopter)	
Year of Manufacture:	1972	
Date and time (GMT):	22 July 1984 at 1446 hrs	
Location:	Netley Marsh	
Type of flight:	Commercial (pleasure)	
Persons on board:	Crew — 1	Passengers — 2
Injuries:	Crew — None	Passengers — None
Nature of damage:	Damage confined to engine	
Commander's Licence:	Commercial Pilot's Licence (Helicopters)	
Commander's Age:	30 years	
Commander's total flying experience:	360 hours (rotary wing) of which 106 were on type	
Information Source:	Aircraft Accident Report Form completed by the pilot, and subsequent AIB investigation of the engine failure

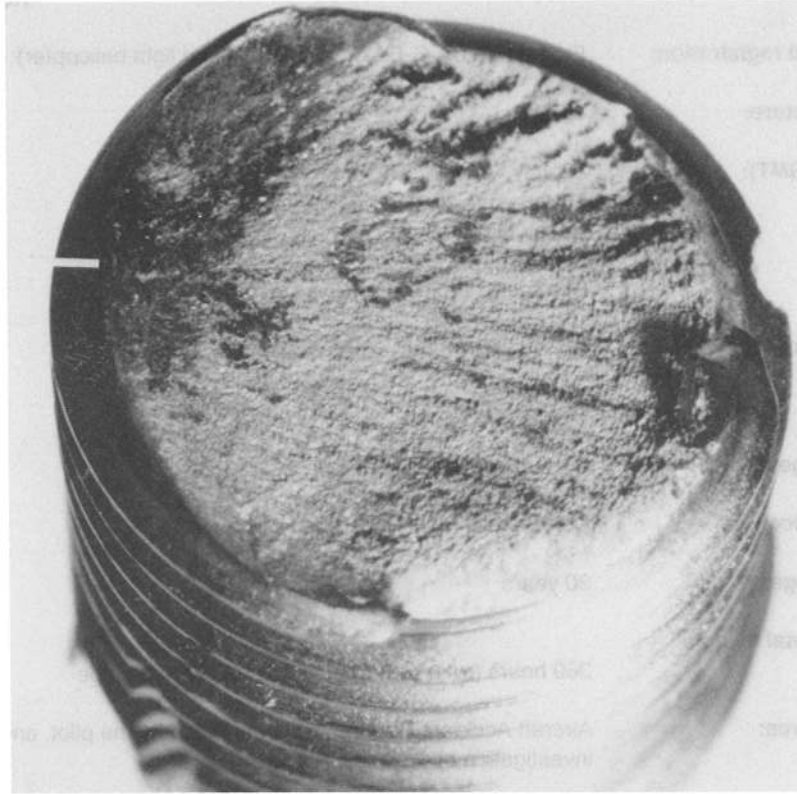
FIG.1 FRACTURE OF FIRST BOLT TO FAIL

Sections of the No 1 big-end cap bolts, (Lycoming Pt No 75060), were recovered during the examination and metallurgically inspected. Both bolts had failed in their threaded lengths and one of them had also fractured through a waisted part of the shank. Mechanical damage to the fracture surfaces, shown in Figures (1) and (2), had obscured the origins of both fractures in the threaded lengths, but it was possible to establish the initiation positions, arrowed, by the curvature of the striated crack growth features visible to the naked eye on the surfaces. In the case of the bolt with the single fracture, Figure (1), its general appearance suggested a high strain low cyclic crack growth mechanism, the striation's curvature indicating that initiation had occurred over a length of thread root.

From the examination it seems likely that the fracture to the bolt shown in Figure (1) occurred first and resulted in the more rapid failure of the second bolt. However, the available evidence indicates that the primary failure also developed rapidly and under conditions of abnormally high loading, no metallurgical reason being found to account for this first failure.

**REGION OF
INITIATION**

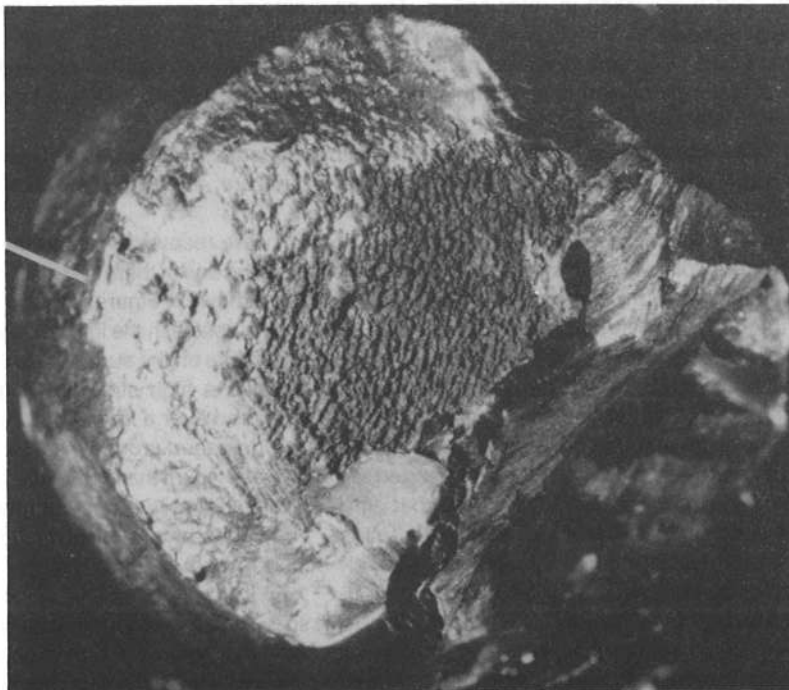
FIG.2 INITIAL FRACTURE OF MATING BOLT

The fracture surface of the other bolt, Figure (2), was quite severely damaged around the outer edge but, again, exhibited striated features over the whole of the undamaged region. It was evident that this failure had occurred after considerable plastic deformation around the thread root although the striated features suggested that the mid-region failed under conditions of low cycle, high strain fatigue. The second fracture through the bolt exhibited features consistent with ductile shear overload and probably occurred as a result of entrapment between the crankshaft and crankcase after separation of the cap.

**REGION OF
INITIATION**
