AAIB Bulletin No: 2/94

Ref: EW/C93/10/1

Aircraft Type and Registration: Stolp Starduster Too, G-BPOD

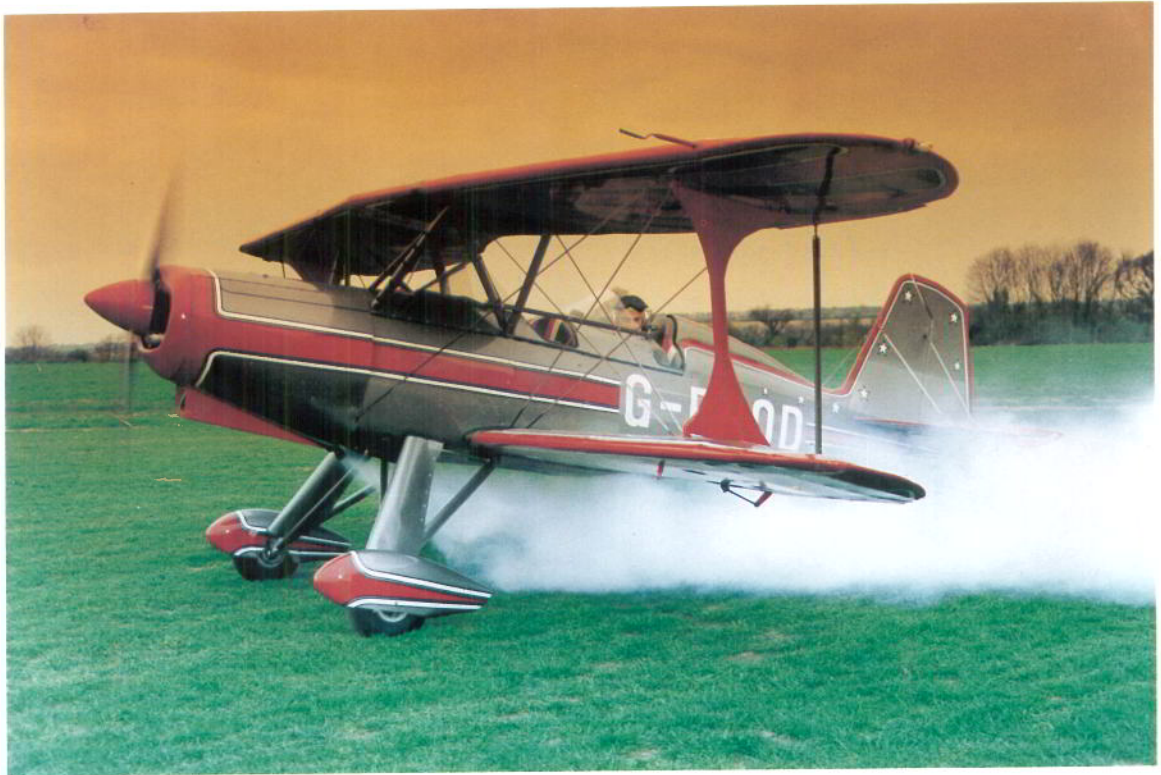
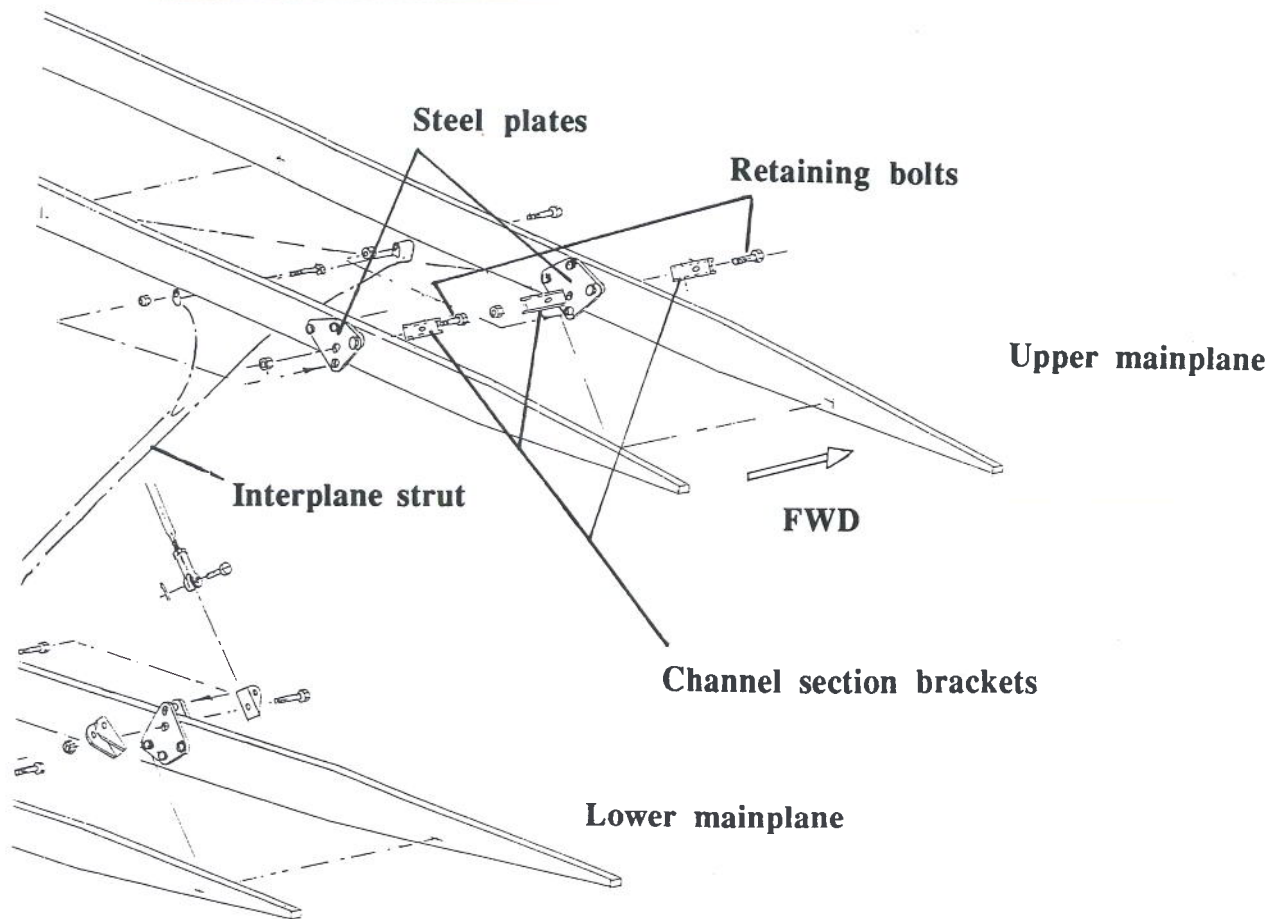
It was quickly established that although the aircraft had been structurally complete at impact, there had been pre-impact detachment of two out of the three flying wires attaching to the underside of the right hand upper mainplane. The Stolp is of typical biplane construction in that the wings are effectively pin jointed to the fuselage and centre struts, the positive and negative g loads being carried respectively by the 'flying' and 'landing' wires. There are three flying wires on each side of the fuselage, all attaching to the outboard upper mainplanes. The rear-most is attached to the rear spar, while the remaining two are attached to the front and rear faces of the front spar. The flying and landing wires cross over in the interplane area, and they are all lashed to a longitudinally orientated wooden pole, often referred to as an 'acorn'. The flying wire details are shown in Figure 1, and it can be seen that the two forward wires are retained by a single bolt passing through the spar. The spars are of wooden construction, but have steel plates bolted to the front and rear faces at the flying wire attachments. The plates also serve as the interplane strut attachments. The flying and landing wires are stainless steel strips, elliptical in section in order to minimise aerodynamic drag. The ends are terminated with turn barrels and fork end fittings which, at their outboard ends, are attached via nut, bolt and split pins, to channel section brackets. The latter are then bolted to the spars.

FIGURE 1. Detail from aircraft drawings

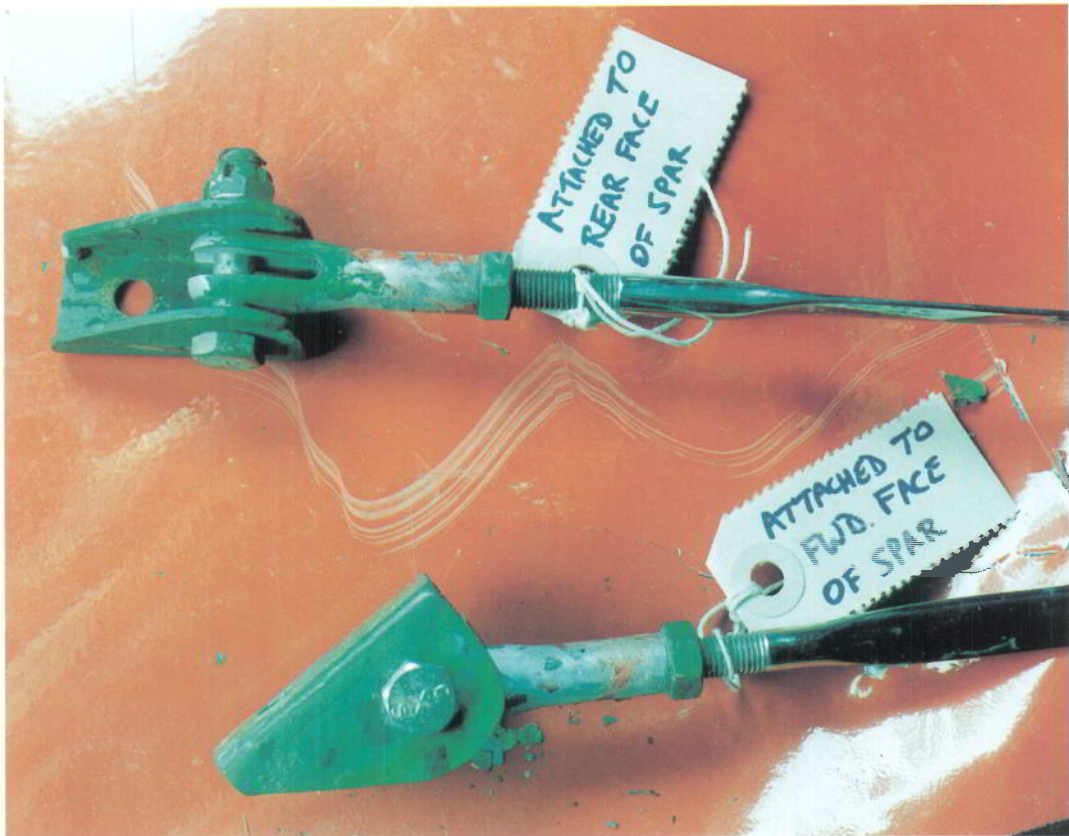
Figure 2 shows the two front, right hand side, flying wires in their as-found condition. It was noted that the holes in the channel section brackets bore no evidence of any distress, such as elongation, that could be expected as a result of impact forces with the bolt in position. The same was true of the holes in the associated reinforcing plates, the one attached to the spar front face being shown in Figure 3. Such evidence indicated that the bolt had not been present at the time of impact. Neither the bolt nor its associated nut were recovered, despite a search of the accident site using metal detectors.

FIGURE 2. Right hand front flying wire attachments; as found

93-70 It is recommended that the CAA should require that all flying and landing wire attachment bolts on UK registered Stolp Starduster aircraft be replaced with correct size bolts and, since limited rotation of the flying wire/spar attachments occurs, castellated nuts and split pins should be required. (Issued 17 January 1994)

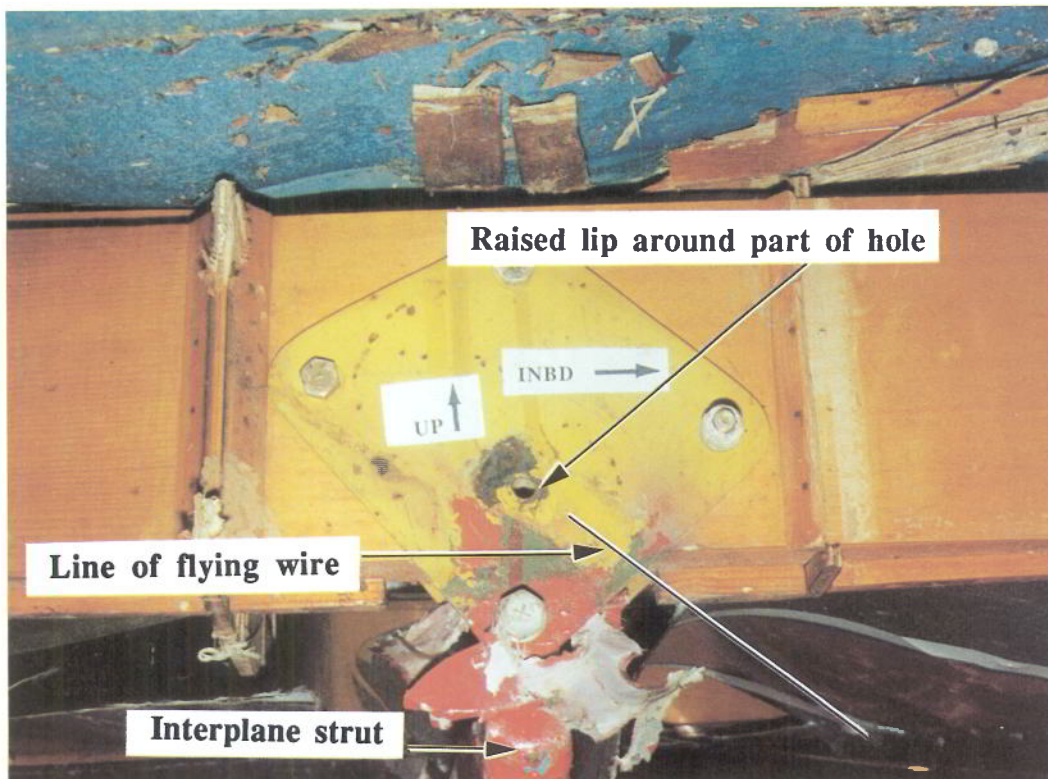
Also visible in Figure 3 is an area where the paint had been worn away due to fretting between the plate and the channel section bracket. Similar evidence was found on the underside of the bracket, and indicated relative rotation, about the bolt, between the two components.

The hole in the spar plate (front face) had a raised lip on an arc of its circumference centered on a line whose radial orientation was aligned with the flying wire. This feature was considered likely to have occurred as a result of tension in the front flying wire giving rise to a levering action as the bolt completed its forward migration out of the hole. Additional evidence of the forwards migration of the bolt was provided by a series of marks that conceivably could have been made by the bolt head, on the inner surface of the sheet alloy leading edge.

FIGURE 3. View on forward face of front spar of RH upper mainplane. Note area of paint removal due to fretting from channel bracket

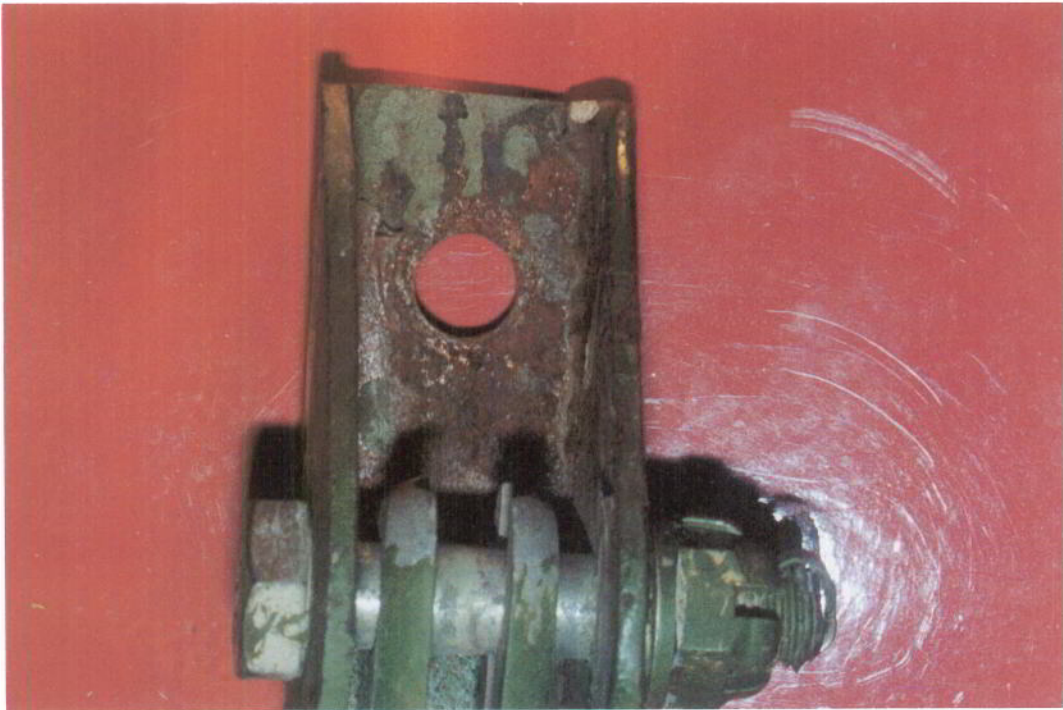
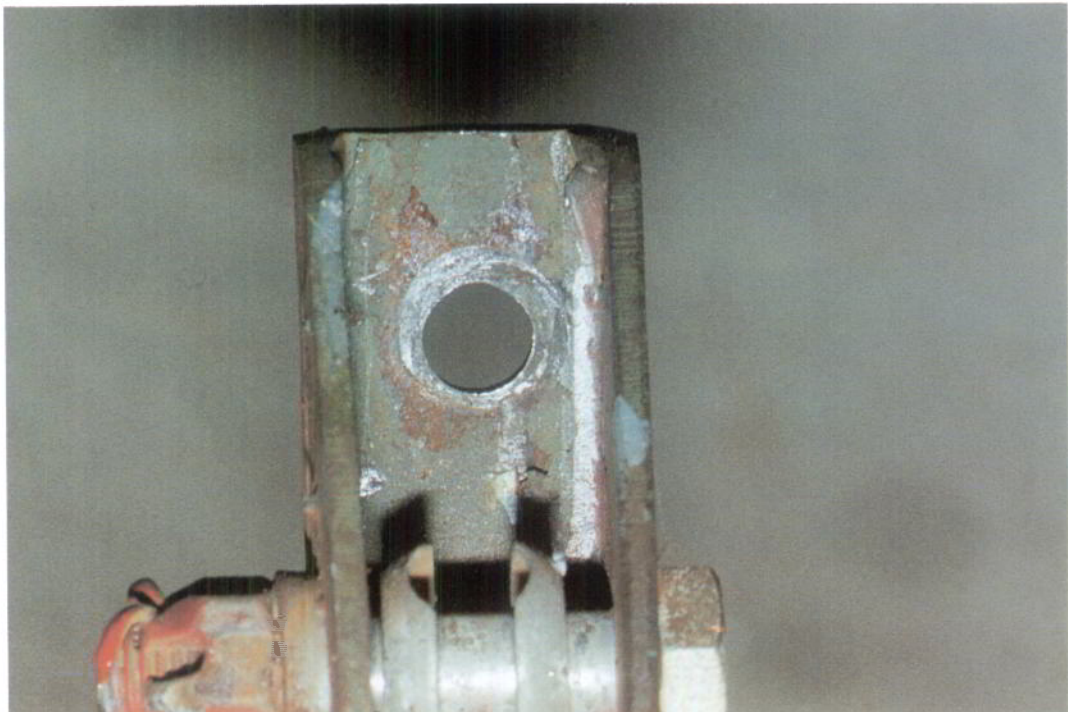
The front flying wires were removed from the left upper mainplane and the attachment components examined. Before removing the bolt and its associated stiffnut (which required 7.5 ft lbs break-out torque), it was observed that 2 to 3 threads were visible aft of the end of the nut. The faces of the spar plates and the undersides of the channel section brackets showed evidence of rotational fretting, although to a slightly lesser extent than that observed on the right hand side. The bracket attached to the rear face of the spar displayed a bright, uncorroded area around the hole where it had been in contact with the face of the retaining nut. This was in stark contrast to the corresponding bracket from the failure area, which displayed evidence of long term corrosion, although it was possible to discern the contact area of the nut. This led to the conclusion that the nut had been missing from the right hand assembly for some time. Photographs of the brackets are presented in Figure 4.

The reason for the nut detachment could not be determined. It is possible that flying wire vibration, or structural flexing, resulted in the channel bracket unwinding the nut via a 'ratchet' action. However, the corrosion evident around the hole in the bracket indicated that there had been no significant contact with the face of the nut for some time.

FIGURE 4. Comparison of channel bracket from failed side (top) with item from intact left wing. Contact area of nut face is clearly visible in lower picture. (Note: holes are $\frac{5}{16}$ " dia.)
