## BAe 146-200, G-MANS

<b>AAIB Bulletin No: 3/2004</b>	<b>Ref: EW/C2003/03/03</b>	<b>Category: 1.1</b>
<b>INCIDENT</b>		
<b>Aircraft Type and Registration:</b>	BAe 146-200, G-MANS	
<b>No &amp; Type of Engines:</b>	4 Lycoming ALF 502R-2 turbofan engines	
<b>Year of Manufacture:</b>	1987	
<b>Date &amp; Time (UTC):</b>	30 March 2003 at 1757 hrs	
<b>Location:</b>	Brussels Airport, Belgium	
<b>Type of Flight:</b>	Public Transport	
<b>Persons on Board:</b>	Crew - 5	Passengers - 43
<b>Injuries:</b>	Crew - None	Passengers - None
<b>Nature of Damage:</b>	Damage to tail bumper	
<b>Commander's Licence:</b>	Airline Transport Pilot's Licence	
<b>Commander's Age:</b>	33 years	
<b>Commander's Flying Experience:</b>	3,680 hours (of which 480 were on type)	
	Last 90 days - 90 hours	
	Last 28 days - 24 hours	
<b>Information Source:</b>	AAIB Field Investigation

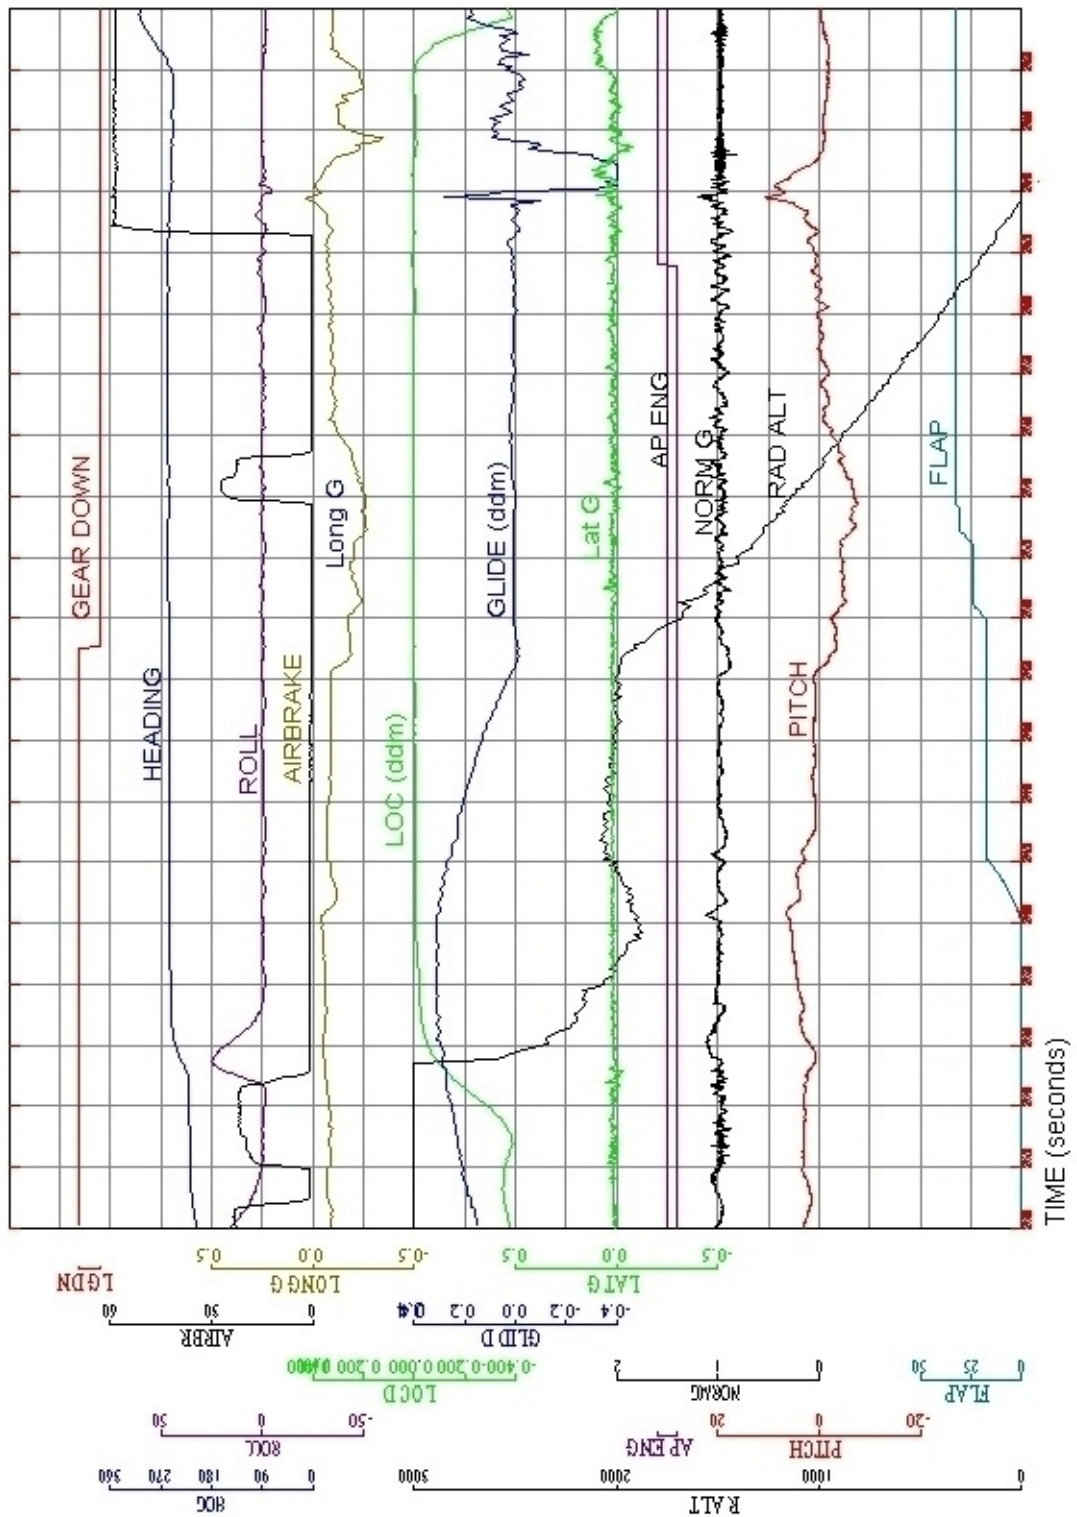
Figure 1

A plot of relevant data recorded during the approach and landing is at Figure 1.

The absence of altitude, airspeed and engine parameters severely restricted the usefulness of the recorded data. The data that was recorded showed that the aircraft had captured the glideslope at 2,000 feet agl. As soon as the aircraft started to descend with the glideslope the landing gear was lowered. At 1,170 feet agl, after the final stage of flap had been selected, a little less than half of the available airbrake was deployed for a period of 16 seconds; the airbrakes were then restowed.

The autopilot was disengaged at 215 feet agl, 22 seconds before touchdown. At 125 feet agl the airbrake was deployed to 55° and remained in that position until the aircraft had landed. After the airbrake had been deployed the recorded pitch attitude increased, as did the rate of descent which, by 70 feet agl, had developed to about 900 fpm. In the final second before touchdown the pitch attitude increased rapidly and the rate of descent was reduced to about 300 fpm.

At touchdown the recorded pitch attitude was 10.6° nose up. Immediately after touchdown the pitch attitude was reduced to 7° as the aircraft began to roll to the left, reaching a maximum of 4.5° left wing down over the next four seconds.
