Boeing 747-267B, TF-ATD

AAIB Bulletin No: 8/2003 Ref: EW/C2002/10/01 Category: 1.1

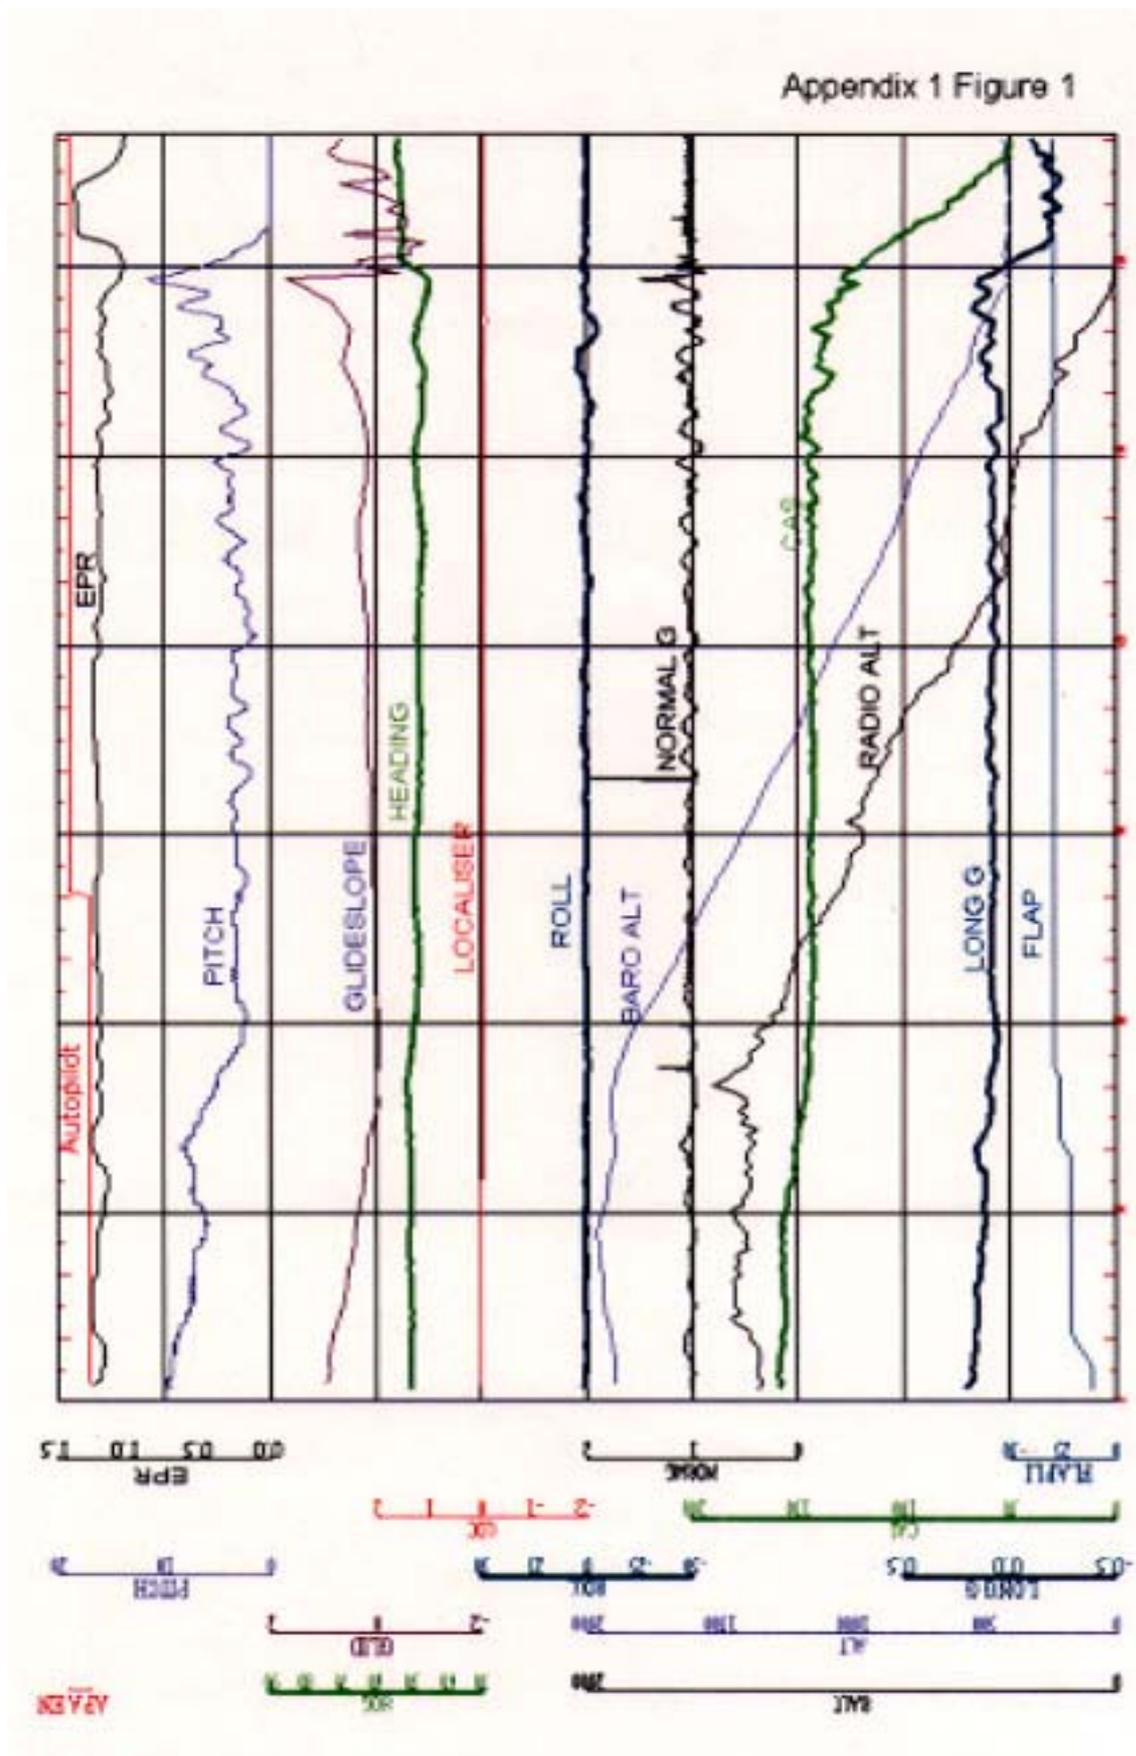
Appendix 1 Figure 1 shows a graphical time history of selected FDR parameters beginning three minutes before landing. Figure 2 is an expanded graph of the data with relevant annotations from the CVR recording.

From Figure 1 it is clear that the aircraft was tracking the glidepath and localiser signals until about 400 feet agl. At 400 feet there was a small reduction in engine power, the barometric altitude indicated an increase in rate of descent and the ILS glidepath signal showed the aircraft beginning to deviate below the glidepath. The aircraft remained below V_{APP} , but above V_{REF} until 300 feet when the airspeed increased to 148 kt remaining at around 146 kt to 250 feet. Thereafter, pitch attitude increased and the airspeed started to reduce. Coincident with the flight engineer's 200 foot call the GPWS initiated the first of two Mode 5 aural "GLIDESLOPE" warnings. The aircraft pitch attitude continued to increase and the glidepath deviation stabilised for about 7 seconds at about 1/2 dot 'fly up' demand. As the pitch attitude increased, the airspeed reduced and at 100 feet agl the speed was 136 kt. There was a small increase in power at about 90 feet agl; however, the pitch attitude continued to increase and the airspeed decayed further. Airspeed continued to decay to 129 kt at 36 feet with the aircraft 1/2 scale deflection below the glide-slope and thrust reducing. At about that time the CVR recorded the non handling pilot call "watch the speed". From 20 feet above the runway the fuselage nose-up pitch angle increased rapidly from 7° and at 5 feet above the runway, the airspeed was 121 kt with the thrust set at idle.
