<b>Aircraft Type and Registration:</b>	DH82A Tiger Moth, G-ALIW	
<b>No &amp; Type of Engines:</b>	1 De Havilland Gipsy Major I piston engine	
<b>Year of Manufacture:</b>	1938	
<b>Date &amp; Time (UTC):</b>	15 February 2005 at 1330 hrs	
<b>Location:</b>	Private Strip at Littlebredy, Dorchester, Dorset	
<b>Type of Flight:</b>	Private	
<b>Persons on Board:</b>	Crew - 2	Passengers - None
<b>Injuries:</b>	Crew - None	Passengers - None
<b>Nature of Damage:</b>	Damage to propeller, underside of lower wing and detached undercarriage strut on right side	
<b>Commander's Licence:</b>	Airline Transport Pilot's Licence with Instructor Rating	
<b>Commander's Age:</b>	68 years	
<b>Commander's Flying Experience:</b>	8,186 hours (of which 568 were on type) Last 90 days - 72 hours Last 28 days - 24 hours	
<b>Information Source:</b>	Aircraft Accident Report Form submitted by the pilot

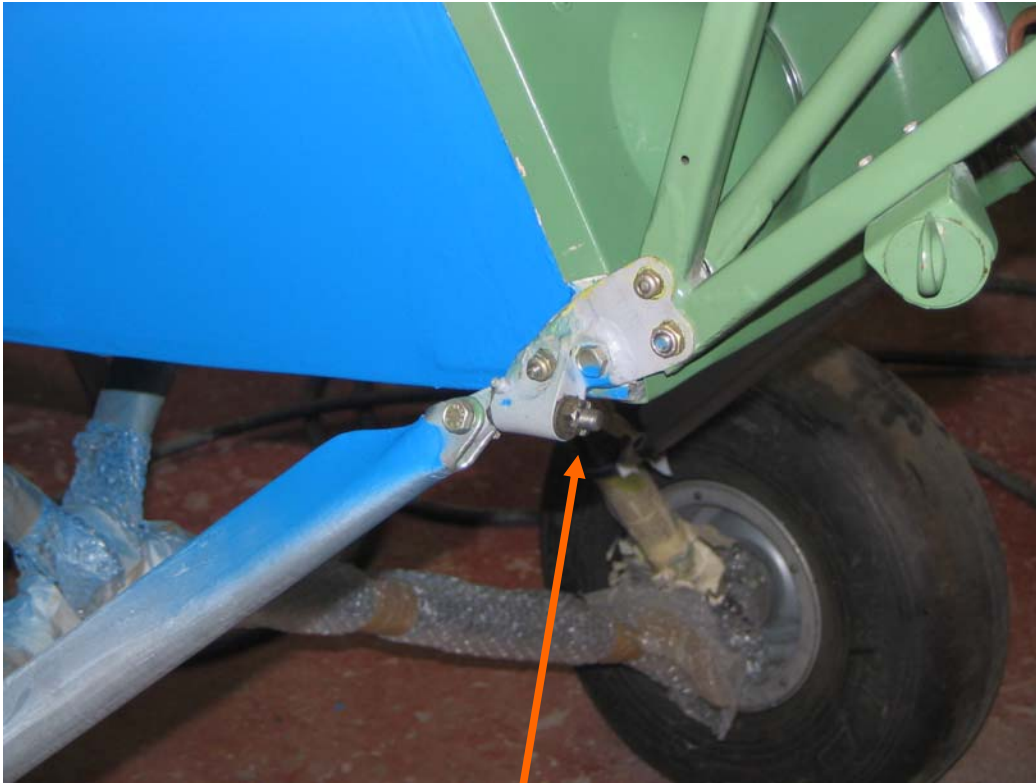
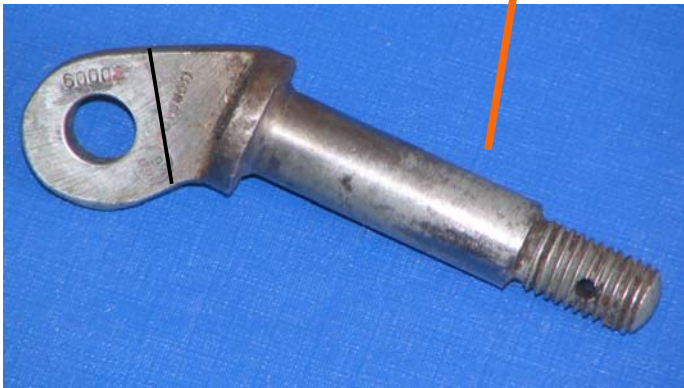
Figure 1

The instructor, who is a retired metallurgist, found that the right undercarriage drag strut had detached from the fitting securing it to the fuselage due to failure of the swivel bolt, part number H.22186 (see Figure 1). On a brief visual examination, he diagnosed that the fracture involved a fatigue crack. One half of the fracture was sent to the AAIB for examination: this concurred with his diagnosis with the additional observation that it appeared to be low-cycle fatigue occurring over a

relatively short period and that the bolt passing through the strut fork fitting and the swivel bolt appeared to have been excessively tightened at some point. The history of the failed item is unknown but a report was found, dated 1960, in which a De Havilland investigation identified an almost identical failure. The report did not recommend any action as "this is the first recorded defect of this particular nature".

Tiger Moth Main Undercarriage drag strut showing location of failed pin and approximate line of fracture.

The maintainer of the aircraft has advised that he intends to inspect the swivel bolts during annual inspection of Tiger Moth aircraft in future and it would seem prudent for other maintainers to do likewise. The age and history of these components is scarcely ever recorded and loads experienced can vary greatly with runway conditions and also the effectiveness of lubrication, since the bolt must be free to articulate in the fitting as the undercarriage struts 'spread' under load.
