No: 11/90

Ref: EW/C1168

Aircraft Type and Registration: Agusta A109A II, G-PJCB

Location: Near Rocester, Staffordshire

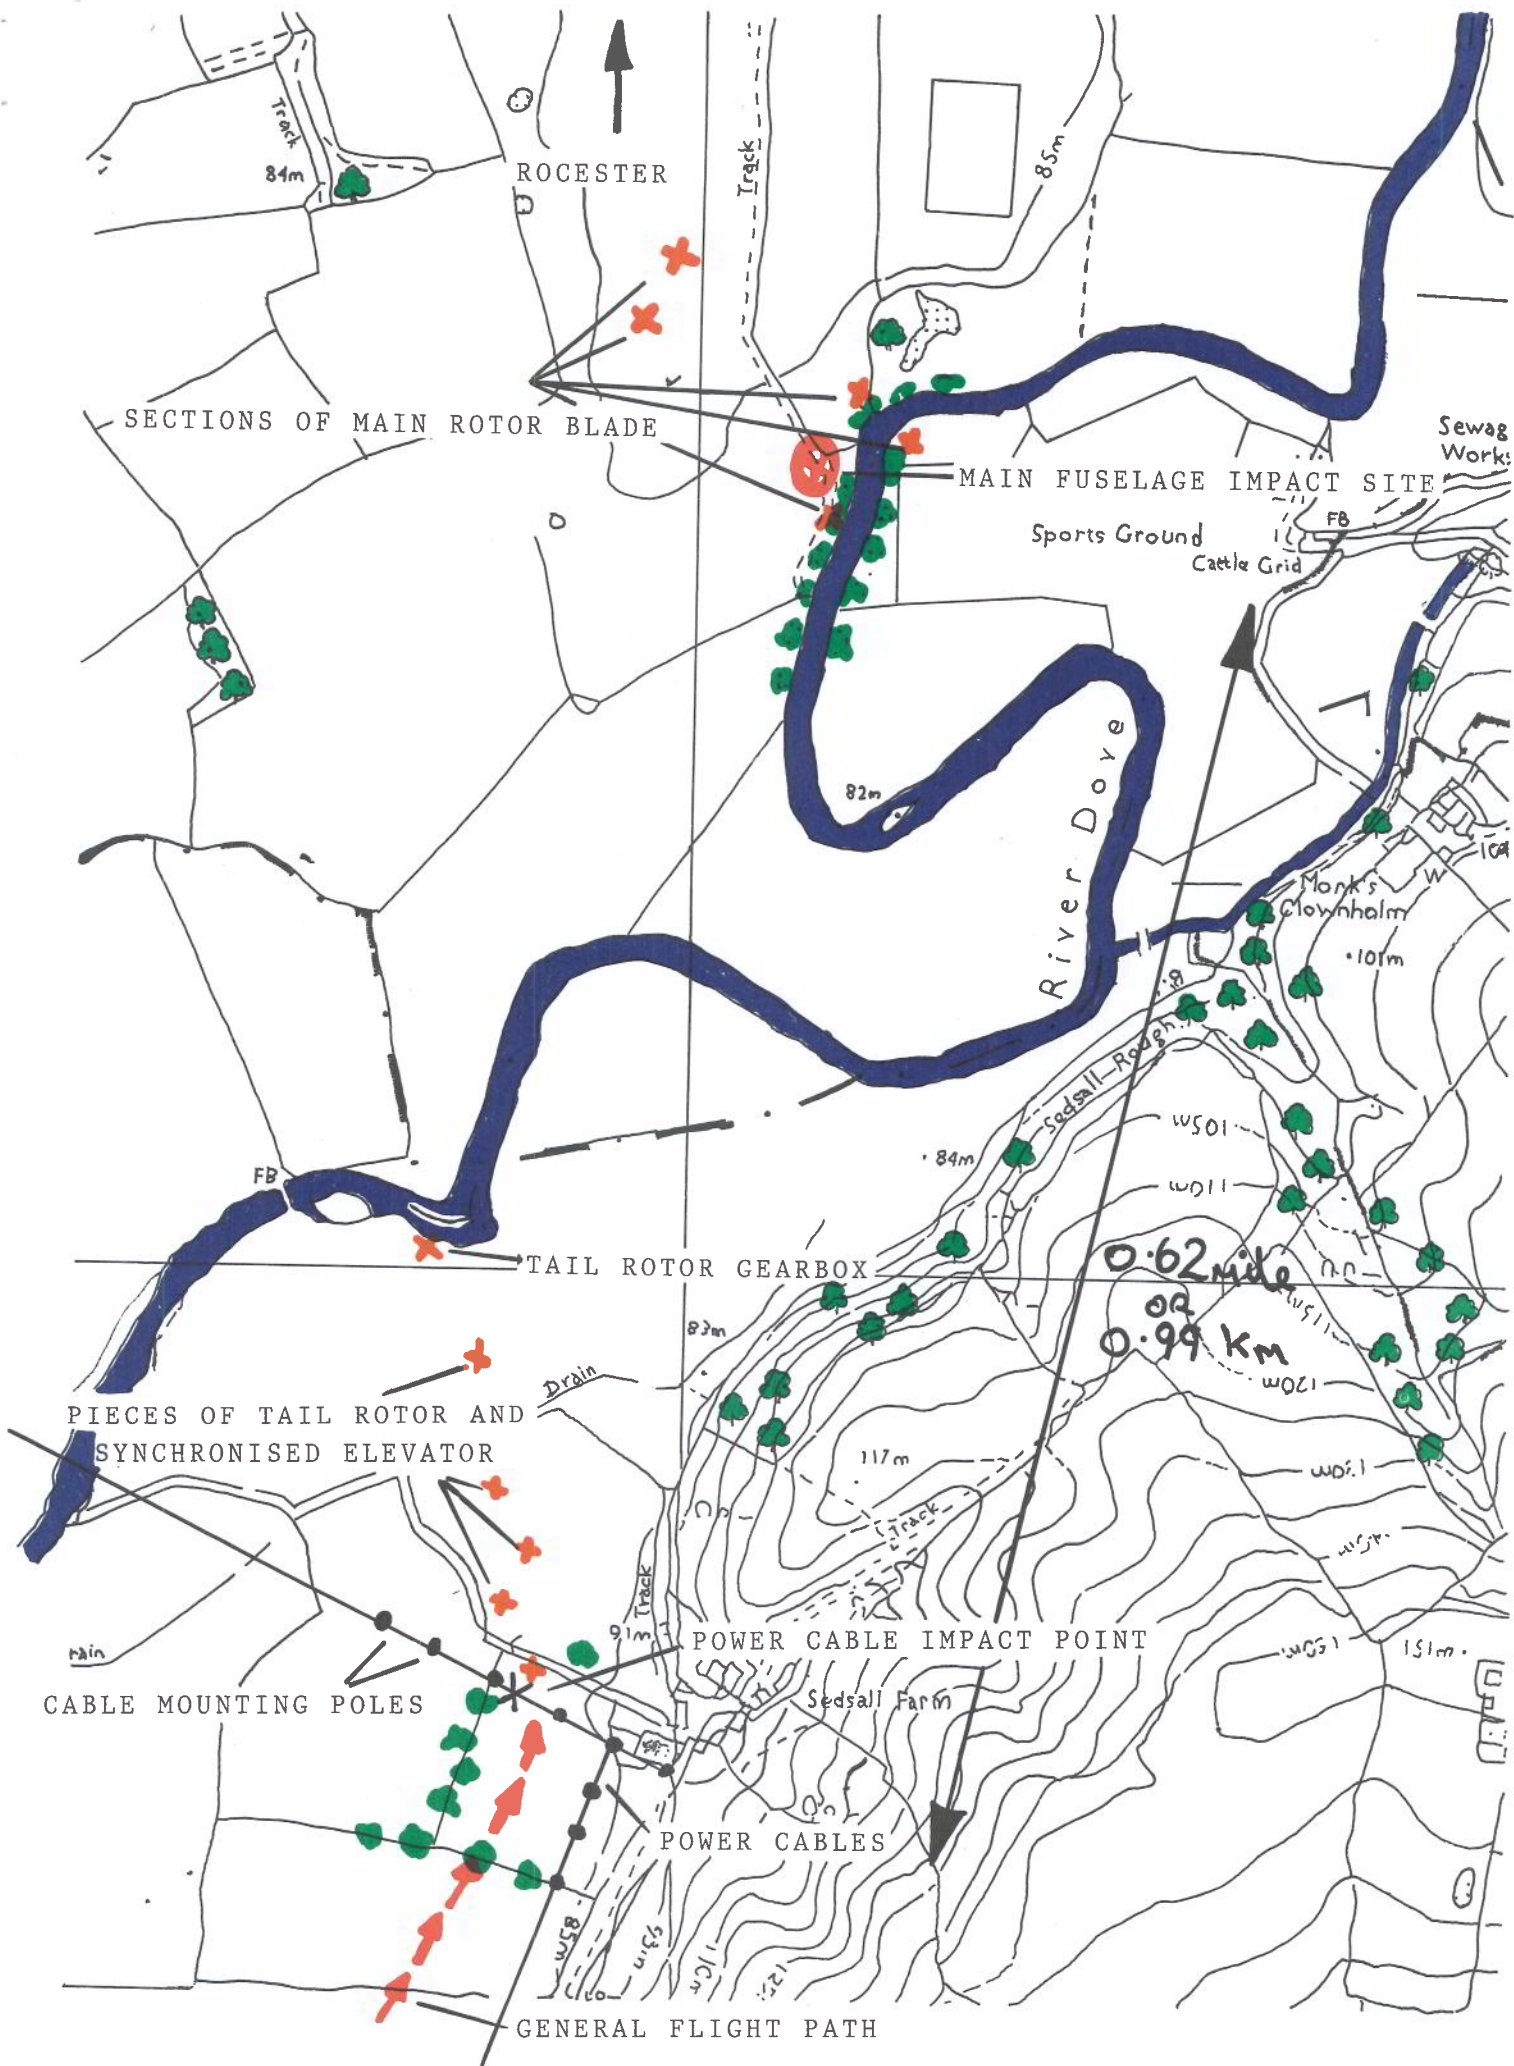
FIGURE 1. ACCIDENT SITE AGUSTA 109 G-PJCB

The accident site, shown in Figure 1 covered a distance of 1000 metres. It consisted of flat agricultural land interspersed with trees, hedgerows, farm tracks, overhead telephone and electricity cables and farm buildings. Through the middle of the area ran the River Dove. Approximately 400 metres to the east of the area there was a ridge of high ground which lay in a general north north east to south south west direction. The height of the ridge above the accident area was approximately 190 feet.

Examination of the accident site showed that the helicopter had struck a set of electricity power cables prior to the main body of the helicopter impacting the ground. The power cables were high voltage three phase cables which ran at right angles to the helicopter's flight path and were mounted on wooden poles to a height of approximately 35 feet above the ground. The helicopter struck the cables approximately 26 metres from the cable mounting pole that was situated to the west of the helicopter's flight path. This pole could well have been hidden from the pilot's view by a large tree. The pole to the east of where the helicopter struck the power cables may have been masked from the pilot's view by a large tree in the distance. The cables were of copper construction and coated with a layer of copper oxide which was green in colour. In the area between where the helicopter struck the power cables and the River Dove, which was approximately 400 metres to the north of the power cables, pieces of the helicopter's tail rotor blades, tail rotor drive shaft and the tip section of the left hand synchronized elevator were found. The tail rotor gearbox complete with the tail rotor hub and the remains of the tail rotor blades was found on the southern bank of the river. The main helicopter fuselage came to rest at the edge of a field of standing crop which was situated next to the River Dove. The fuselage impacted the ground whilst rotating in a clockwise direction as viewed from the top, banked to the left by approximately 30°, nose down by approximately 7°, with effectively no forward speed and descending in excess of 500 feet per minute. The main rotor blades struck the ground and broke-up on their initial strike. The rear passenger seat frame was disrupted by the vertical force imparted by one of the passengers which in turn ruptured one of the main fuel tanks. No fire occurred.
