ACCIDENT

Aircraft Type and Registration:	SZD-48-1 Jantar Sandard 2, G-CFHV	
No & Type of Engines:	None	
Year of Manufacture:	1980	
Date & Time (UTC):	31 May 2009 at 1400 hrs	
Location:	Long Mynd Airfield, Shropshire	
Type of Flight:	Private	
Persons on Board:	Crew - 1	Passengers - None
Injuries:	Crew - 1 (Fatal)	Passengers - N/A
Nature of Damage:	Glider destroyed	
Commander's Licence:	BGA Bronze certificate	
Commander's Age:	49 years	
Commander's Flying Experience:	53 hours (of which 2 were on type) Last 90 days - 38 hours Last 28 days - 11 hours	
Information Source:	AAIB Field Investigation

Synopsis

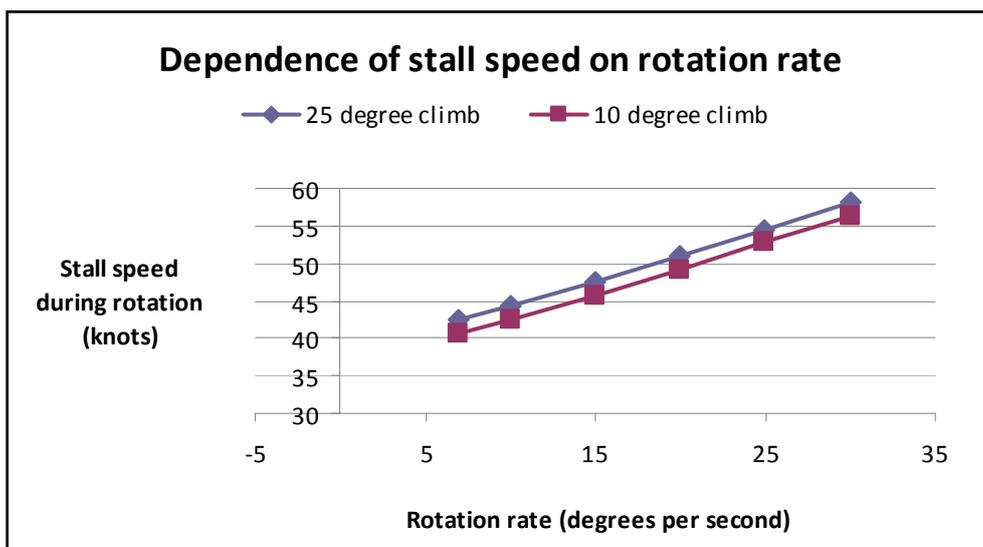
Figure 2

The forces on a glider during rotation may be modelled and the load factor (g) estimated for different rotation rates, pull forces in the cable, climb angles and other variables. This modelling shows the stall speed during rotation is very dependant on the rate of rotation, ie, the higher the rate of rotation, the shorter the time in which the glider has to be accelerated vertically from 0 to 35 kt. As this requires a greater lift force from the wings, there is an associated increase in the stall speed.

The dependence of stall speed on rate of rotation for a Jantar Standard 2 (with an unaccelerated stalling speed of 34.5 kt and maximum lift to drag ratio of 39), at climb angles of 10° and 25°, with a cable pull of 80% of the weight of the glider, is indicated in Figure 2.

Relationship of stall speed with rate of rotation

At the 10° climb angle, the stalling speed increases from 41 kt at a rotation rate of 7° per second, to 56 kt, at a rotation rate of 30° per second. The corresponding stall speeds at a 25° climb angle are 43 kt and 58 kt.
