## ACCIDENT

| <b>Aircraft Type and Registration:</b> | Europa XS, G-BYFG | |
| <b>Information Source:</b> | AAIB Field Investigation | |

## Synopsis

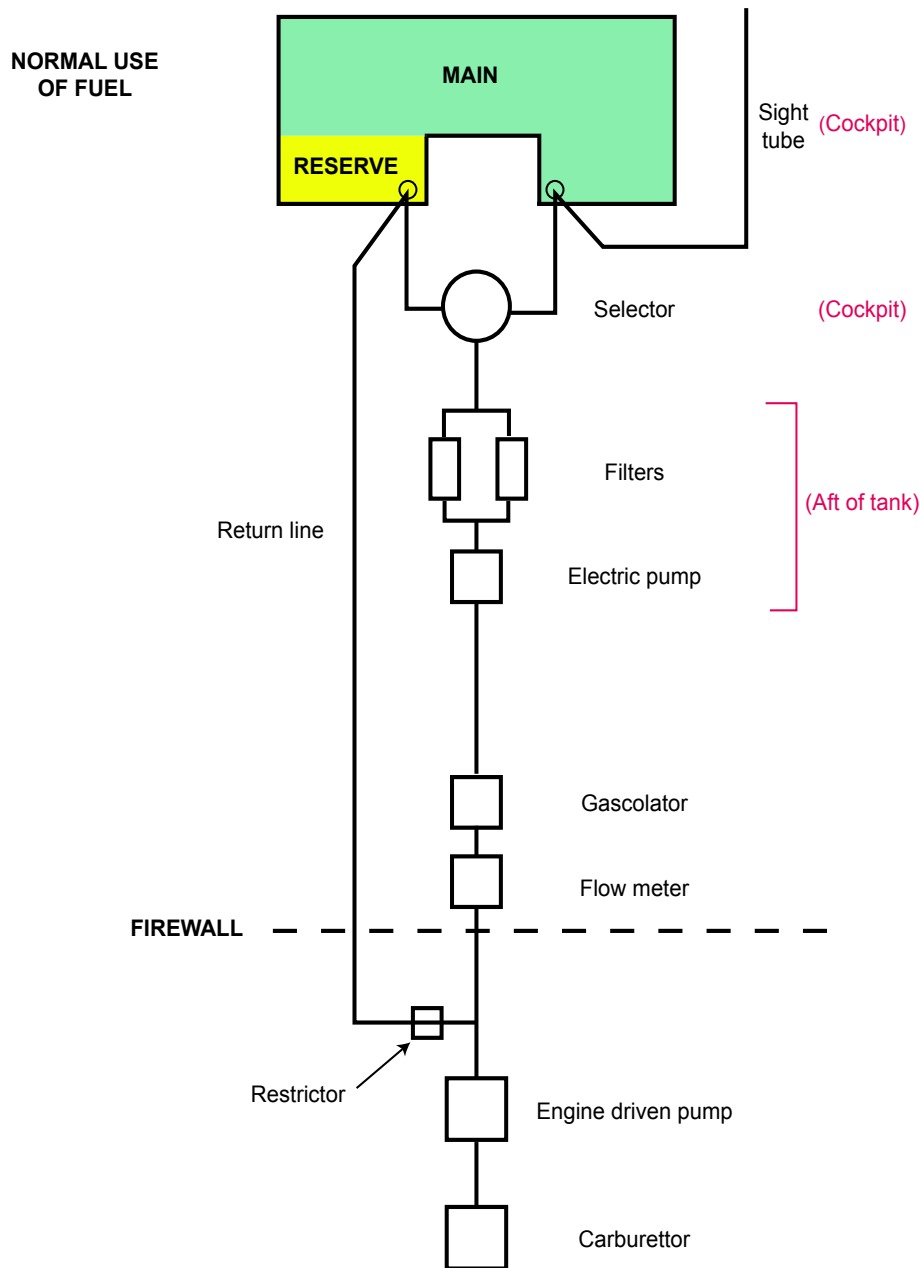
**Figure 1**

G-BYFG fuel system schematic

Under the direction of an LAA inspector, the fuel lines were replaced in June 2007 and a worksheet, signed by another LAA inspector, certified the satisfactory completion of this task. The entry also states that an additional return line 'required for MOGAS usage' had been installed at the same time. This modification was not approved by the LAA. Examination of the aircraft showed that the bleed return line was connected between the main fuel line, immediately upstream of the engine-driven fuel pump, and the reserve side of the fuel tank. A restrictor was soldered into the 'T-piece' connecting the bleed return line to the main fuel line. Placards were fitted to the aircraft indicating that unleaded Mogas could be used. The co-owner

A further test was performed using an electric fuel pump to simulate the engine-driven pump. This pump was run with the fuel selector in the RESERVE position until that side of the tank was depleted, whereupon the flow decreased and eventually stopped. The fuel selector was then selected to MAIN and the electric fuel boost pump was then selected ON. Although the flow recommenced, it was at a much lower rate than before, even with both pumps running. It was apparent that air was being drawn into the fuel system through the fuel bleed return line from the now empty reserve side of the tank. Blocking the bleed return line restored the flow to its previous level.

some minor remedial action to correct accident damage, it was mounted in a test stand. The engine started on the first attempt and ran smoothly at various power settings, despite one ignition system being inoperative due to accident damage. Following this test, the fuel bleed return line was introduced into the fuel system to replicate the aircraft's fuel system. It was found that the engine would run normally with the bleed return line closed off, but as soon as it was opened to atmosphere, air was drawn into the engine-driven fuel pump in preference to fuel, resulting in a significant loss of engine power.

The intention of fitting the bleed return line was to reduce the possibility of vapour locking. However, by connecting it upstream of the engine-driven fuel pump instead of downstream, it introduced the possibility of air or debris being drawn into the fuel system, with the potential for interrupting the fuel flow to the engine.

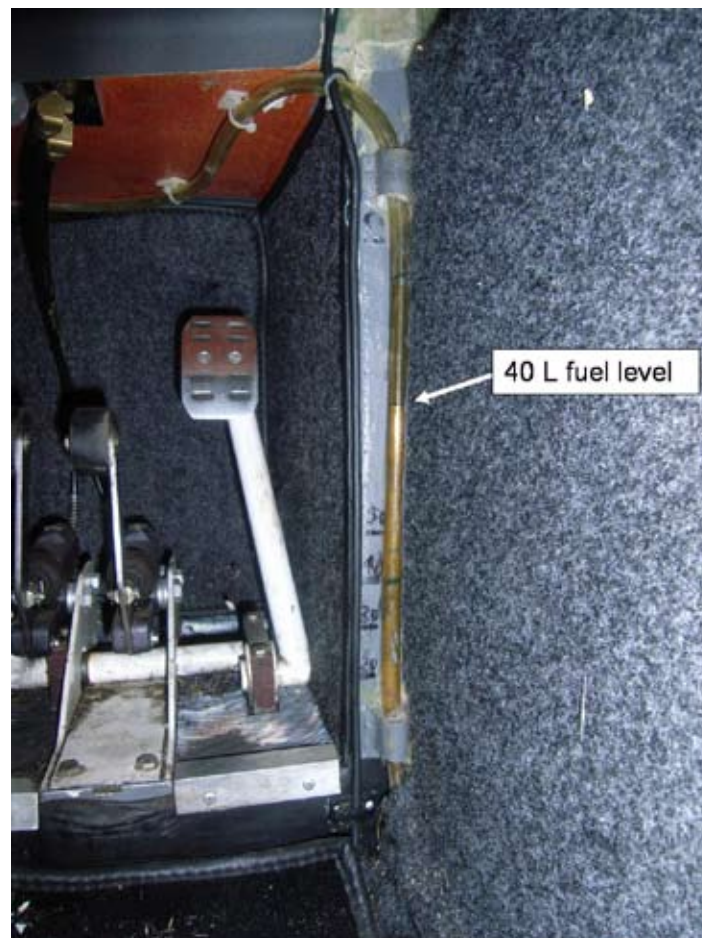
**Figure 2**

Fuel quantity indication was provided by means of a clear plastic sight tube mounted on the centre tunnel, close to the pilot's right lower leg (Figure 2). The sight tube must be calibrated during aircraft construction. The kit manufacturer's build manual suggests adding a card with dark and light stripes behind the tube to make the fuel level in the sight more visible; however, this was not used on this aircraft. Due to its location forward of the tank, the indicated fuel level is sensitive to changes in pitch attitude.

The fuel sight tube on G-BYFG was discoloured and it was therefore difficult to read the fuel level in the tube. Graduation markings (20, 30, 40 and 50) were visible on the structure behind the sight tube (Figure 2), but it was not clear what these markings represented. Close examination of the sight tube revealed a line marked on the sight tube next to the '40' graduation. The significance of this line was not established. During the wreckage examination by the AAIB, water was poured into the fuel tank with the aircraft in its normal ground attitude, until the level in the sight tube reached the '40' graduation. This corresponded to an actual quantity in the tank of only 20 litres. When 40 litres were added to the tank, the level in the sight tube was well above all the graduations. With the level at the top of the sight tube, the total quantity in the tank was in excess of 60 litres.

Discussions with the co-owner revealed that the fuel sight tube had been calibrated following replacement of the fuel lines. These calibrations had been marked on an additional strip of metal that had been affixed beside the sight tube, on top of the abovementioned graduations. The metal calibration strip was subsequently found tucked in the bottom corner of the centre tunnel stowage pocket. It is not known when the strip became detached nor how it came to be in the stowage. The accuracy of these calibration marks could not be verified as the position in which the strip had been attached was not known.

Completion of this mandatory inspection should be recorded in the aircraft logbook, however no such record could be found for G-BYFG.
