No: 7/91

Ref: EW/C91/1/4

Aircraft Type and Registration: BAC One Eleven 510ED, G-AVMS

Nature of Damage: Fracture of HP bleed air duct leading from No. 1 engine and extensive overheat damage in No. 1 stub wing and rear fuselage

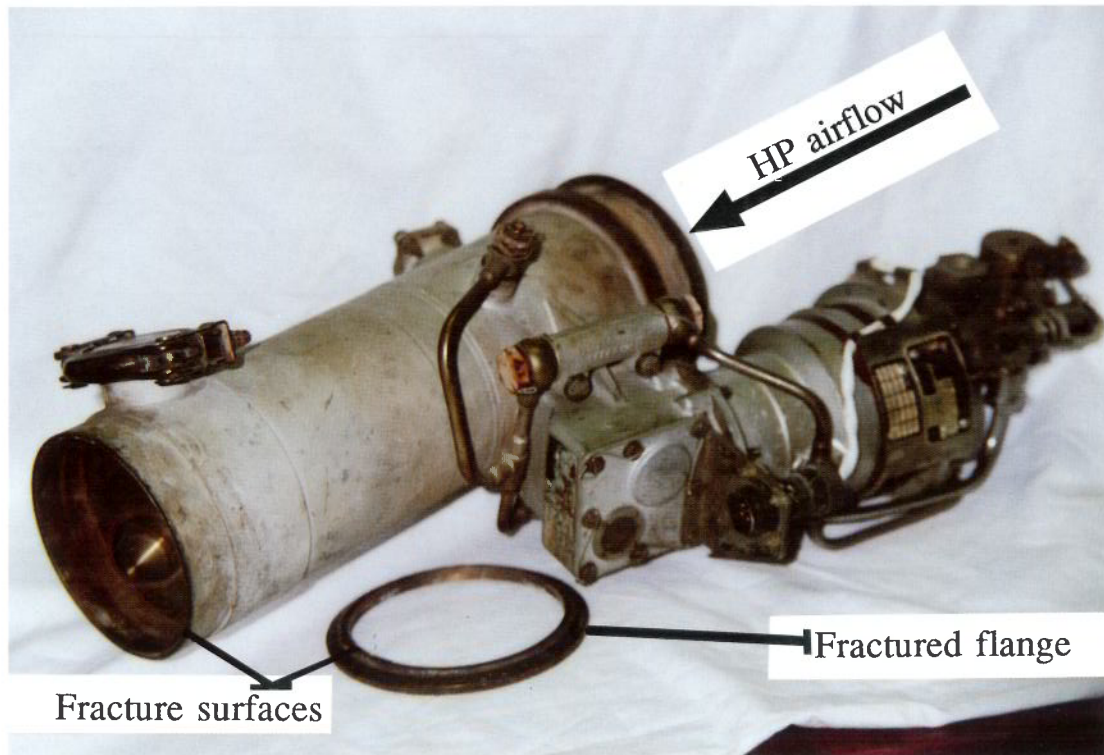
No. 1 HP shut-off valve - G-AVMS

primary heat exchanger at the aft end of the stub wing. The actual fracture (see figure) was around the entire circumference of the duct at the downstream flange of the HP shut-off valve (isolation valve) and this separation had allowed HP bleed air to escape into the stub wing between the No. 1 engine and the fuselage. The resulting pressure increase had caused one of the stub wing lower surface panels partially to detach. There had been a considerable transfer of heat before the No. 1 engine was shut down and this had damaged portions of the electrical systems which pass through the stub wing. The adjacent fuselage skin had also sustained thermal damage and the plastic covering of the cabin insulation was charred.

The fracture of the shut-off valve was examined in detail. On this valve, an end flange fitting is used to clamp the shut-off valve assembly to the next length of duct and the skirt of this flange fitting is nickel-brazed within the duct. The metallurgical examination indicated that the fracture was by a fatigue mechanism propagating through the nickel braze material and then through the flange fitting itself, culminating in a rapid overload failure through the small amount of remaining wall material. The pattern of the fatigue was similar around the entire circumference of the duct, indicating that the fatigue mechanism had resulted from in-service cyclic stresses.

Further examination of the valve body and flange fitting did not show any evidence of material fault, incorrect manufacture or assembly which could have contributed to the fatigue mechanism. In addition, neither the manufacturer nor the operator had any record of a previous duct failure with this type of valve. However, a programme has been initiated by the operator and the valve manufacturer to ensure that any of these valve bodies removed from aircraft are submitted to NDT inspections for crack detection by the valve manufacturer. In addition, the operator has removed a sample of 10 serviceable high-time shut-off valves for these inspections.
