# AAIB Bulletin S1/2009

### INCIDENT

<b>Aircraft Type and Registration:</b>	Embraer 190-200, G-FBEH
<b>No &amp; Type of Engines:</b>	2 General Electric CF34-10E7 turbofan engines
<b>Year of Manufacture:</b>	2007
<b>Date &amp; Time (UTC):</b>	15 January 2009 at about 0740 hrs
<b>Location:</b>	Overhead Edinburgh
<b>Type of Flight:</b>	Commercial Air Transport (Passenger)
<b>Persons on Board:</b>	Crew - 5                      Passengers - 40
<b>Injuries:</b>	Crew - None                      Passengers - None
<b>Nature of Damage:</b>	None
<b>Commander's Licence:</b>	Airline Transport Pilot's Licence
<b>Commander's Age:</b>	40 years
<b>Commander's Flying Experience:</b>	6,250 hours (of which approximately 100 were on type) Last 90 days - 137 hours Last 28 days - 33 hours
<b>Information Source:</b>	AAIB Field Investigation

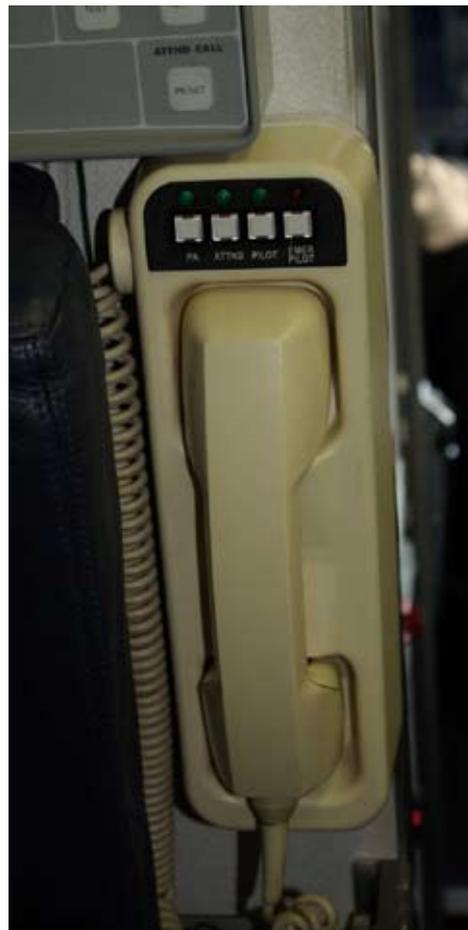
**Figure 1**

The SCCM attempted to call the flight crew on the cabin interphone system, by pressing the PILOT call button. The green light above the button (Figure 1) illuminated, but the flight crew did not answer. Despite repeated attempts, using handsets in both the forward and rear galleys, the SCCM could not establish communication with the pilots in this way.

Cabin interphone handset at front galley

With emergency power (from the RAT and batteries) applied to the aircraft, the EMER system functions normally. However, if a PILOT call is initiated from either handset in the cabin, the green light above the pushbutton illuminates and a single chime is heard in the flight deck, but the pushbuttons on the pilots’ audio panels do not illuminate, and voice communication cannot be established.

The PILOT function of the interphone system seemed, to the cabin crew, to indicate that it was functioning normally. However, the CAB pushbutton in the flight deck did not illuminate, and no voice contact was possible. The cabin crew did not attempt to use the EMER PILOT function, as this would involve an emergency call, which differed (in the cabin crewmembers’ perception) from the normal call only in the number of chimes.

The ‘false positive’ indication of the PILOT call was crucial to the incident; had the PILOT call not appeared to function correctly, it is probable that the cabin crew, instead of contemplating incapacitation of the flight crew or serious emergency on the flight deck, would have attempted to establish communication using the EMER PILOT call.

It is recommended that Embraer (Empresa Brasileira de Aeronautica SA) immediately notify all operators, of the Embraer 190 family of aircraft, to inform their flight and cabin crew of the functioning of the interphone system when the aircraft is supplied only with emergency electrical power.

It is recommended that Embraer (Empresa Brasileira de Aeronautica SA) modify the functioning of the interphone systems of Embraer 190 family aircraft to provide crew with the facility to make both normal and emergency calls when the aircraft is supplied only with emergency electrical power.

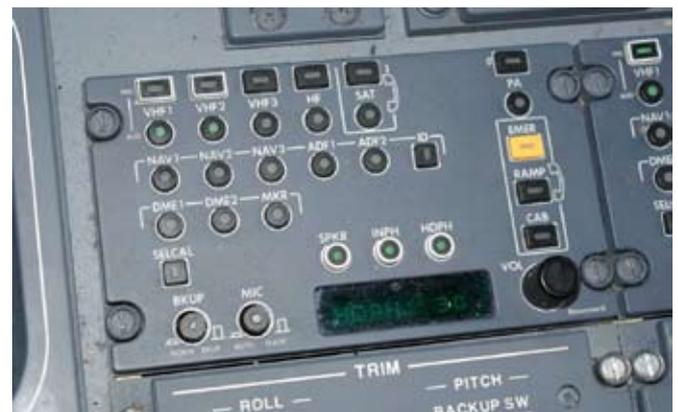
**Figure 2**

The interphone system includes handsets with illuminated pushbuttons at the forward and aft galleys (Figure 1) and illuminated push-buttons on audio panels in the flight deck (Figure 2). With normal power applied to the aircraft, removing the handset from its cradle and then pressing the PILOT call pushbutton above the handset causes a single chime to sound in the flight deck, and the CAB pushbuttons on the pilots’ audio panels illuminate to show an incoming communication. Pressing the pushbutton

Pilot’s audio panel in flight deck
