SERIOUS INCIDENT

Aircraft Type and Registration:	Boeing 747-436, G-BNLA
No & Type of Engines:	4 Rolls-Royce RB211-524G2-19 turbofan engines
Year of Manufacture:	1989
Date & Time (UTC):	29 July 2009 at 0359 hrs
Location:	Heathrow Airport
Type of Flight:	Commercial Air Transport (Passenger)
Persons on Board:	Crew - 19 Passengers - 237
Injuries:	Crew - None Passengers - None
Nature of Damage:	Minor damage to No 1 engine cowling.
Commander's Licence:	Airline Transport Pilot's Licence
Commander's Age:	57
Commander's Flying Experience:	19,569 hours (of which 6,831 hours were on type) Last 90 days - 58 hours Last 28 days - 58 hours
Information Source:	AAIB Field Investigation

Synopsis

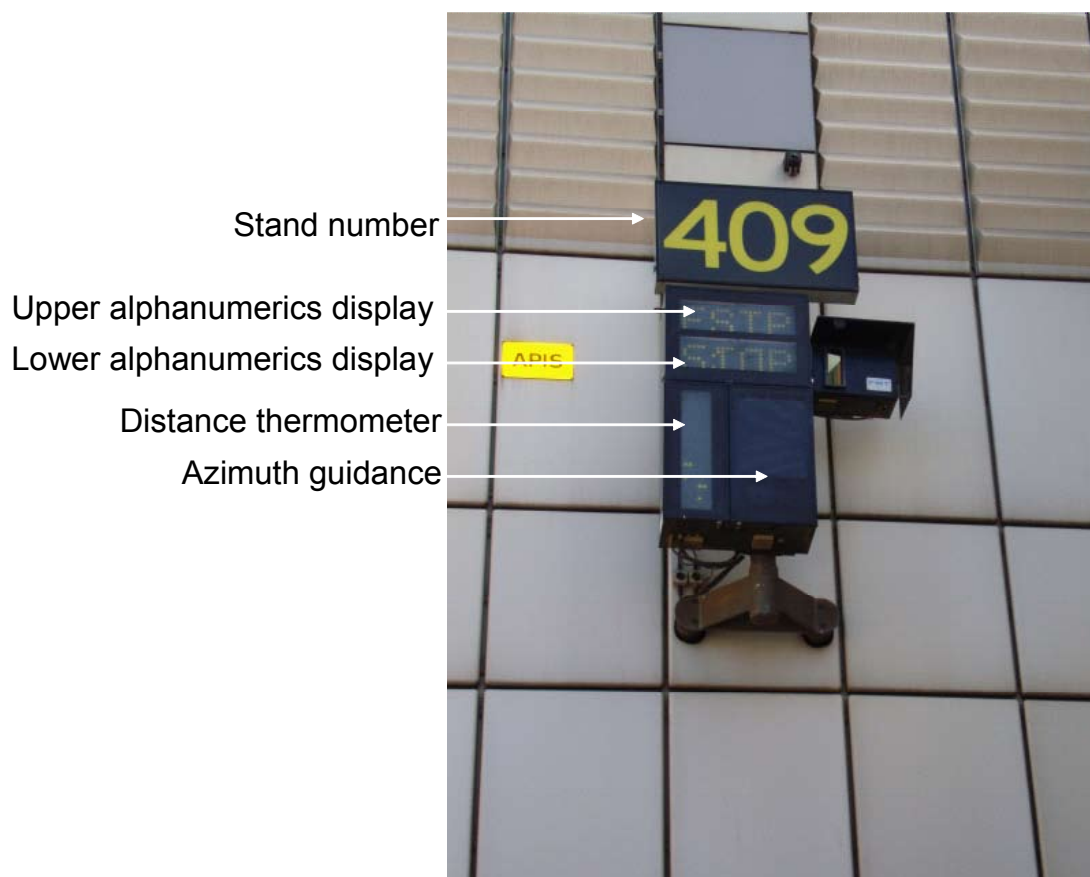
Figure 1

The APIS had not been activated but due to a wiring defect, the lateral guidance was illuminated which it should not have been.

Stand 409 Aircraft Parking Information System (APIS)

A fault history of the APIS is recorded by the logic computer and this was downloaded for the investigation. It provided no record of when the fault which caused the lateral guidance board to remain illuminated when the system was de-activated. Further inspection of the faulty APIS showed that a wire in the lateral guidance module was defective and this caused the board to remain illuminated. It could not be established when the fault had occurred but there were no recorded reports of the problem.

HAL then withdrew use of the APIS and following an internal investigation, changed the unit. It also undertook to inspect the remaining systems to ensure no others were defective. This would include a visual check of the display windows before the SEGS was activated to ensure they were indicating correctly.
