# McDonnell Douglas Hughes 369E, G-LOGO

<b>AAIB Bulletin No: 11/2004</b>	<b>Ref: EW/C2003/12/02</b>	<b>Category: 2.3</b>
<b>Aircraft Type and Registration:</b>	McDonnell Douglas Hughes 369E, G-LOGO	
<b>No &amp; Type of Engines:</b>	1 Allison 250-C20B turboshaft engine	
<b>Year of Manufacture:</b>	1991 (Manufacturer's Serial No 0454E)	
<b>Date &amp; Time (UTC):</b>	2 December 2003 at 1428 hrs	
<b>Location:</b>	Near Kensworth, Bedfordshire	
<b>Type of Flight:</b>	Private	
<b>Persons on Board:</b>	Crew - 1	Passengers - None
<b>Injuries:</b>	Crew - None	Passengers - N/A
<b>Nature of Damage:</b>	Aircraft destroyed	
<b>Commander's Licence:</b>	Private Pilot's Licence	
<b>Commander's Age:</b>	40 years	
<b>Commander's Flying Experience:</b>	4,900 hours (of which 1,100 were on type)	
	Last 90 days - 68 hours	
	Last 28 days - 24 hours	
<b>Information Source:</b>	AAIB Field Investigation

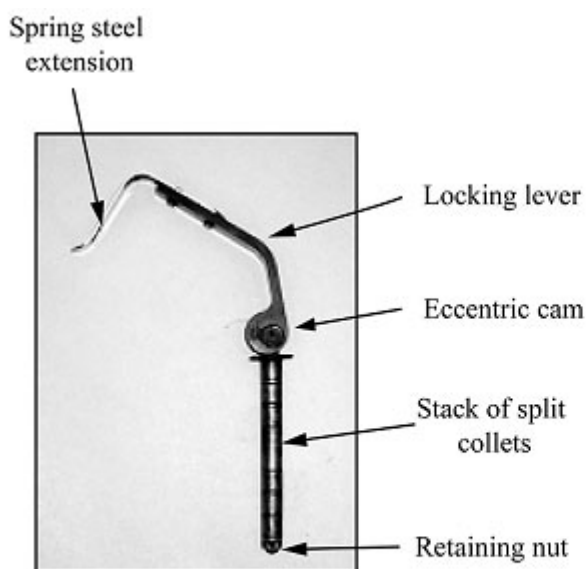
Figure 2 - Pin Open

Each main rotor blade is attached to the hub via a pair of quick release pins engaging in steel mounting lugs. A third generally similar pin secures the lead-lag damper to its bracket at the trailing edge of the blade. Each of the blade pins consists of a central spindle passing through a series of split collets, each having internally tapered ends. A nut threaded onto the lower end of the spindle retains the collets and a series of conical inserts that engage in the corresponding tapered recesses in the ends of the collets. An over-centring lock lever is attached to the top end of the pin by means of a lateral shaft into which the top of the spindle is threaded. The locking lever incorporates an eccentric section which reacts against a washer at the top of the collet stack and draws the lateral shaft and hence the spindle upwards as the lever is rotated downwards in a plane parallel to the spindle centre-line. This action compresses the stack of collets and conical inserts between the top washer and the bottom nut and forces the inserts into the internally tapered ends of each of the split collets, causing the latter to increase in diameter and to create an interference fit in the blade mounting lugs. A spring steel extension on each locking lever incorporates a hexagonal cut-out which engages with the bottom nut when the lever is in the fully over-centred position parallel with the spindle axis. A quick release pin in both the open and closed positions is illustrated in Figures 2 and 3.

The aircraft manufacturer stated that, in-flight, the centrifugal load on the pin would have been in excess of 19,000 lbf.

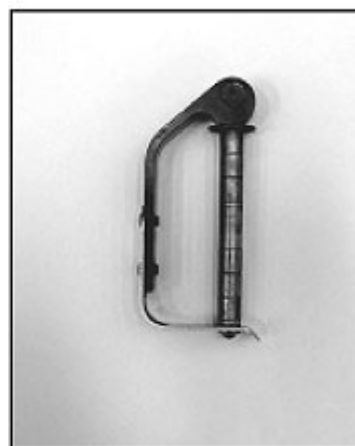
Figure 3 - Pin Closed

The only obvious features found during wreckage examination judged not to be consistent solely with the aircraft impact parameters were the absence of one blade retaining pin, coupled with the condition of the associated blade and the undamaged state of its attachment lugs. The unusual blade damage was not only entirely different from the damage to the remaining four blades, but it was judged to be consistent with the presumed effect of the aircraft overturning with the pin not being located in the lugs. Although a search was made of the likely area of fall of the pin, had it separated whilst in flight close to the point where the wake encounter probably occurred, the inability to find it was not conclusive evidence of its absence from that area. Similarly, failure to find it at the accident site was not conclusive evidence that it was missing at the time the aircraft overturned. Moreover, the manufacturer stated that the centrifugal load on in the pin, in conjunction with the in-built interference fit, would have ensured that the pin could not migrate upwards during flight.

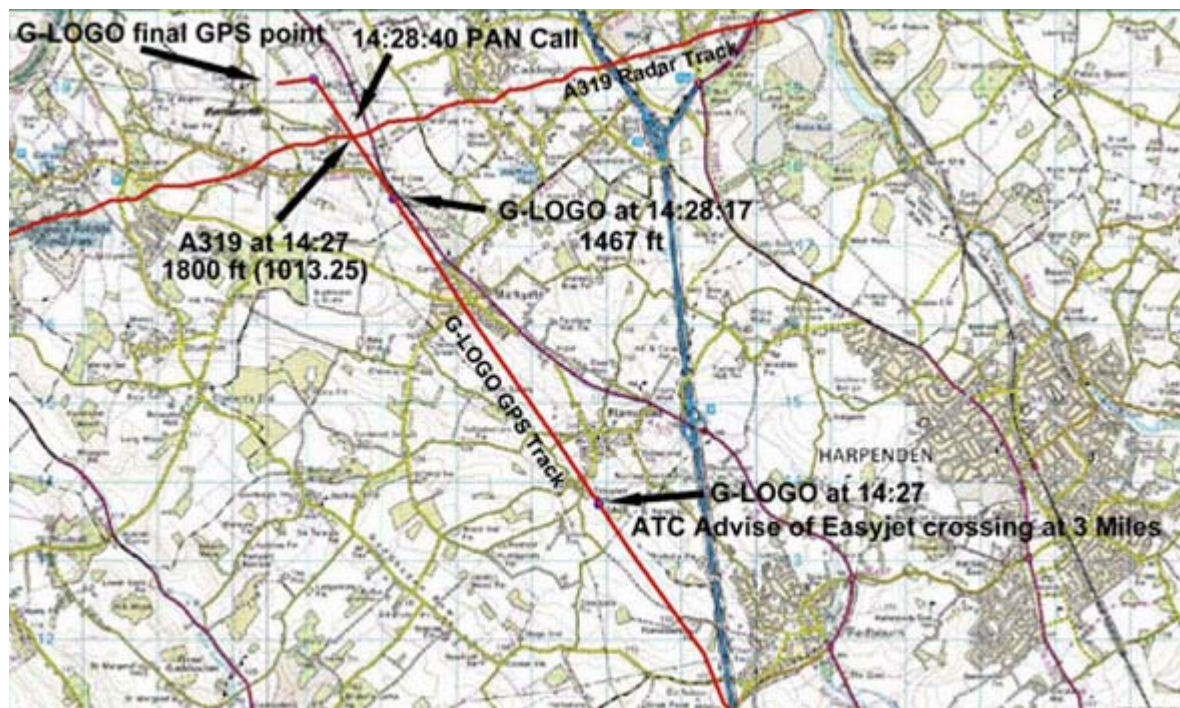
### **G-LOGO Final GPS log**

When combined the data showed that at 14:27:02 (radar time) the A319 was descending on the approach to Runway 08 at Luton Airport passing 1,800 feet amsl and decelerating through 140 kt groundspeed. At 14:28:30 (GPS time) the helicopter passed immediately under the same location at a height of 1,500 feet amsl and with a groundspeed of 125 kt. At 14:28:39 (ATC time) the helicopter made a PAN call to Luton ATC. (See Figure 4)

At the time of the initial event the helicopter had just climbed to reach level cruise flight at close to 1,500 feet amsl with a groundspeed of 125 kt. Prevailing winds at this altitude were across the track so it is reasonable to assume the airspeed was approximately equal to the groundspeed. The A319 was heading directly into the wind so it would be expected that the trailing vortices would remain approximately along the line of its track. The intersection point of the two aircraft tracks was at a distance of 5 nm from the touchdown zone of Runway 08, thus the A319 at 1,800 feet was on or close to the glideslope. (Luton Airport's elevation is 526 feet amsl.)

Although there may be differences between the time references used for the different data sources it is considered that these will not be more than +/- 2 seconds. The helicopter crossed about a minute and a half behind the Airbus A319 and some 300 feet below its flightpath. The known characteristics of wake vortices are that, unless disturbed, they will persist for several minutes and drift downwards at about 100 to 200 ft/min. Wind conditions were light and, although the meteorological forecast indicated that the airmass was somewhat unstable, it is in just such circumstances that a wake vortex encounter seems likely.
