# AAIB Bulletin S1/2011

## SPECIAL

### SERIOUS INCIDENT

<b>Aircraft Type and Registration:</b>	ATR 72-202, EI-SLG	
<b>No &amp; Type of Engines:</b>	2 x Pratt and Whitney PW124B turboprop engines	
<b>Year of Manufacture:</b>	1990	
<b>Date &amp; Time (UTC):</b>	15 March 2011 at 2130 hrs	
<b>Location:</b>	Near Edinburgh Airport	
<b>Type of Flight:</b>	Commercial Air Transport (Non-Revenue)	
<b>Persons on Board:</b>	Crew - 2	Passengers - None
<b>Injuries:</b>	Crew - None	Passengers - N/A
<b>Nature of Damage:</b>	None	
<b>Commander's Licence:</b>	Air Transport Pilot's Licence	
<b>Commander's Age:</b>	45 years	
<b>Commander's Flying Experience:</b>	TBA	
<b>Information Source:</b>	AAIB Field Investigation

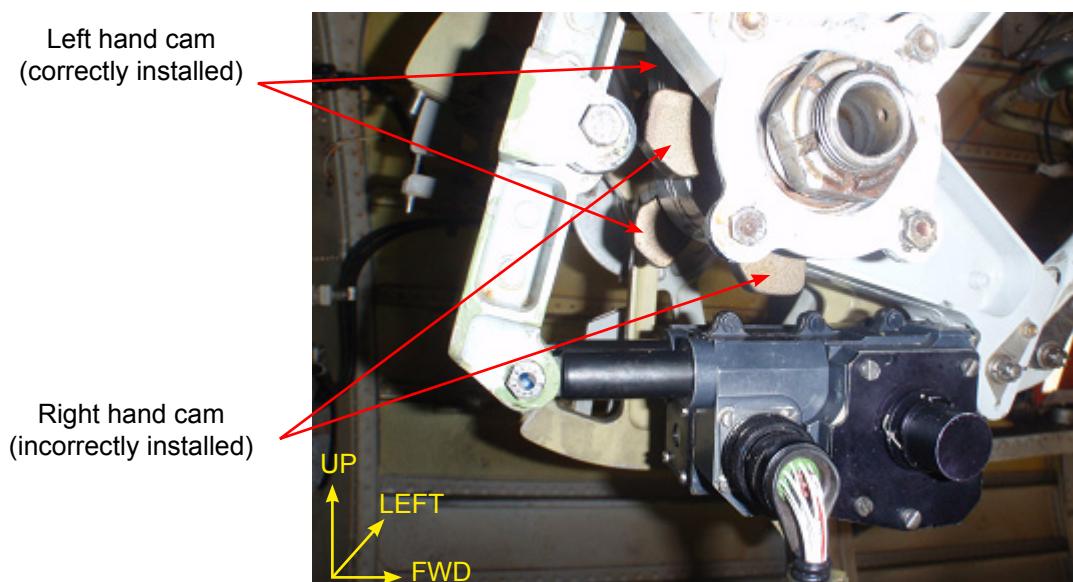
**Figure 3**

The rudder rear quadrant shaft on which the cams are mounted is a splined shaft; a master locating spline ensures correct alignment of all components. Teeth on the internal bore of the cams correspond to the profile of the splined shaft, with a missing tooth in the position of the master spline. During reassembly, the orientation of right hand cam was transposed through  $180^\circ$  (such that the inboard face of the cam was facing outboard). As the missing tooth on the cam is not located centrally between the two cam lobes, but is offset by approximately  $19^\circ$  to one side, the incorrect installation of the right hand cam resulted in the right hand cam no longer being symmetrically aligned with the left hand cam (Figures 3 and 4).

Travel Limitation Unit with right hand cam incorrectly installed – rudder in neutral position

(Note that the lobes of the right hand cam are not aligned with the lobes of the left hand cam and that the right hand roller is facing the upper lobe of the right hand cam)

It was demonstrated that with the right hand cam installed in the incorrect orientation, it presented a restriction to the travel of the corresponding roller. When the TLU was activated, this situation prevented both rollers from engaging in the vee groove of the cams and caused an uncommanded rudder input and corresponding rudder deflection.

It is recommended that ATR immediately informs all operators of ATR aircraft equipped with a Travel Limitation Unit that it is possible to install the cams on the rear rudder quadrant shaft in the incorrect orientation.

It is recommended that ATR amends all relevant Aircraft Maintenance Manual tasks to include a warning to highlight that the cams on the rear rudder quadrant shaft can be installed incorrectly.

It is recommended that ATR amends the Aircraft Maintenance Manual task '*Operational Test of the Rudder Travel Limitation Unit*' to state that: (1) the test should be carried out for a minimum of 30 seconds and (2) should an asymmetric restriction of the rudder pedals be detected or if the FLT CTL light illuminates, further inspection of the TLU system should be conducted.

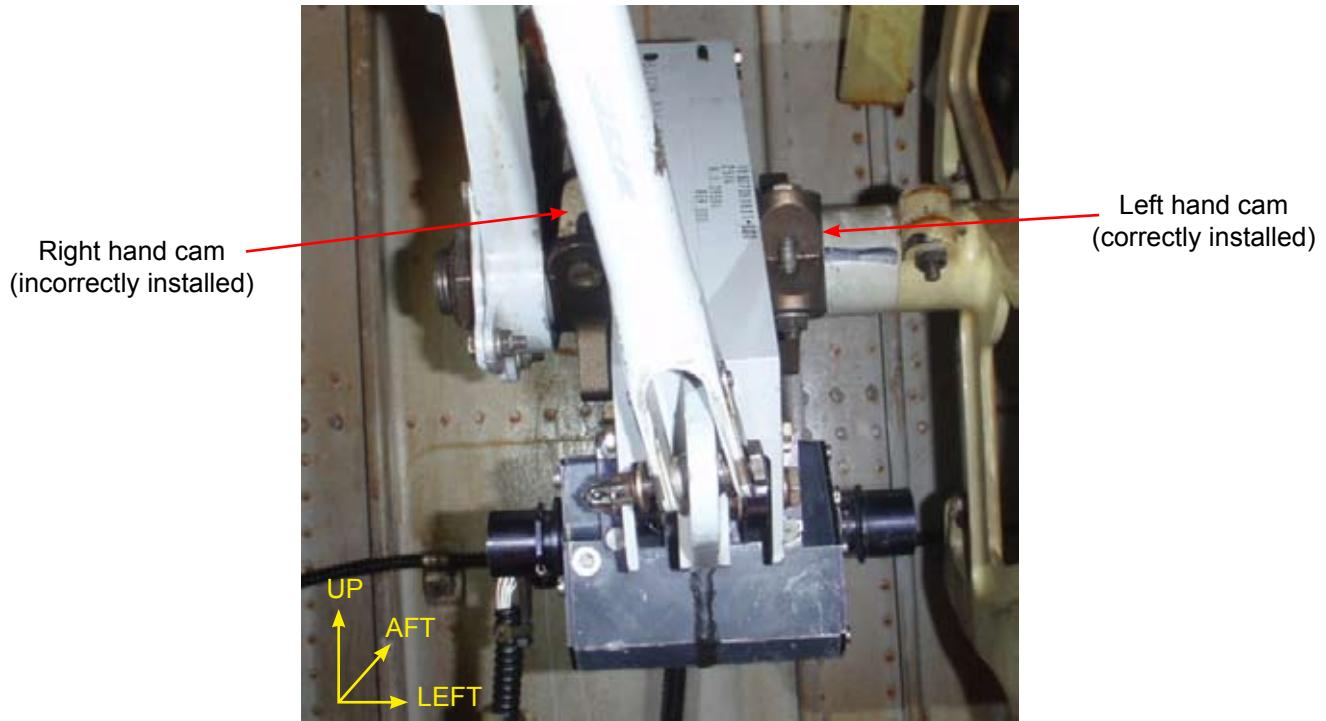
**Figure 4**

View looking aft on Travel Limitation Unit with right hand cam incorrectly installed - rudder in neutral position
