AIRCRAFT ACCIDENT REPORT 4/93

Air Accidents Investigation Branch

**Report on the incident to
British Aerospace 146-300, G-UKHP,
at Aberdeen Airport, Dyce, Scotland,
on 31 March 1992**

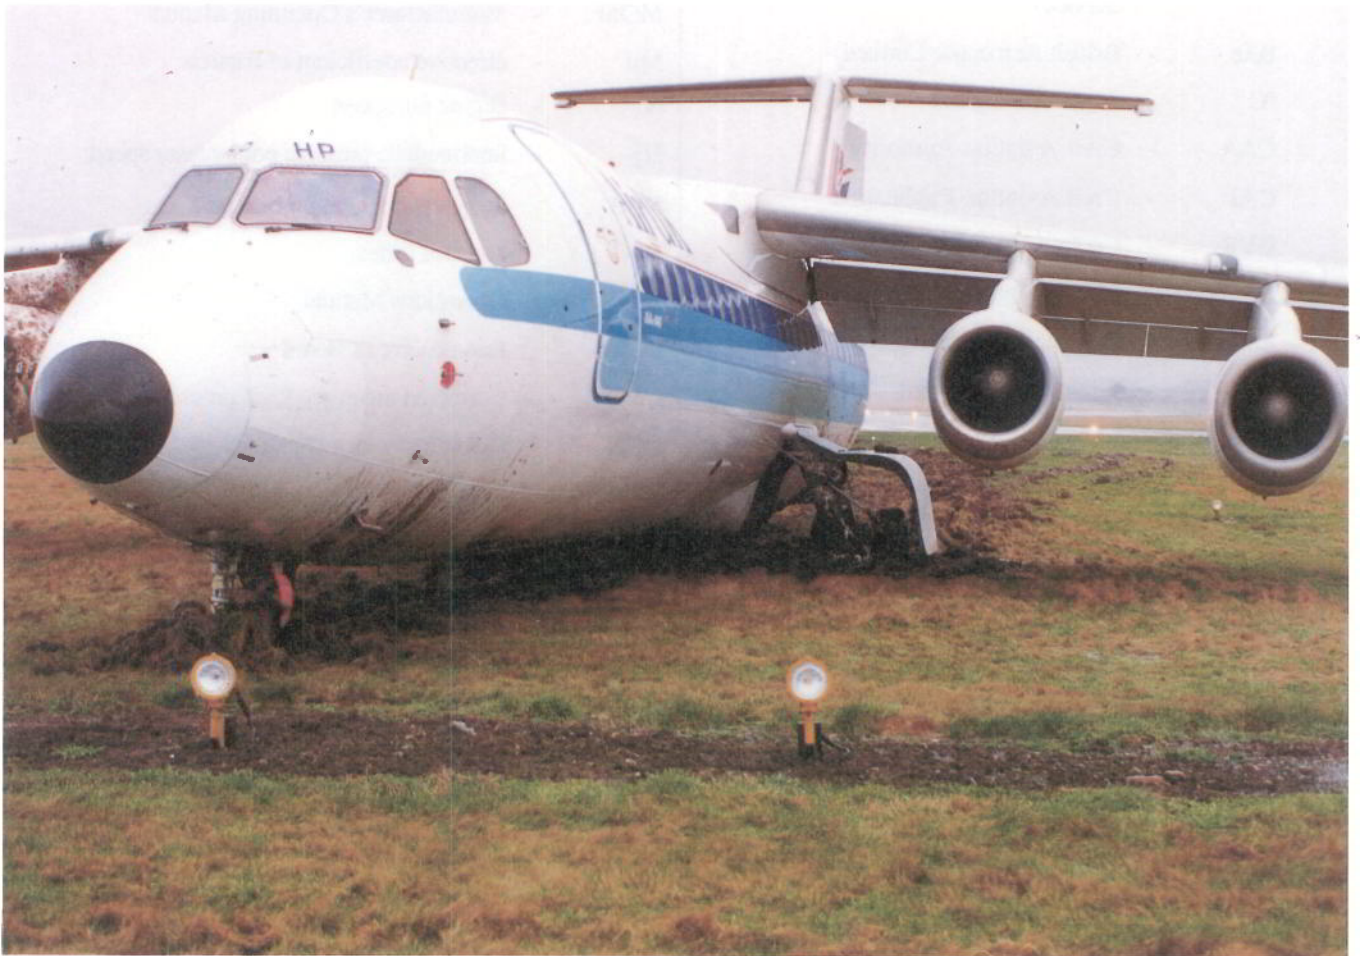
PHOTOGRAPH SHOWING G-UKHP ON SITE

The incident occurred when the aircraft, which was on a scheduled passenger flight from Edinburgh to Aberdeen, overran runway 34 whilst landing in heavy rain and strong crosswind conditions. The lift spoilers were not deployed and the aircraft brakes produced insufficient retardation to stop the aircraft on the wet runway surface. The passengers, who disembarked some time after the event, sustained no injuries. The aircraft suffered mud contamination of its wheels, brakes and engines.
