## Boeing 747-240B, AP-BAT

<b>AAIB Bulletin No: 3/2004</b>	<b>Ref: EW/C2002/06/03</b>	<b>Category: 1.1</b>
<b>INCIDENT</b>		
<b>Aircraft Type and Registration:</b>	Boeing 747-240B, AP-BAT	
<b>No &amp; Type of Engines:</b>	4 General Electric CF6-50C2 turbofan engines	
<b>Year of Manufacture:</b>	1980	
<b>Date &amp; Time (UTC):</b>	13 June 2002 at 0646 hrs	
<b>Location:</b>	Manchester International Airport, Manchester	
<b>Type of Flight:</b>	Public Transport	
<b>Persons on Board:</b>	Crew - 16	Passengers - 303
<b>Injuries:</b>	Crew - None	Passengers - None
<b>Nature of Damage:</b>	Outboard half of the No 3 engine thrust reverser translating sleeve separated from aircraft	
<b>Commander's Licence:</b>	Airline Transport Pilot's Licence	
<b>Commander's Age:</b>	56 years	
<b>Commander's Flying Experience:</b>	12,945 hours (of which 3,071 were on type)	
	Last 90 days - 132 hours	
	Last 28 days - 44 hours	
<b>Information Source:</b>	AAIB Field Investigation

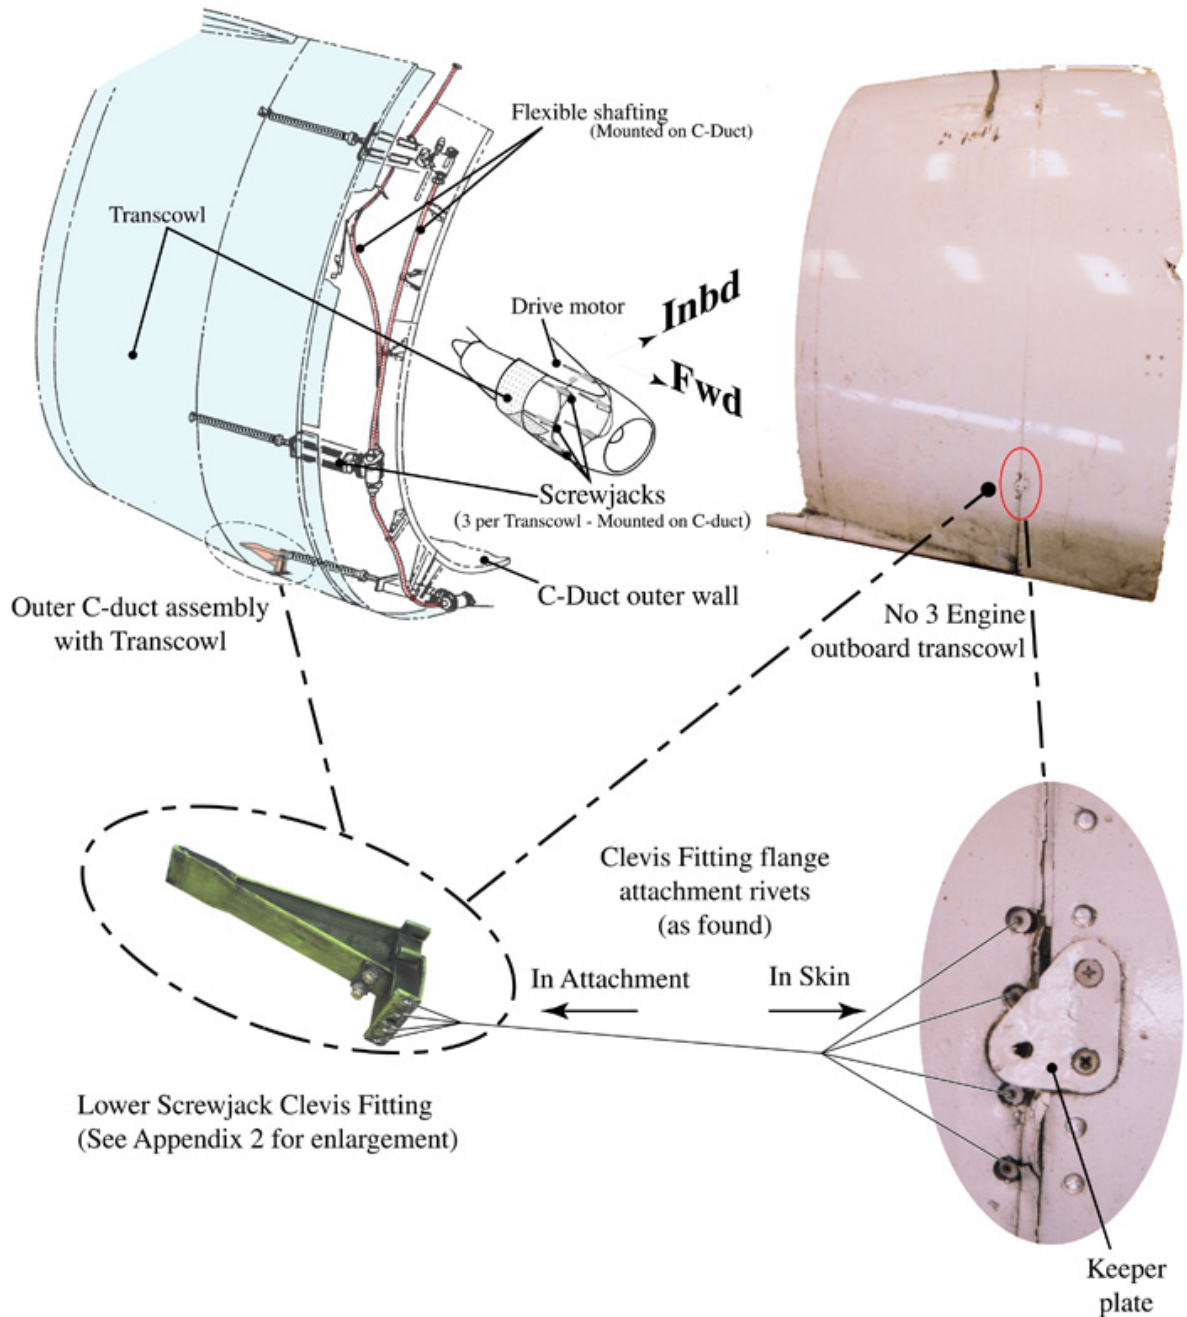
Location of Transcowl drive system components and lower clevis fitting on No.3 Engine outboard C-duct and transcowl

The thrust reverser assembly constitutes the rear section of the engine's fan-stream duct and is constructed in two halves, one either side of the pylon centreline. Each half consists of two major sub-assemblies which are the C-duct, which is supported at the top by hinges on the pylon and latched

The eye ends of the screwjack shafts are attached to the transcowl by pins which are inserted, through holes in the nacelle outer skin, into clevis fittings which are built into the transcowl structure. The pins are retained at their outer ends by small cover plates attached to the transcowl outer skin and at their inner ends by blocks on the clevis fittings. There is an anti-rotational fitting on each of the screwjack eye-ends.

Owing to the cross-sectional shape of the nacelle, the lower clevis fitting is larger and has a different attachment to the transcowl structure than the simpler upper and centre clevis fittings. The upper and centre fittings are relatively narrow and their inner and outer flanges are attached directly to the transcowl skin structure using solid rivets. By contrast, the lower clevis is stood off from the transcowl outer skin (see Appendix 2, Figures 2a & 2b) and has a more complex rivetted and bolted attachment.

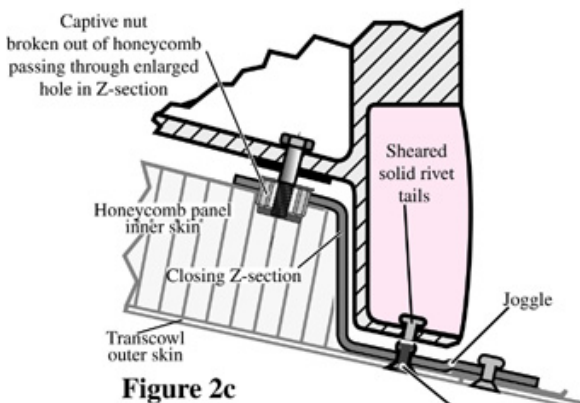
**Figure 2c**  
Detail section of Fitting  
flange and forward bolt  
attachments before separation.

Examination of the lower clevis fitting showed that the tails of the four solid flange to skin attachment rivets were still retained in their holes in the flange. (See Appendix 2, Figures 2c & 2d.) All four had failed in shear in a direction consistent with the fitting being pulled forwards relative to the transcowl. The two bolts immediately aft of the riveted flange were still attached to the clevis fitting and their captive nuts, which had been bonded into the transcowl honeycomb skin structure, were still attached to the bolts. Of the two bolts which should have attached the tail of the fitting to the skin structure, one was completely missing and only the threaded portion of the other remained in the captive nut.

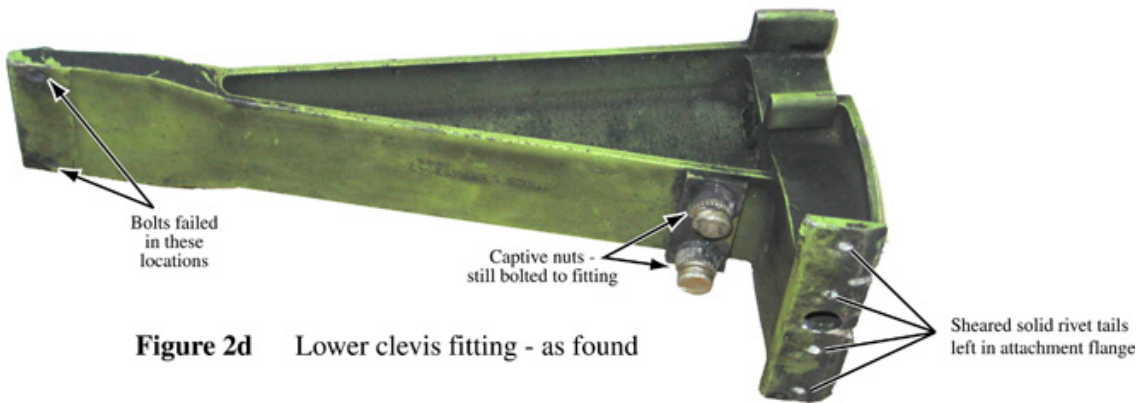
**Figure 2d** Lower clevis fitting - as found

Examination of the lower clevis fitting attachment zone revealed evidence that the original solid rivets attaching the fitting to the transcowl had failed in shear overload. (Appendix 2, Figure 2d.) One of the two aft attachment bolts had failed in shear but there was no trace of the second. The bond between the closing section and the honeycomb panel inner skin had failed, allowing the honeycomb panel closing Z-section to flex forwards, tearing out the bolt holes in the inner skin to its forward free edge and destroying the bond between the honeycomb and the Z-section web. The captive nuts at this location had also separated from the inner skin, allowing the bolts to enlarge the holes in the Z-section. (Appendix 3, Figure 3c.)

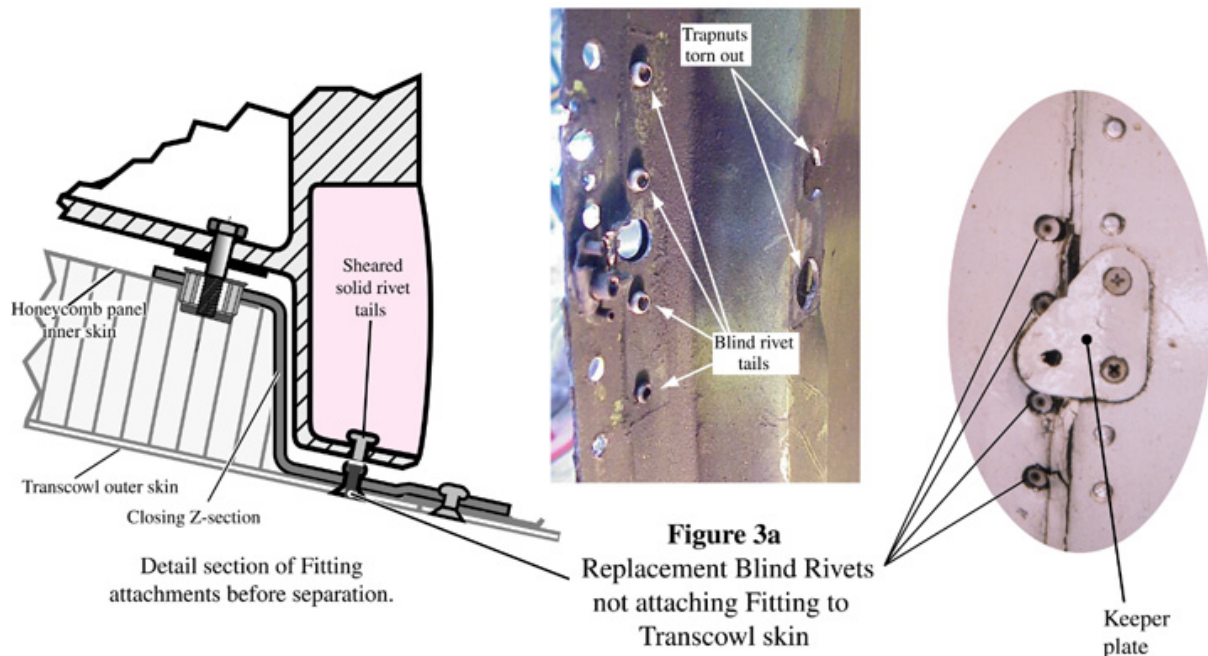
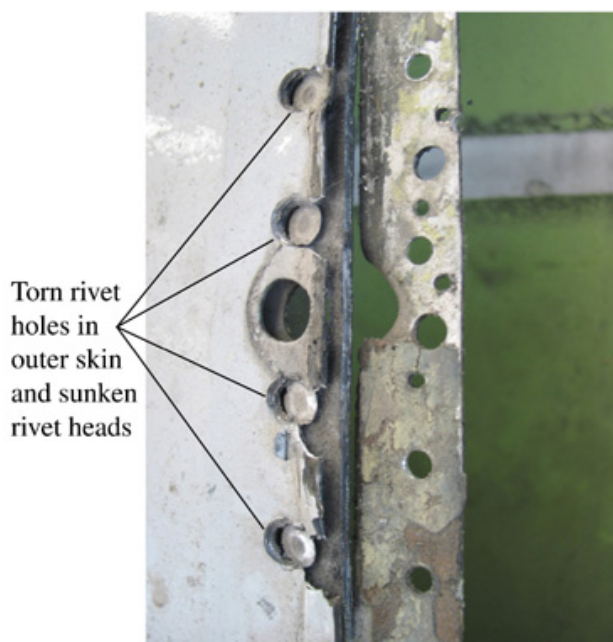
**Figure 3b**  
View on outer skin and Z section  
forward flange (forward skin removed)

The lower clevis fitting had separated, complete and undistorted, from the transcowl and there was little evidence of overload distortion on the outside of the transcowl, in the area of its attachment. The heads of the four rivets which should have attached the forward flange of the fitting to the transcowl outer skin were all apparently in place and appeared to be 'blind' type, (see Appendix 1) unlike all the other rivets in the area which were countersunk alloy 'solids'. The replacement rivets were all deeply set into the countersinks and the metal between the holes and the forward edge of the transcowl skin section had been torn out (Appendix 3, Figure 3b). The clevis pin keeper plate was still in position.

When the keeper plate had been removed it could be clearly seen that the skin forward of all four of the rivet holes had been broken out but there was no shear distortion of any of the rivets. This indicated that the rivets had been installed with the holes already in this condition. The forward skin of the transcowl was removed for better access to examine the failed clevis fitting attachment points. This confirmed that, on the lower fitting, the flange attachment had not been effective since the installation of the existing rivets.

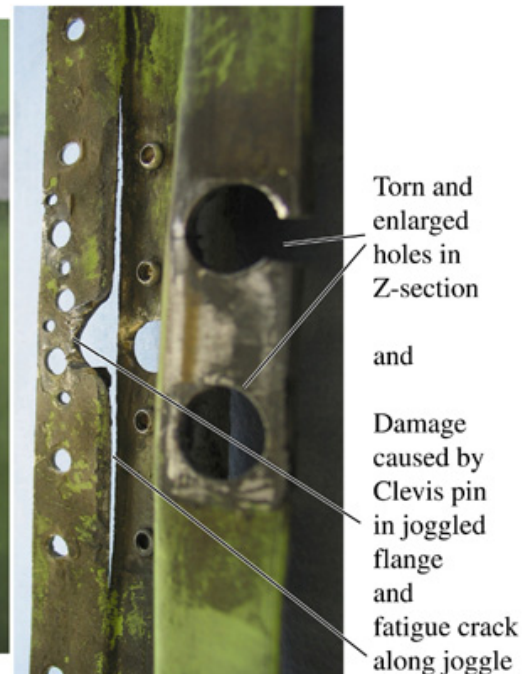
**Figure 3c**  
View on inside of Z-section

There were marks on the attachment flange of the clevis fitting made by the tails of the blind rivets which appear to have been installed to fill the holes left in the outer skin and Z-section flange. These marks indicated that the fitting was generally held against the rivet tails, at a slight angle to its proper orientation and slightly forward of its proper position. (Appendix 2, Figure 2c.) There were other marks on the fitting flange which, together with a set distortion of the Z-section web and damage to its forward flange, indicated that the fitting had been drawn forward, repeatedly and progressively further, relative to the transcowl structure. This movement had resulted in the clevis pin end riding up out of its insertion hole through the Z-section and striking the joggle in the forward flange of the section. (Appendix 3, Figure 3c.)

This action had resulted in a fatigue failure initiating and running circumferentially round the joggle line in both directions from the point at which the clevis pin had contacted the joggled edge. This contact had torn an indentation into the raised element of the joggled flange and progressively rolled its lip forward. The presence of this fatigue indicated that the damage had resulted from repeated operation of the thrust reverser with the lower clevis fitting inadequately attached to the transcowl. The fatigue had characteristics consistent with relatively rapid progression, indicating that the shear failure of the clevis fitting attachment rivets had been relatively recent.
