AIRCRAFT ACCIDENT REPORT 7/2008

Air Accidents Investigation Branch

**Report on the accident to
Aerospatiale SA365N, registration G-BLUN
near the North Morecambe gas platform
Morecambe Bay
on 27 December 2006**

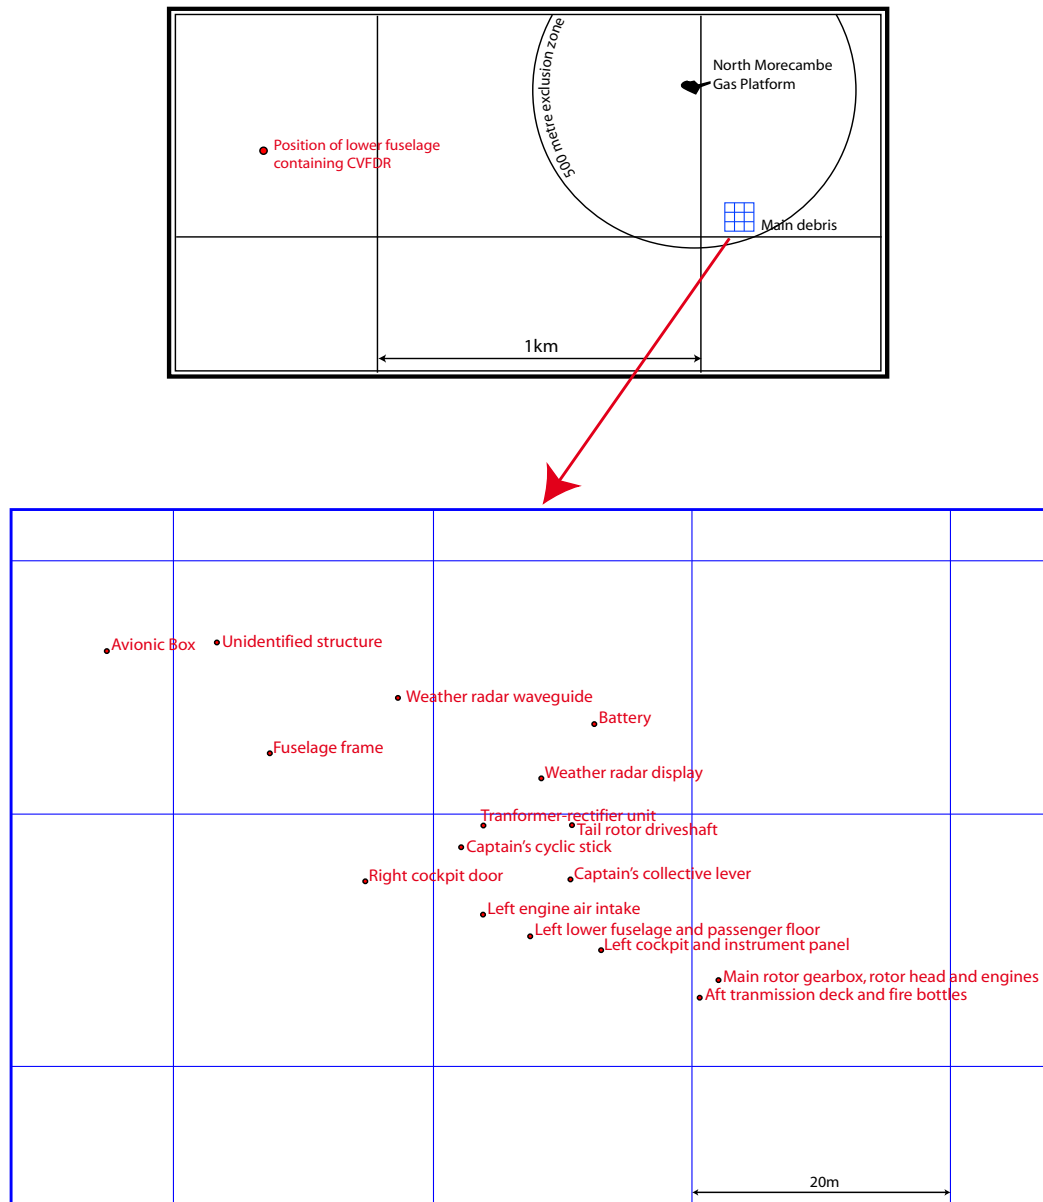
The diving support vessel confirmed that the sonar contacts were indeed substantial pieces of G-BLUN, lying amongst a field of smaller debris (see Figure 6). The most substantial piece was a section of transmission deck with the main rotor gearbox, main rotor head with varying lengths of blade still attached, and the engines. The engine mounts were disrupted but, when the gearbox was raised on 10 January 2007, the engines remained attached by fuel pipes, wiring looms etc and were also recovered. Throughout this period, attempts were made to locate precisely the locator beacon using detection equipment mounted on a Remotely Operated Vehicle (ROV); however, this was not successful.

Bad weather delayed further salvage attempts but eventually all the parts depicted in Figure 6 were recovered, plus a number of smaller items. Meanwhile, slightly improved conditions allowed an accurate location of the CVFDR to be completed. It was recovered on 16 January 2007, still within its rack in the baggage compartment, located in a large intact section of the lower rear fuselage. This section of the structure also housed the main landing gears, which were locked in the extended position. As can be seen from Figure 6, it was found about 1.3 km west-north-west of the main debris field and was the

Map of debris field showing main identifiable wreckage and (inset) location of debris field relative to North Morecambe gas rig

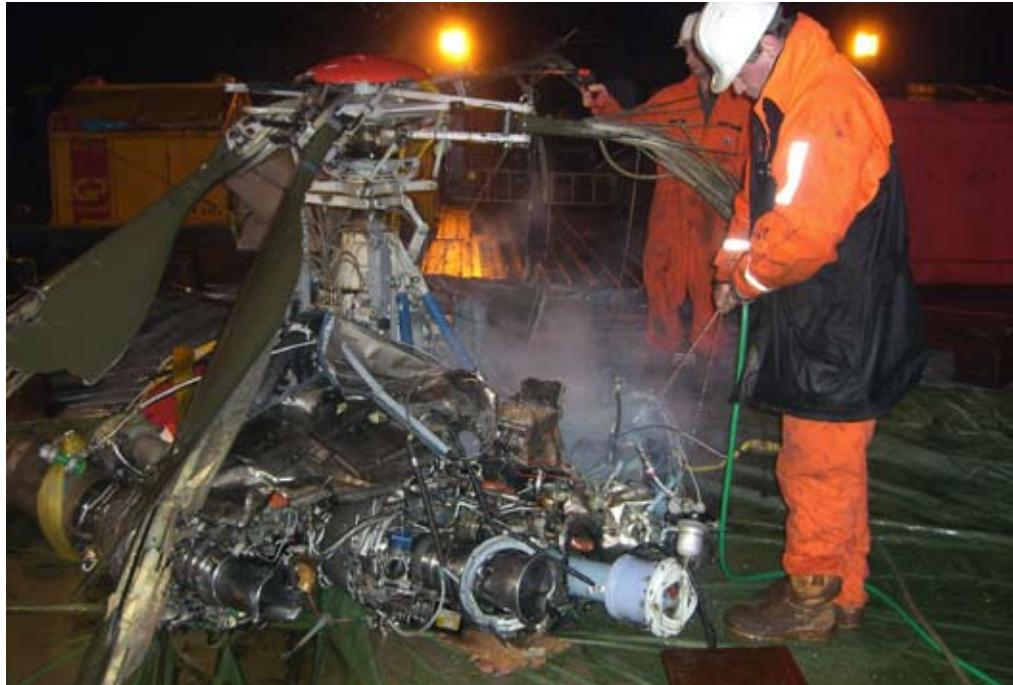
Figure 7

The main rotor gearbox, together with the rotor head and the remains of the rotor blades, was recovered still attached to the transmission deck. Damage to the three gearbox support struts indicated that the transmission system had been subject to a significant overtorque loading, as might be experienced through, for example, a main rotor strike on water. The inboard sections of the four rotor blades were still attached to the rotor head, which had been severely damaged; all of the elastomeric bearings had failed allowing the blade attachment beams to separate from the outboard ends of the rotor head star

(see Figure 7). Although severely distorted, all of the blade control linkages remained connected. After removal of the rotor blades, the transmission deck, gearbox and rotor head were shipped to the manufacturer in France for disassembly under AAIB supervision.

Main rotor head

During disassembly, impact marks observed on the lower gearbox suspension torque stops indicated that the transmission system had been subject to a very high torque load, consistent with the rotor system striking the water whilst under moderate to high power. Prior to disassembly of the transmission system the gearbox driven hydraulic pumps, used to power the main and tail rotor actuators, were removed and examined. The presence of corrosion products prevented the units being bench-tested; however, disassembly confirmed that they had not suffered any internal failure and after clearing they could be rotated freely. The rotor head hydraulic actuators were also removed for testing and examination by their manufacturer under AAIB supervision. Examination of the components of the main rotor gearbox confirmed that there was no evidence of any pre-existing defects or failures within the system.

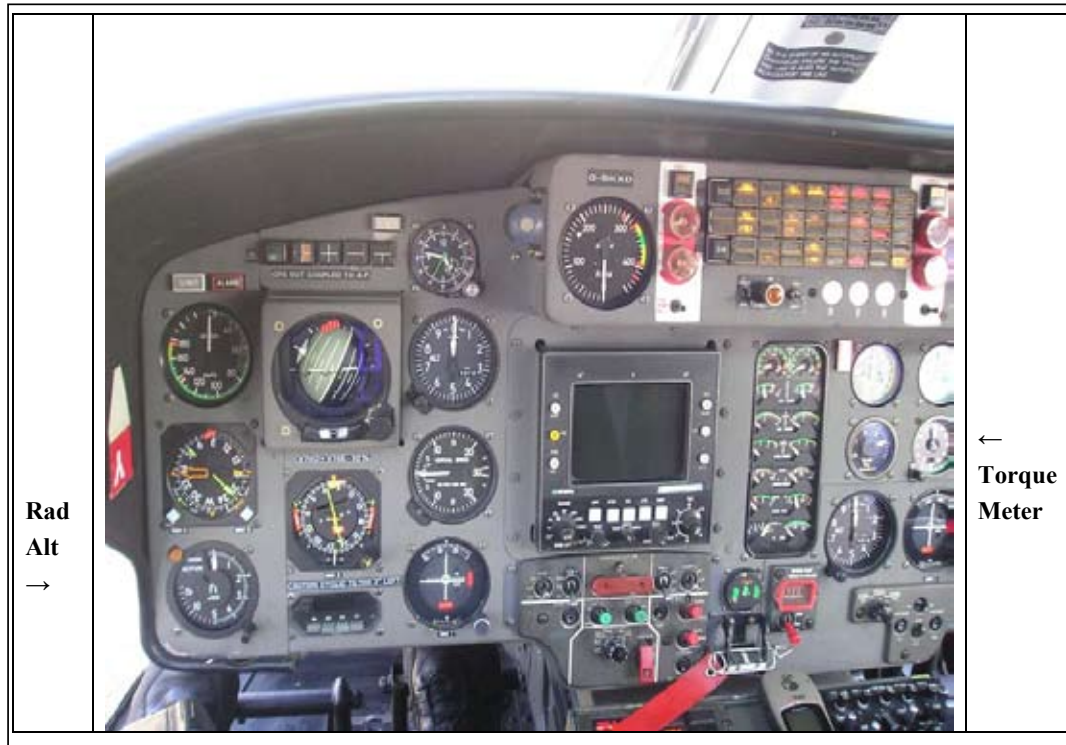
Fig 2. The LHS Panel and position of the torquemeter

The small torquemeter was difficult to read and was positioned well outside the LHS occupant's normal FOR. The higher power figures required to hover or go-around were situated in the arc from 6 o'clock to 10 o'clock and were partially obscured by the instrument bevel when viewed cross cockpit. It was not possible to conduct a normal scan on the LHS instruments while monitoring or setting torque. From the transcript of the accident aircraft CVR and in discussions

with the CHC TRE there did not appear to be any procedural method of the RHS occupant calling torques to assist the LHS handling pilot.
