**No:** 7/92

**Aircraft Type and Registration:** Aerospatiale AS332L Super Puma, G-TIGO

**Date & Time (UTC):** 22 February 1992 at 0830 hrs

**Location:** Aberdeen Airport

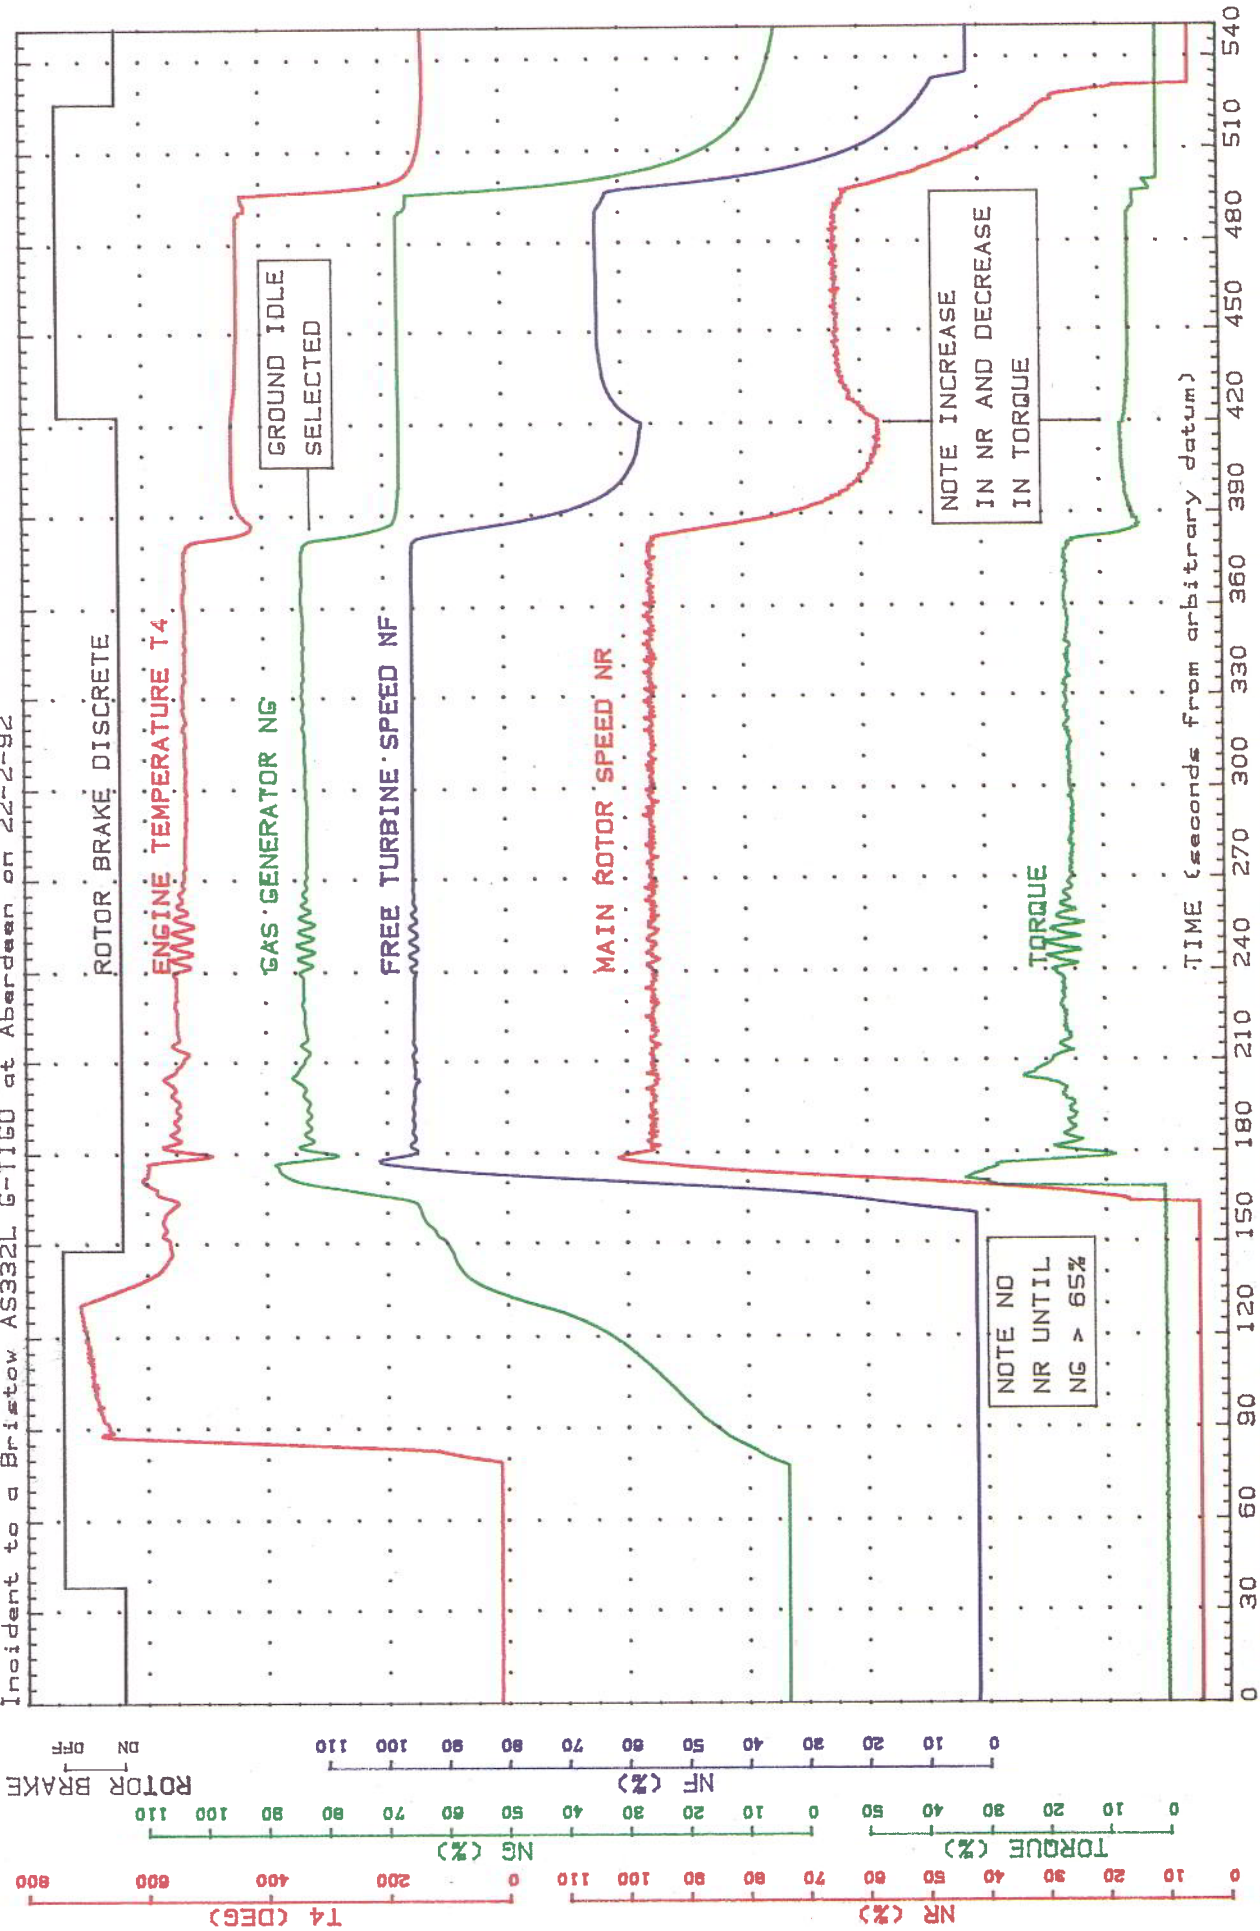
Incident to a Bristov AS332L G-TIG0 at Aberdeen on 22-2-92

The appended recordings show several No. 2 engine parameters, together with main rotor rpm (NR) and the rotor brake discrete recording. It can be seen that the rotor brake trace appeared to indicate that the rotor brake had been released approximately 30 seconds prior to starting the engine (the latter indicated by the gas generator rpm (Ng) starting to rise). However, the rotors would normally be expected to start turning at an Ng of less than 20% with no brake applied, whereas it can be seen that the NR did not start to rise until the Ng had exceeded 65%, some 12.5 seconds *after* the brake had apparently been reapplied. It was therefore initially concluded that there had been a recording fault associated with the discrete signal, over the period covering the engine start.

Approximately one minute after the engine parameters stabilised, an apparent instability can be seen. This was not fully explained; however, it was surmised that it may have been due to a series of "grab/fade" cycles on the brake pads. The oscillations on the Ng and Nf (free turbine rpm) traces were in anti-phase; ie the Ng reduced as the Nf increased, which is to be expected. Some 35 seconds after ground idle was selected, the rotor brake discrete showed an "OFF" indication. This appeared to be a valid indication, since there was an accompanying increase in NR, together with a torque reduction. Finally, the end of the trace showed a reapplication of the brake which resulted in a rapid reduction in NR (and Nf).
