Avid Speedwing (Modified), G-BUZM

AAIB Bulletin No: 10/2004	Ref: EW/C2004/03/06	Category: 1.3
Aircraft Type and Registration:	Avid Speedwing (Modified), G-BUZM	
No & Type of Engines:	1 Jabiru 2200A piston engine	
Year of Manufacture:	1994	
Date & Time (UTC):	28 March 2004 at 1245 hrs	
Location:	Caernarfon, Wales	
Type of Flight:	Private	
Persons on Board:	Crew - 1	Passengers - None
Injuries:	Crew - None	Passengers - N/A
Nature of Damage:	Damage to propeller and nose landing gear	
Commander's Licence:	Private Pilot's Licence	
Commander's Age:	67 years	
Commander's Flying Experience:	301 hours (of which 172 were on type)	
	Last 90 days - 22 hours	
	Last 28 days - 19 hours	
Information Source:	Aircraft Accident Report Form submitted by the pilot with subsequent telephone and written enquires.

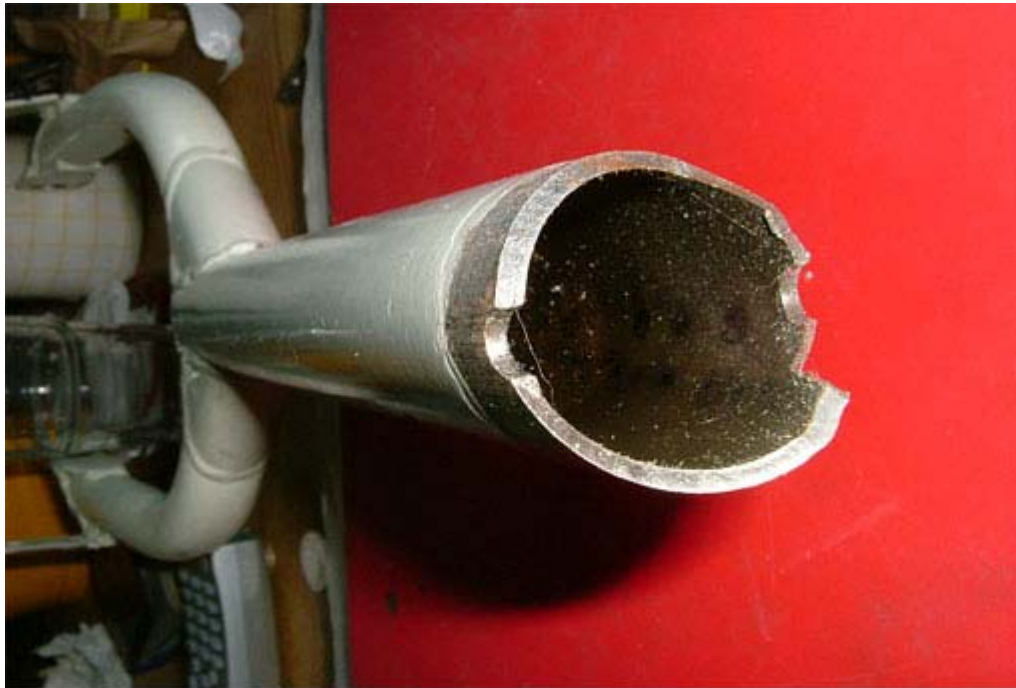
Whilst taxiing, following an uneventful landing, the nose landing gear collapsed. Subsequent investigation revealed that circumferential cracking had developed from a through bolt hole used to retain a stop bushing (or lower bearing sleeve) on the nose gear strut. These holes had been drilled aligned with the fore and aft axis of the aircraft and were in the area of highest stress whenever the gear flexed, for example, during touchdown. It was recommended by the manufacturer and the PFA that the axis of this hole should be aligned perpendicular to the line of flight, in the axis of minimum stress loading, which is left to right and parallel to the nose wheel axle.

Subsequent engineering examination of the nose gear strut revealed that it had fractured at the position of a hole drilled through the strut, a hole through which the retention bolt for a stop bushing was located. The axis of this hole was aligned with the longitudinal axis of the aircraft and, consequently, the two holes were located in the higher stress region of the strut when fore and aft deflection of the strut occurred, for example, during touchdown. Over time, the two holes in the strut walls had elongated and circumferential cracks had developed, originating at these holes, Figure 1. The crack surfaces close to the holes exhibited the characteristics of a fatigue mechanism, but the majority of the fracture showed evidence of overload failure, most likely occasioned at the time the nose gear collapsed.

Figure 1. Lower section of failed nose gear. Note the bolt hole orientation

It is recommended that the PFA ensure all Avid Speedwing aircraft under construction or in service in the UK, that are fitted with a nose landing gear, have the nose gear strut installed with the axis of the bolt hole for the stop bushing aligned parallel to the nose wheel axle, and that none have been modified to leave redundant holes aligned with the aircraft longitudinal axis.

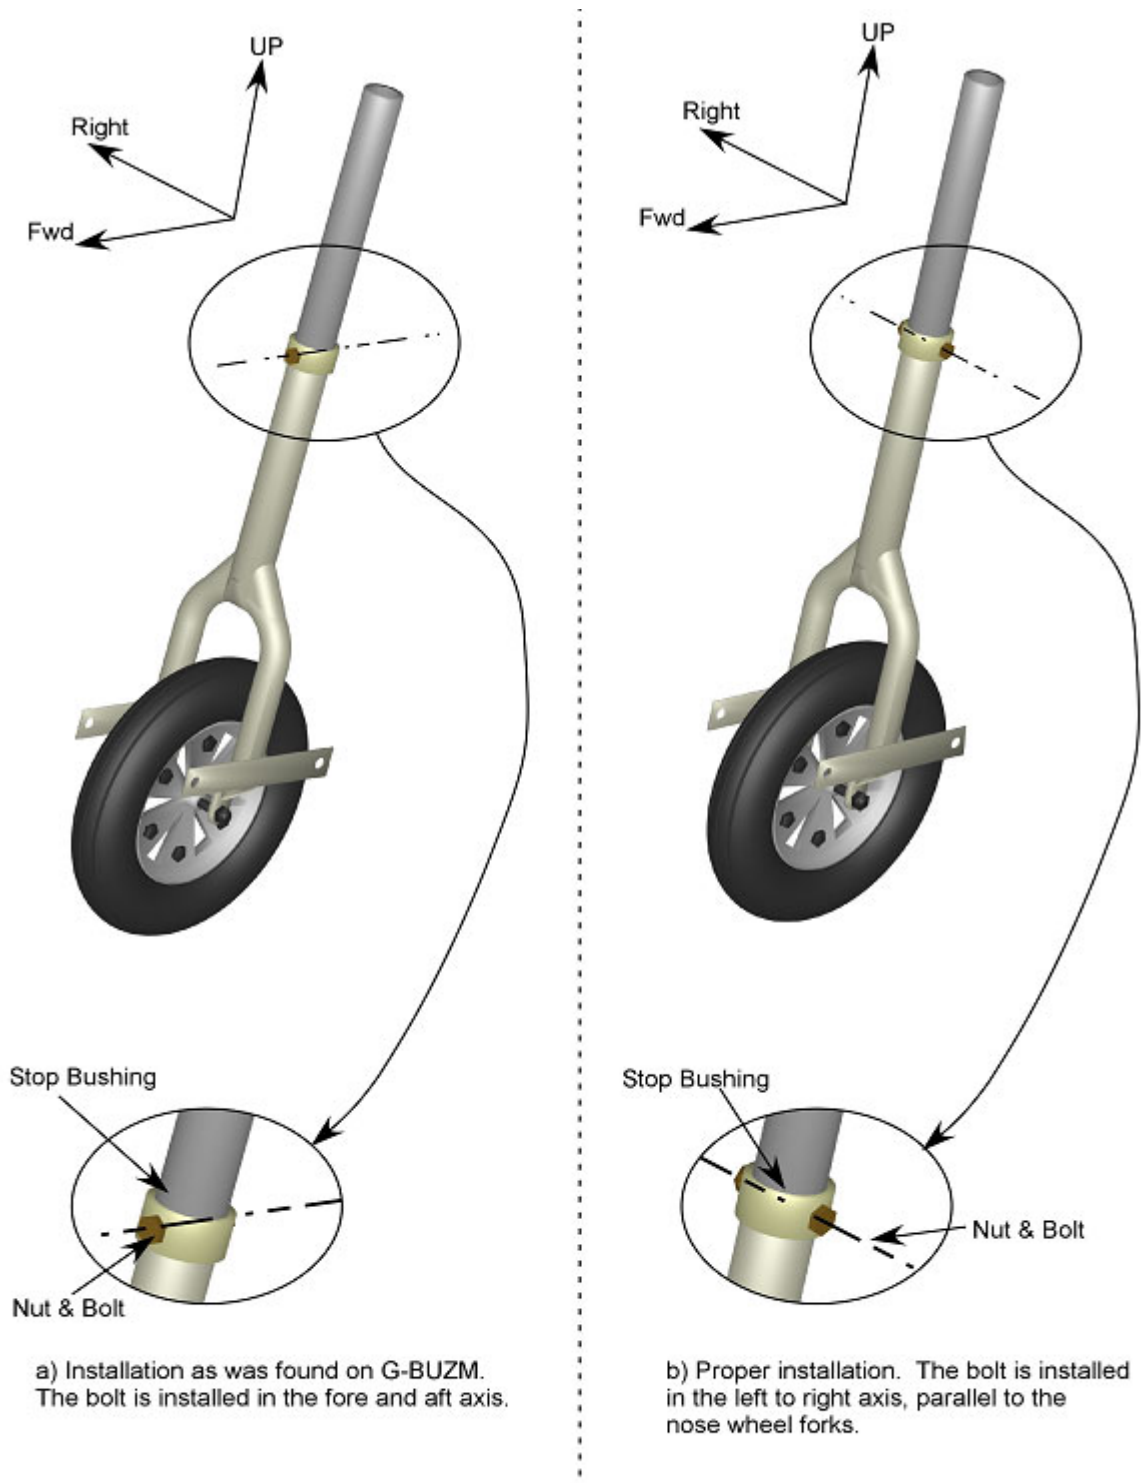
However, this may not have been read by all of the Avid Speedwing constructors or owners. No changes were made to the manual or any checks required to be made of aircraft in service or under construction. Figure 2a shows a representation of the nose gear with the stop bushing and bolt installed in the fore and aft direction as found on G-BUZM. Figure 2(b) shows the same nose gear representation but with the bolt now installed as detailed in the 1988 manual, parallel to the nose gear forks.

Figure 2. Gear Installation representation showing the stop bushing and bolt orientation.

The stresses experienced by the nose gear strut are usually bending and compressive due to the friction of the nose wheel on the ground and the weight of the aircraft. This would result in the maximum bending induced stresses being concentrated on the fore and aft faces of the nose leg. The placing of a bolt hole in the fore and aft axis puts them in the area of highest stress and results in regions of stress concentration, which then leads to cracking. To reduce this likelihood of cracking the bolt holes should be placed in an area of the lowest stress, which in this case would be parallel to the nose gear forks as shown in Figure 2b and this was as detailed in the original kit construction manual.
