No: 7/90

Ref: EW/C1149

Aircraft Type and Registration: Boeing 737-300, G-BLKD

Location: East Midlands Airport

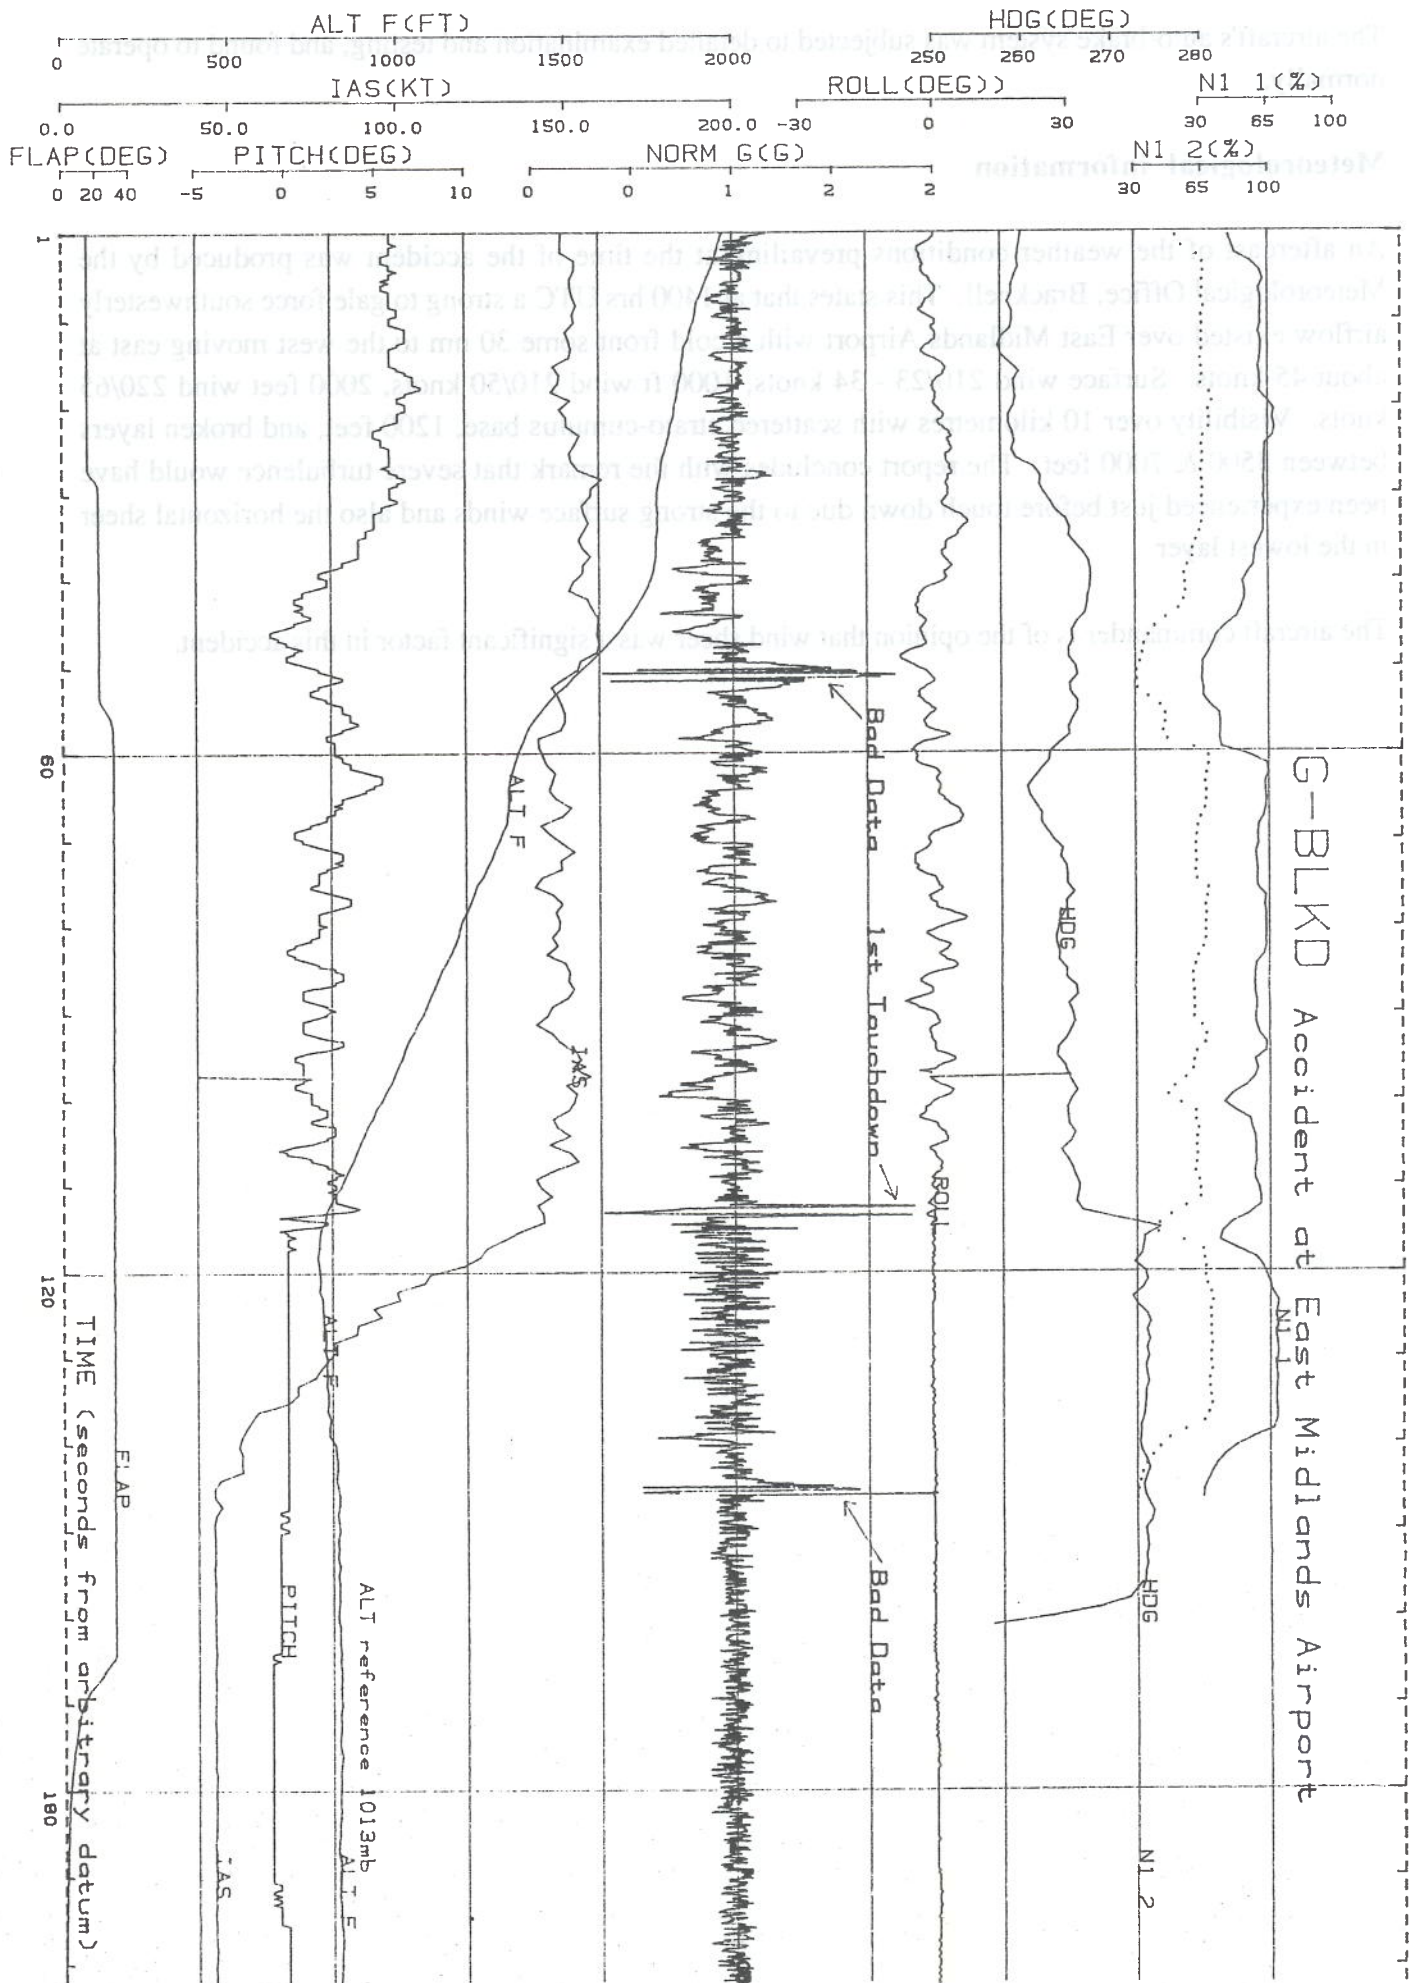
The Flight Data Recorder (FDR) was a Sundstrand UFDR which recorded 13 analogue parameters and 4 discrete events. A satisfactory replay was obtained except that there was occasionally some random corrupt data from the 'normal g' trace. A plot of the data on the final approach and landing is included at the end of this report, and an explanation of the data is as follows.

Flap 30 degrees was achieved 56 seconds before touchdown as the aircraft passed 600 feet AGL, with the N1 at 40% and 45% on the No1 and No2 engines respectively and a rate of descent of about 1200ft/min. Power was increased to about 60% on each engine at around 560 feet AGL which reduced the rate of descent and the approach stabilised at about 600ft/min. The average airspeed on the approach was 148 knots (Vref 132 knots), but there were considerable variations from this which can directly be attributed to the gusty wind conditions. The maximum normal acceleration recorded at touchdown was 1.89G, with a second peak value one second later of 1.88G. The airspeed at touchdown was 143 knots.

The aircraft's pitch attitude at the first touchdown was 4 degrees nose up, decreasing to around zero degrees one second later at the second peak recorded on normal acceleration. The mean heading during the final approach was 265 degrees M, and after touchdown on the runway the heading stabilised at 273 degrees M, indicating the significant crosswind component. At the first touchdown the aircraft's heading was 266.4 degrees M, at the second peak normal acceleration the heading was 270.7 degrees M, and one second later the heading was 275 degrees M.
