AAIB Bulletin No: 3/96

Ref: EW/C95/11/2

Aircraft Type and Registration:	Cessna 310, N3TQ	
No & Type of Engines:	2 Continental IO 470 piston engines	
Year of Manufacture:	1973	
Date & Time (UTC):	10 November 1995 at about 1700 hrs	
Location:	Bournemouth (Hurn) International Airport	
Type of Flight:	Private	
Persons on Board:	Crew - 1	Passengers - 1
Injuries:	Crew - None	Passengers - None
Nature of Damage:	Erosion of underside of nose, including landing gear support structure and doors, one propeller blade tip on each engine bent	
Commander's Licence:	FAA Commercial Pilot's Licence	
Commander's Age:	44 years	
Commander's Flying Experience:	521 hours total (of which 104 hours were on type) Last 90 days - 30 hours Last 28 days - 7.3 hours	
Information Source:	AAIB Field Investigation

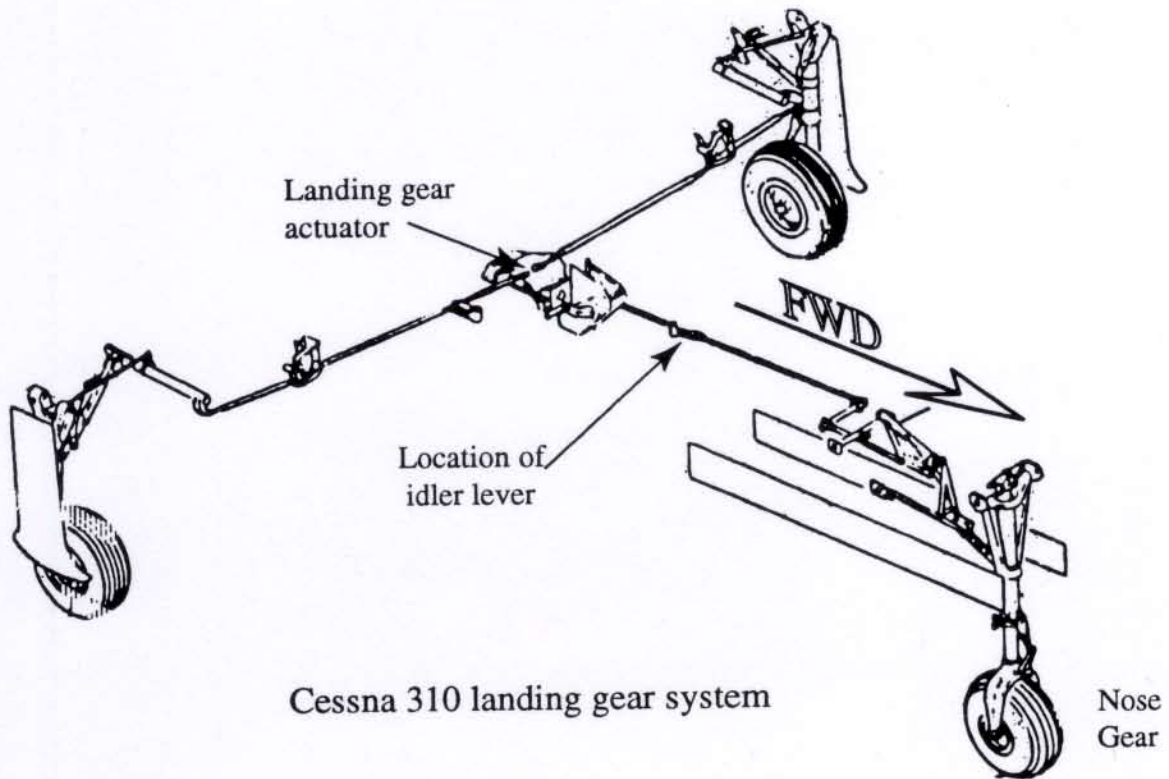
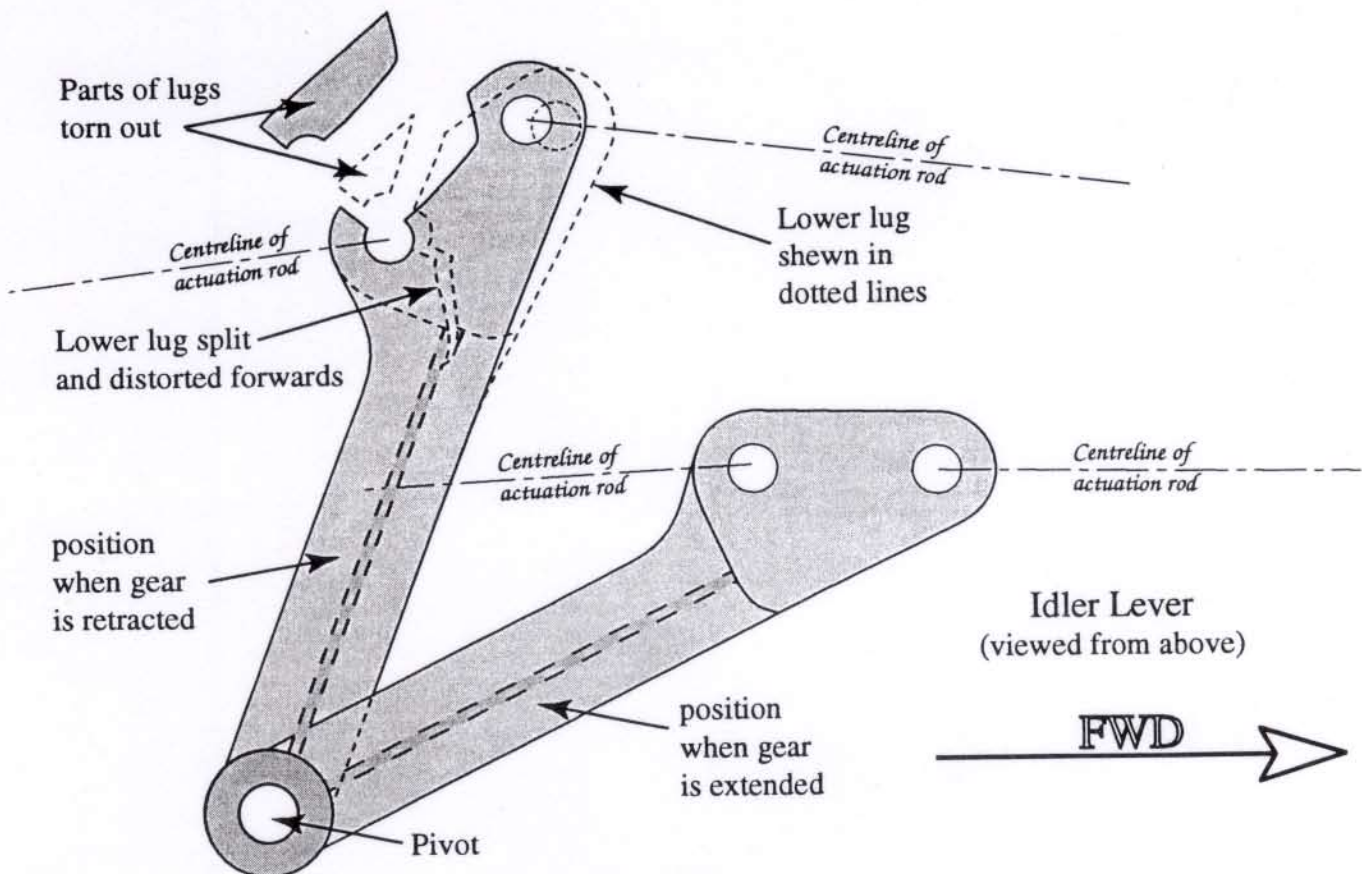
Subsequent examination of the nose gear operating mechanism revealed that there had been an overload failure of the lugs of the idler lever which is located under the floor, beneath the pilots feet. (see diagrams) The position and direction of this failure was consistent with it having occurred as a result of high forces being generated towards the end of the retraction cycle. The damage to the forward part of the aircraft resulting from the groundslide of the nose during the landing precluded the possibility of establishing the pre-landing rigging of the nose gear mechanism.
