McDonnell Douglas MD-11F, N583FE

AAIB Bulletin No: 8/2003 Ref: EW/C2003/01/03 Category: 1.1

Aircraft Type and Registration: McDonnell Douglas MD-11F,
N583FE

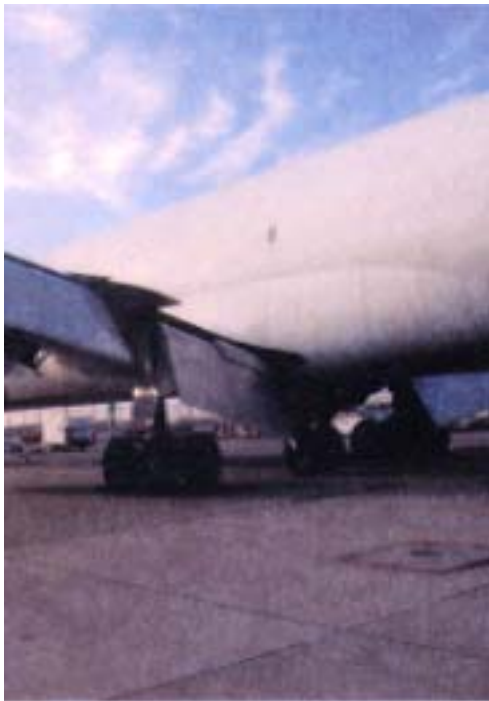
The inboard flap vane is an aerofoil section fitted to the leading edge of the inboard trailing edge flap. It is supported at three positions on spring loaded tracks, which extend the vane as the flap moves away from its retracted position. Examination of the aircraft showed that the outboard half of the vane on the left inboard flap was missing, together with its attachment fittings at the outboard and centre positions. The inboard section of the vane was still attached to the flap and both the inboard and centre vane tracks showed significant distortion. Retraction of the flaps during taxiing had resulted in damage to the flap shroud structure and the No 2 hydraulic system.

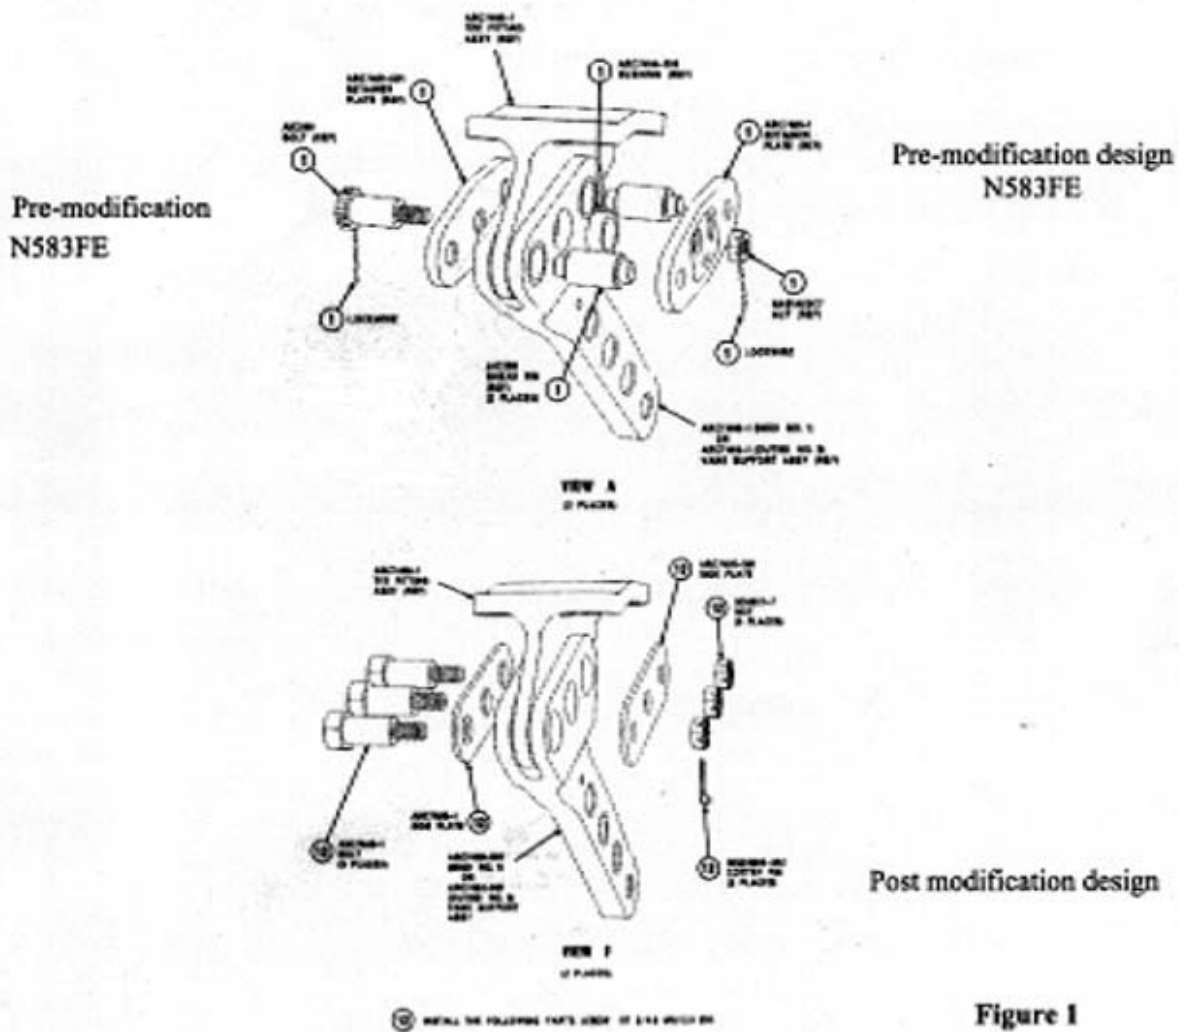
Figure 1 is reproduced with acknowledgements from the manufacturer's Service Bulletin MD11-57-034 and shows details of both the pre and post modification design of the vane attachment to the inboard flap. The vane outboard attachment was of the pre-modification design

After dismantling, a locking (retainer) plate and nut, each with part of the broken locking wire attached, were found inside the flap, in a pocket for the vane outboard track. No other attachment parts were found, and for these parts to have been retained in the flap it was necessary for them to have detached whilst the flap was retracted. Subsequent operation of the flap would have allowed the remaining attachment items to fall from the aircraft.

Analysis of the fractured lock wire was conducted using a Scanning Electron Microscope (SEM). The material of the lock wire was consistent with the required MS20995C32 specification and ASTM A580 material, which is an annealed and passivated corrosion resistant steel. The standard of workmanship employed in locking the wire appeared adequate. The two strands of the wire had fractured in a brittle manner, consistent with a fatigue process, and there was evidence of a notch or groove in the wire at one of the two fractures, which were co-located. It is possible that the wire had been accidentally nicked. The position of the fracture was such that it was likely that the wire would have made rubbing contact with a corner of the nut, and this may also have accounted for the nick and subsequent fracture.

There was normally no maintenance requirement to disturb the outboard attachment area of this vane and, during checks, only routine visual inspections would have been conducted. In March of 2002, a Special Inspection to check for cracks in the flap vane 'Tee' fittings (see Figure 1) would have required this area to be dismantled. The last major work input associated with this area was during a 'C' check, carried out in July 2002, when this area was inspected but not disturbed.

In 1996, the aircraft manufacturer issued Service Bulletin MD11-57-034, in response to a report of the in-flight loss of an inboard flap vane, during the approach to land. This event was attributed to flap vane attachment points becoming disconnected due to either broken or missing lockwire. The Service Bulletin introduced at the inboard and outboard positions as an optional modification, three bolts/nuts locked with cotter pins, in place of the one bolt/nut locked with safety wire and two location pins.

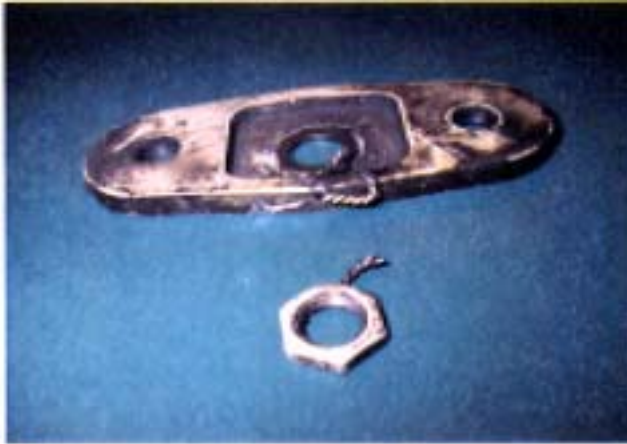
It seems probable that the vane outboard rail had become detached before the approach to Stansted, and that this possibly accounted for the initial slight amount of trim required when the flaps were set to 35°. With the flap vane attached at only the inboard and centre positions, it became possible for aerodynamic forces to fail the vane as flap 50° was deployed. Loss of the outboard half of the flap vane would then account for the roll moment noted by the crew, as there would have been an

asymmetry of lift between the left and right wings, and the consequent necessity for the pilot to apply right aileron. Upon retraction of the flaps to 35°, this lift asymmetry would have been reduced.
