INCIDENT

Aircraft Type and Registration:	Boeing 747-443, G-VROM
No & Type of Engines:	4 General Electric CF6-80C2B1F turbofan engines
Year of Manufacture:	2001
Date & Time (UTC):	26 July 2005 at 2107 hrs
Location:	Approx 100 nm north-east of Nassau, Bahamas
Type of Flight:	Public Transport (Passenger)
Persons on Board:	Crew - 18 Passengers - 278
Injuries:	Crew - 14 (Minor) Passengers - 10 (Minor)
Nature of Damage:	Minor cabin damage
Commander's Licence:	Airline Transport Pilot's Licence
Commander's Age:	49 years
Commander's Flying Experience:	10,427 hours (of which 4,105 were on type) Last 90 days - 185 hours Last 28 days - 71 hours
Information Source:	Aircraft Accident Report Form submitted by the pilot

Synopsis

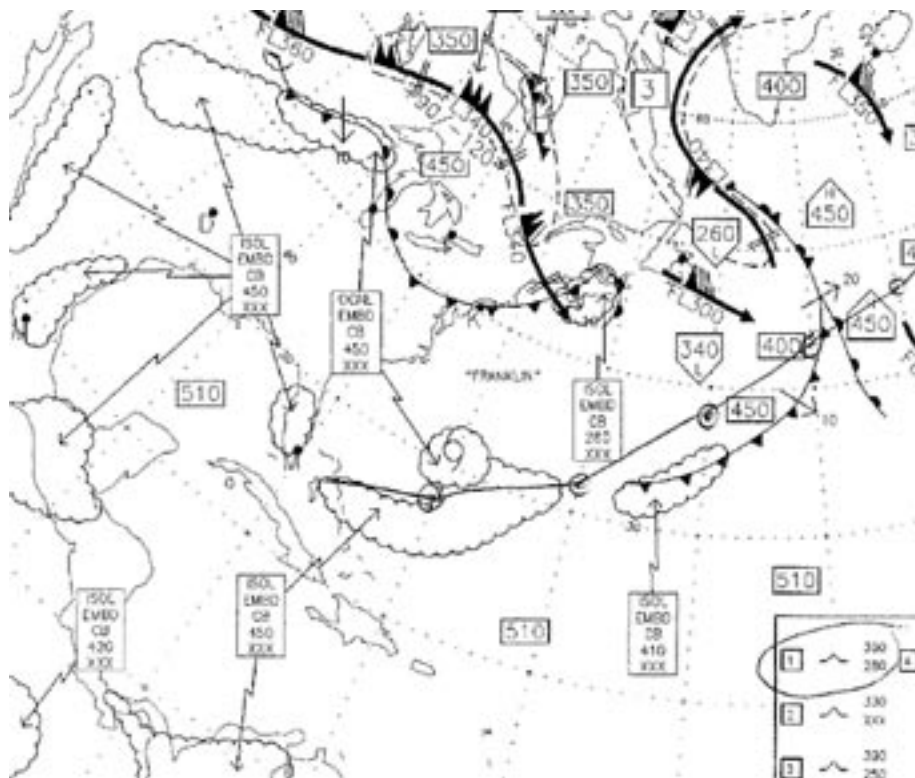
Figure 1

The aircraft had departed Nassau, Bahamas in daylight on a scheduled flight to London Gatwick Airport. Push-back was at 2030 hrs and takeoff at 2047 hrs. The aircraft's planned route is shown at Figure 1, as plotted by the flight crew on the Significant Weather Chart. Tropical Storm Franklin was located approximately 600 nm northeast of the Bahamas. Associated with Franklin and to the south of it was a band of weather lying approximately north-east to south-west. This weather was forecast to contain isolated embedded cumulonimbus (CB) clouds. The intended track passed south of Tropical Storm

The aircraft's planned route marked on the Significant Weather Chart

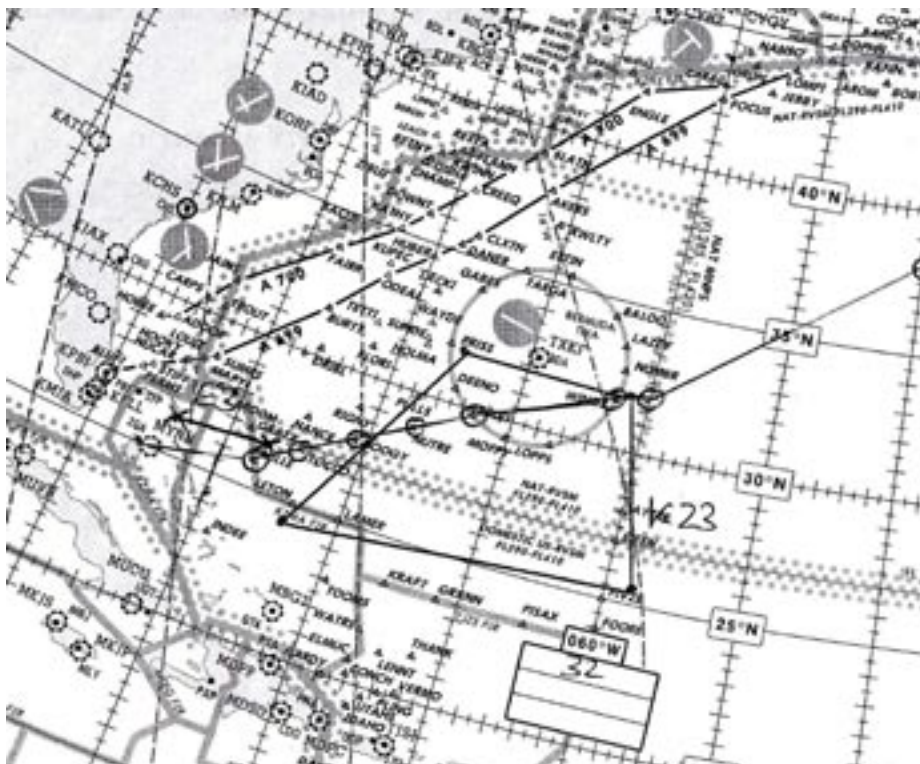
The flight crew had discussed the possible effects of the weather, particularly Tropical Storm Franklin, and they had marked on the Mid-Atlantic Plotting Chart, two SIGMET¹ areas received from New York. A copy of the chart is shown at Figure 2 with the SIGMET areas annotated by the crew as E3 and K23. These were areas of moderate turbulence associated with Tropical Storm Franklin. Area E3 was advised before departure whereas the flight crew were not informed of area K23 until after the turbulence encounter.

Chart with SIGMET CAT areas annotated by the crew as E3 and K23
