No: 6/91

Ref: EW/G90/12/13

**Aircraft Type and Registration:** Denny Kitfox Mk 1, G-BPKK

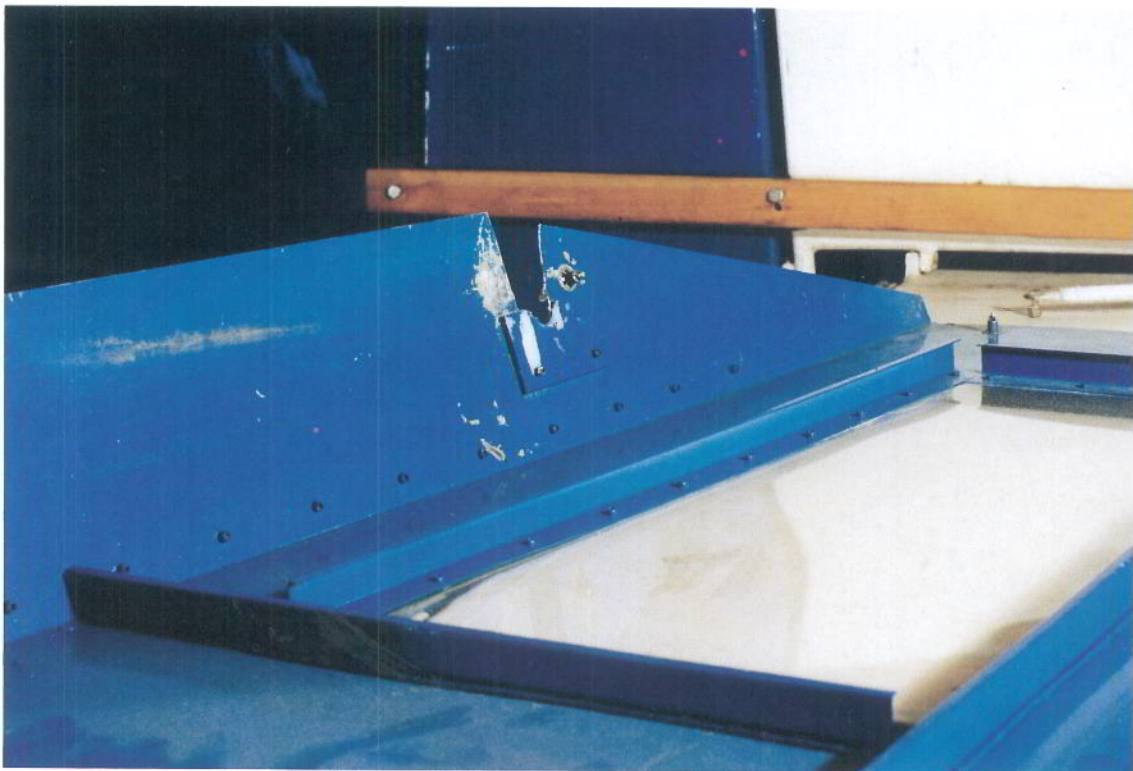
- 1) Several areas of poor construction were evident, potentially the most significant concerning the flapperon torque tube bearings described above. The design itself did not appear conducive to positive location of the torque tube but it had been particularly poorly rendered in this case. There were clearly visible gaps between the tube and the plastic bearing halves with the turtle-deck installed and clear signs of much rough trimming of both the metal and plastic resulting in mis-shapen and oversized profiles (see photograph). Excessive play in control runs can be a

contributory factor to aero-elastic effects such as flutter. Although not relevant to the accident, it was noted that there was also considerable free play in the elevator hinges as if undersize hinge-pins had been used or possibly liners were missing.

G-BPKK rear window assembly incorporating flapperon torque tube bearing half with evidence of rough trimming and mis-shapen profile

- 3) Attempts should be made to quantify the forces acting on the flapperon supports to confirm that there is an adequate strength margin, particularly with the additional weight of the mass-balancing installed.
- 4) The design of the flapperon torque tube bearing should be reappraised with a view to requiring modification to a separate bearing assembly independent of the rear window installation.
- 5) Owners of aircraft constructed of wooden materials should be reminded of the potential loss of strength of components subjected to abnormal loading following ground or airborne incidents. It should be emphasised that latent damage may be invisible to the naked eye.
