ACCIDENT

| Aircraft Type and Registration: | RAF 2000 GTX-SE, G-CBCJ | |
| Location: | 2 nm north of Henstridge Airfield, Somerset | |

Synopsis

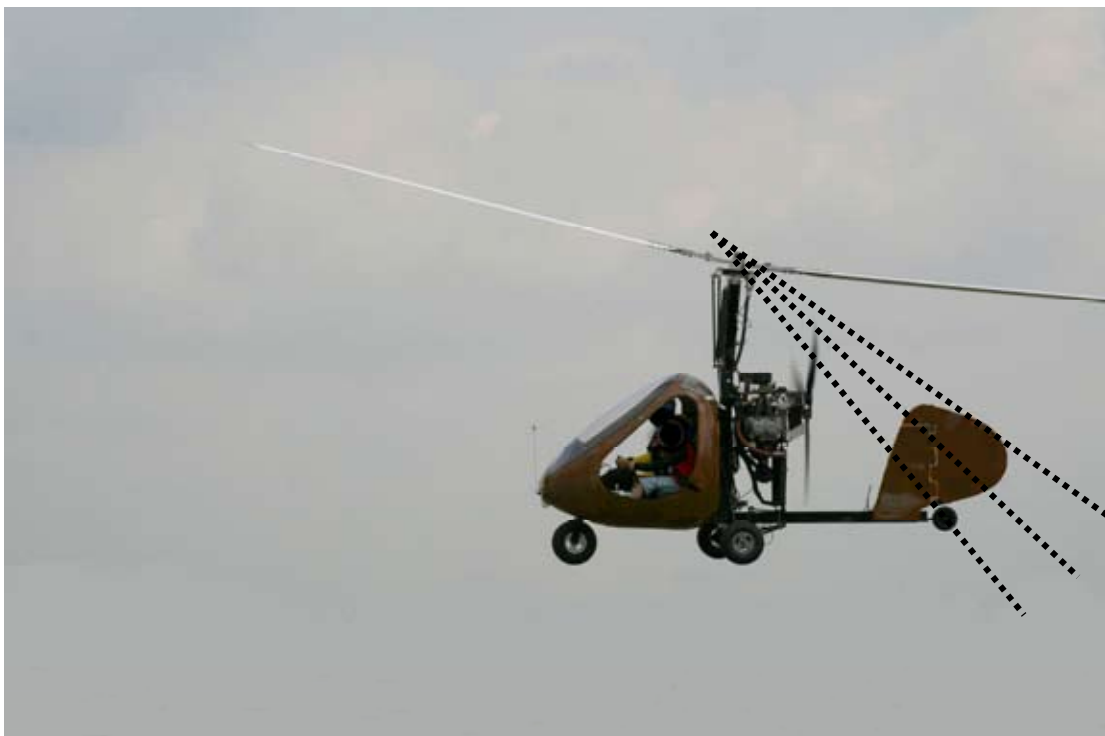
Figure 3

Evidence from ground marks indicated that the rotor blades had not been rotating at impact. However, there was evidence along the length of the blades of multiple impacts with the propeller blades, together with paint transfer arising from impact with the fin and rudder. Reconstruction of the fin and rudder pieces recovered from the wreckage trail indicated that there had been three strikes from the main rotor blade. The first strike had been at the top of the fin/rudder, the second mid-way down, and the third at the base of the rudder, resulting in the detachment of the tailwheel and most of the keel beam. See Figure 3.

Illustration of the three strikes on the fin and rudder by the main rotor

The damage to the empennage and distribution of the wreckage was consistent with the main rotor blades having struck the propeller, fin and rudder whilst the gyroplane was airborne and the engine was producing power. The noises reported by witnesses were probably confirmation of this. The damage to the rotor blades and loss in rotor rpm would have resulted in a high rate of descent and near vertical impact with the surface. This in-flight break-up bore strong similarities with the accident involving G-REBA.
