ACCIDENT

Aircraft Type and Registration:	Boeing B767-3YO ER, ZS-PBI	
No & Type of Engines:	2 Pratt & Whitney PW4000 series turbofan engines	
Year of Manufacture:	1992	
Date & Time (UTC):	11 July 2005 at 1951 hrs	
Location:	London Gatwick Airport	
Type of Flight:	Public Transport (Passenger)	
Persons on Board:	Crew - 11	Passengers - 207
Injuries:	Crew - None	Passengers - None
Nature of Damage:	Damage to tyre treads on two wheels	
Commander's Licence:	Airline Transport Pilot's Licence	
Commander's Age:	51 years	
Commander's Flying Experience:	17,800 hours (of which 1,460 were on type) Last 90 days - 170 hours Last 28 days - 90 hours	
Information Source:	AAIB Field Investigation

Synopsis

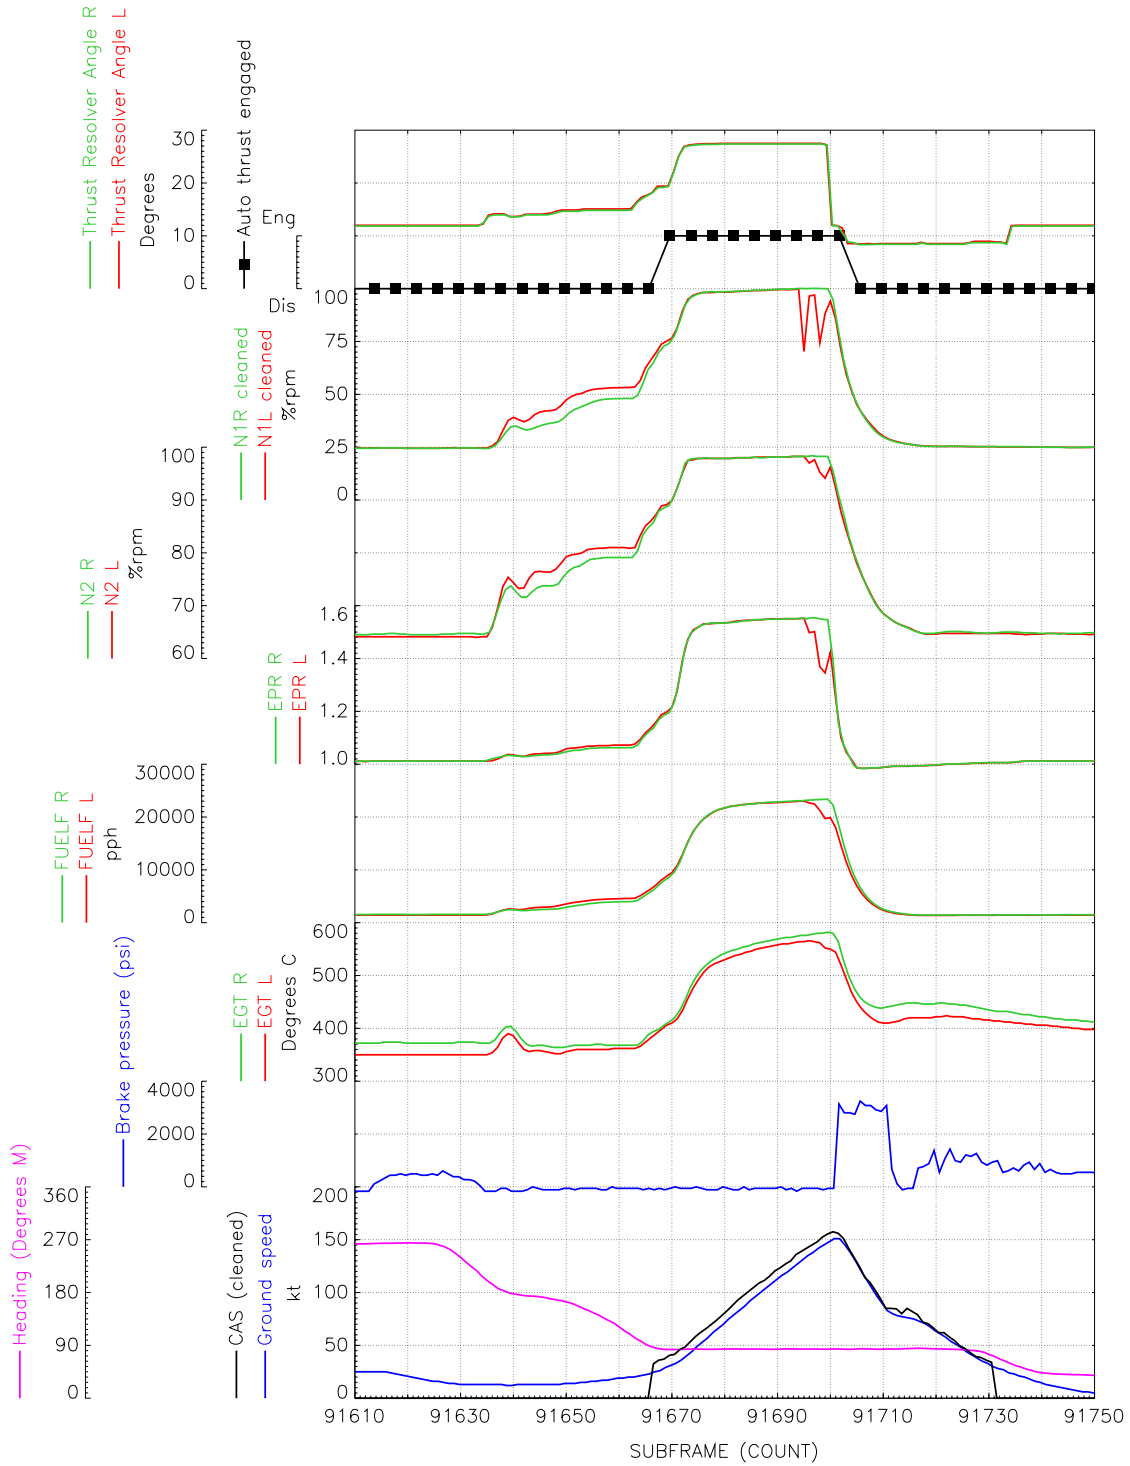
Figure 1
Recorded engine parameters during the rejected takeoff.

The FDR contained data covering just over 29 hours of operation prior to event. There were some anomalies with the recorded data that made the engine N_1 and the computed air speed parameters unreliable below 5.25% and 30.5 kt respectively, and so for the purpose of this report, values below this have been set to zero. All times stated are referenced to UTC. Figure 1 shows the pertinent parameters during the rejected takeoff.

At 1942 hrs the brakes were released and the engine power was increased. The aircraft taxied with a ground speed of between 7 kt, in turns, and 25 kt, on straight sections of the taxiway. At 1950 hrs the aircraft was slowed to 12 kt and turned from the taxiway adjacent to the runway onto Runway 08R. The aircraft accelerated from half way through the turn, reaching 30 kt by the time the heading stabilised on the runway heading of 83°M. At this point the auto thrust was engaged, in takeoff mode, and the aircraft continued to accelerate, with the engine parameters matched throughout the acceleration period. The N_2 values reached a maximum of just under 98%, five seconds after turning on to the runway. The rise in N_1 and EPR started to stabilise shortly afterwards, although both continued to climb slightly throughout the takeoff run, and the EGTs continued to climb as the aircraft speed increased smoothly. Approximately 27 seconds after turning on to the runway, the N_1 of the left engine recorded a sharp drop from the previous 100% reading to a value of just over 70%. In the next second this recovered to 97% but the N_2 , EPR and fuel flow values showed a drop. Over the next four seconds the N_1 remained erratic and

the N_2 , EPR and fuel flow values decreased, at which point the thrust levers were retarded and the brakes were applied.

a replacement engine installed. The suspect engine was sent for examination to an overhaul organisation in Singapore, where the subsequent examination did not show any physical anomaly within the engine. However, it appeared from the recorded data that the engine behaviour had probably been caused by an intermittently erroneous LP rotor speed (N_1) signal. Such a signal fault would cause the FADEC to schedule fuel flow in an unusual manner, with a rapidly decreasing fuel flow when the indicated N_1 increased, followed by a corresponding reduction in fuel flow when the N_1 signal returned to a more normal level.
