INCIDENT

Aircraft Type and Registration:	Piper PA-28-161, G-BGPJ	
No & Type of Engines:	1 Lycoming O-320-D3G piston engine	
Year of Manufacture:	1979	
Date & Time (UTC):	17 August 2006 at 1200 hrs	
Location:	Woodvale Airfield, Lancashire	
Type of Flight:	Private	
Persons on Board:	Crew - 1	Passengers - 1
Injuries:	Crew - None	Passengers - None
Nature of Damage:	Fire damage within engine compartment. Some wiring and hoses damaged	
Commander's Licence:	Commercial Pilot's Licence	
Commander's Age:	52 years	
Commander's Flying Experience:	4,500 hours (of which 2,000 were on type) Last 90 days - 240 hours Last 28 days - 70 hours	
Information Source:	AAIB Field Investigation

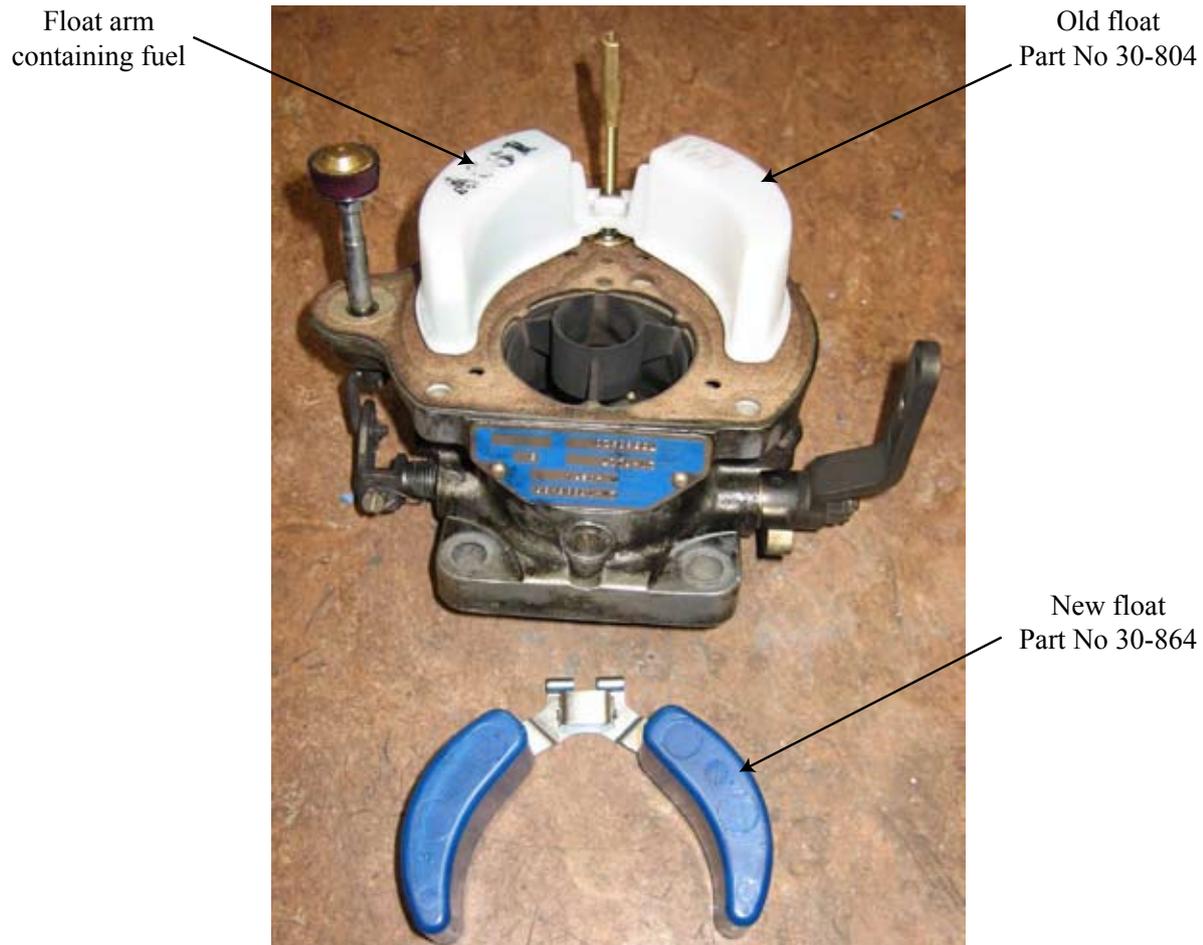
Figure 1

The carburettor, a Marvel-Schebler model MA-4SPA, was taken to an authorised overhaul organisation and placed on a test bench, where it was found that the fuel level in the float chamber was well above the maximum level allowed and, in certain angular positions, fuel poured out from the inside of the carburettor's bore. The unit was dismantled and one arm of the horseshoe-shaped white plastic hollow float, part number 30-804, was found to be almost completely full of an AVGAS - a coloured fluid (Figure 1). It was later confirmed by chemical analysis that this fluid was pure AVGAS. Examination of the float revealed that a minute area of the plastic hot-weld joint between the float chamber and its lid had not been welded during manufacture. This minute gap

in the weld was so small that when the float, containing the AVGAS, was placed in a vacuum chamber only a barely discernible amount of fuel escaped.

Review of occurrence reports, and other information, shows that Marvel-Schebler carburettor floats have a history of absorbing fuel and becoming heavy and therefore less buoyant. Consequently they do not fully close the needle valve between the fuel bowl and the main jets. This allows excess fuel to flow through the carburettor's jets giving a rich fuel mixture which can, at low power, cause the engine to suffer a fuel rich cut and fuel to pour out of the carburettor into the air box.

Float arm containing fuel

It is recommended that the Federal Aviation Administration (FAA) review the continued airworthiness of the Precision Airmotive float, part number 30-804, fitted to Marvel-Schebler/Precision Airmotive carburetors.
