# Robinson R22 Beta, G-BROX, 23 April 1996

**AAIB Bulletin No: 7/96 Ref: EW/G96/04/24 Category: 1.3**

**Aircraft Type and Registration:** Robinson R22 Beta, G-BROX

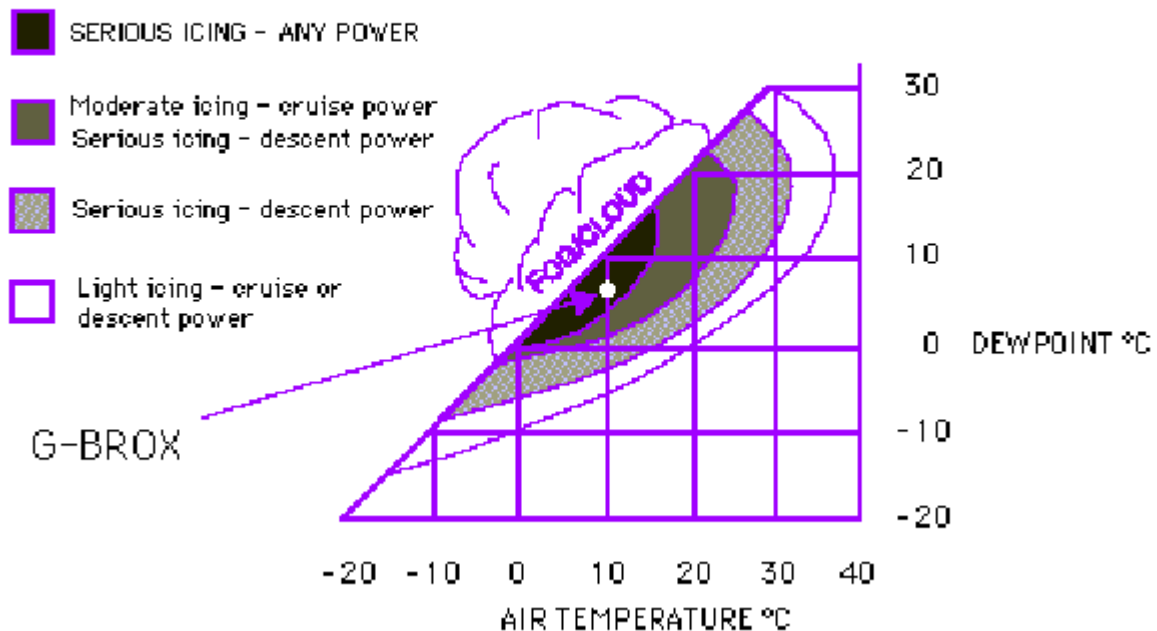
### CARBURETTOR ICING PROBABILITY

The 1550 hrs weather observation at nearby Farnborough recorded an air temperature of 10°C and a dew point of 7°C. These conditions are well inside the boundary for serious icing at any power setting according to the CAA's General Aviation Senseleaflet 3B. The main features of the carburettor icing probability diagram are reproduced below.
