ACCIDENT

Aircraft Type and Registration:	Pierre Robin HR100/210 Safari II, G-BLWF	
No & Type of Engines:	1 Continental Motors Corp IO-360-D piston engine	
Year of Manufacture:	1973	
Date & Time (UTC):	17 April 2010 at 1511 hrs	
Location:	Bourn Airfield, Cambridgeshire	
Type of Flight:	Private	
Persons on Board:	Crew - 1	Passengers - None
Injuries:	Crew - None	Passengers - N/A
Nature of Damage:	Right landing gear detached from spar and bent back into wing and flap. Nose gear and frame pushed up into engine bay and firewall	
Commander's Licence:	Private Pilot's Licence	
Commander's Age:	66 years	
Commander's Flying Experience:	808 hours (of which 2 were on type) Last 90 days - 2 hours Last 28 days - 2 hours	
Information Source:	Aircraft Accident Report Form submitted by the pilot

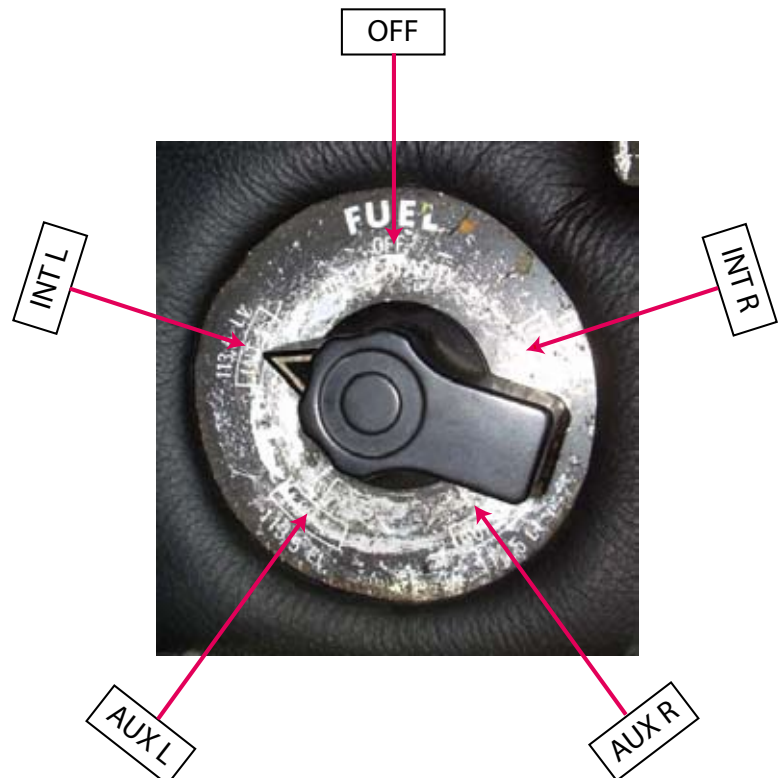
Figure 1

Fuel selector clock

of the fuel system and illustrates the fuel cock with the five selections in the same relative position to that on the actual selector cock; however, these positions are not explicitly labelled. As can be seen in Figure 1, the identification placard for the five detent positions of the fuel selector in G-BLWF was badly scratched and barely legible.

The pilot's assessment of the cause of the accident was a misreading of the worn fuel selector cock placard and a misinterpretation of the aircraft's flight manual description of the fuel system.
