AAIB Bulletin No: 6/95

Aircraft Type and Registration: Cessna 310Q, G-AYND

Nature of Damage: Damage to right propeller, landing gear operating mechanism, flaps and gear doors

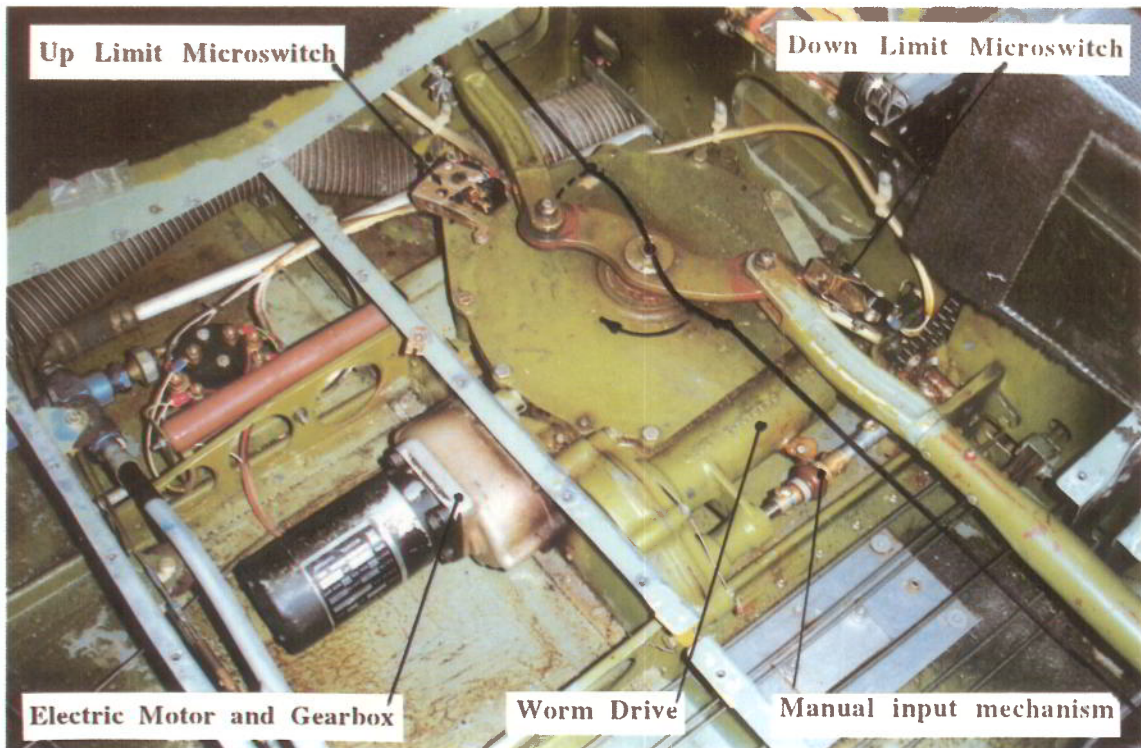
Figure 1

quadrant and levers which, in addition to causing local damage to the airframe, had severely distorted the down limit microswitch mounting, as shown in Figure 1. Subsequent AAIB examination took place after the gearbox had been removed from the aircraft and partially stripped down, and thus it was not possible directly to confirm correct rigging of the system. However, as previously stated, the system had reportedly been checked for satisfactory operation whilst in the hangar and also during the early part of the accident flight.

**Landing Gear Gearbox Assembly 'As Found' in Overtravelled State
ie, Quadrant out of engagement with worm drive thread**

Normal maximum travel position indicated

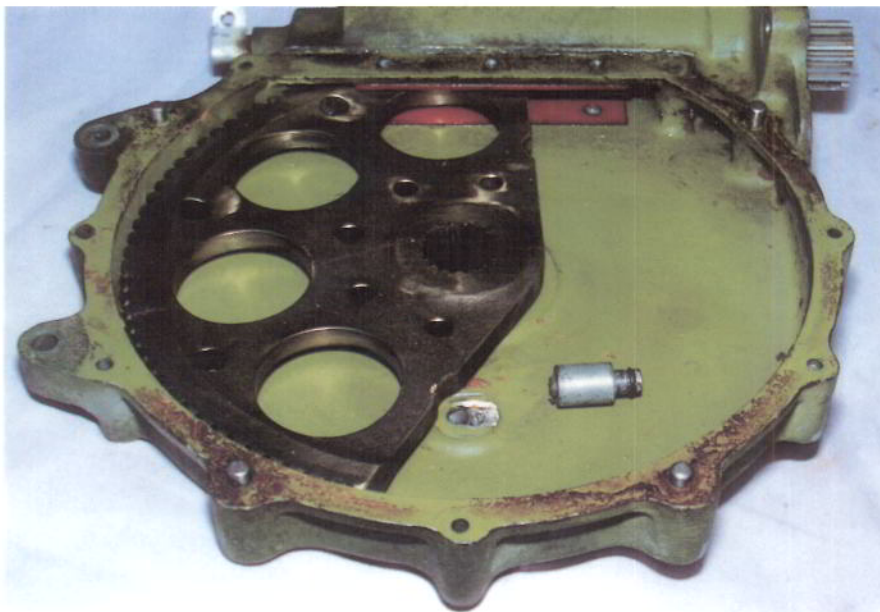
Figure 2

Damage within the gearbox was identified in three main areas, as shown in Figures 2 and 3.

Firstly, the quadrant overtravel stop, which takes the form of a round steel bar fitted between the upper and lower gearbox surfaces, had completely failed due to overload in a gear travelling down direction and damage was present on the region of the quadrant that abuts the stop. Normally, the down limit microswitch should shut off the electric motor just before the quadrant and stop come into contact and, if the system is correctly rigged, this should co-incide with all three landing gears becoming locked down.

Interior view of main gearbox showing failed overtravel stop and normal 'gear down' position of quadrant when system is stopped by the down limit microswitch

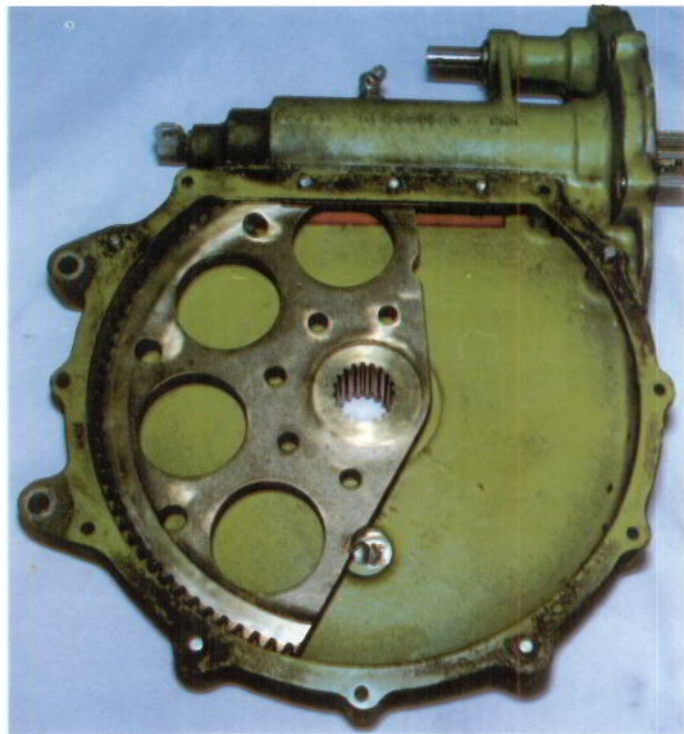
Quadrant position when in contact with the overtravel stop. Worm gear engaged approximately 4 to 5 teeth from end of quadrant.

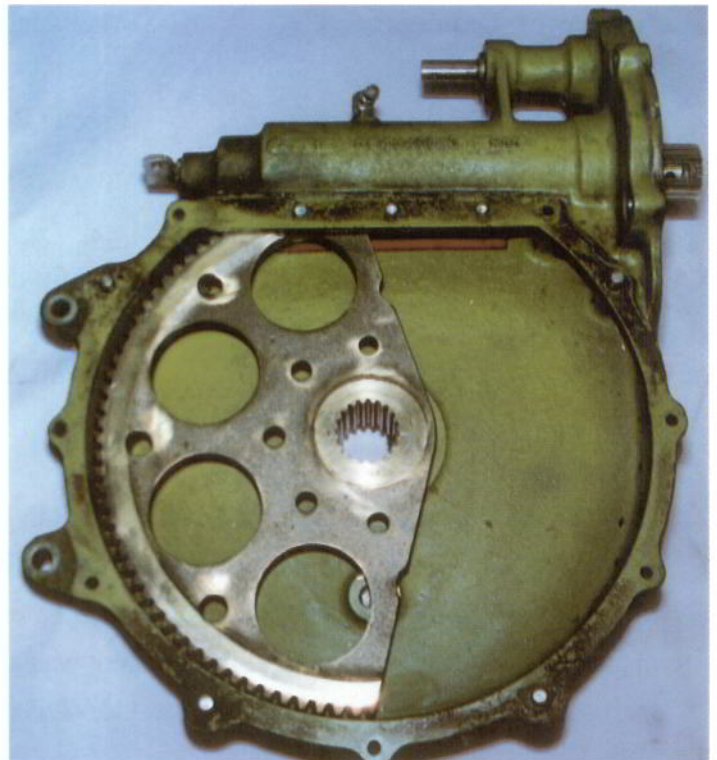
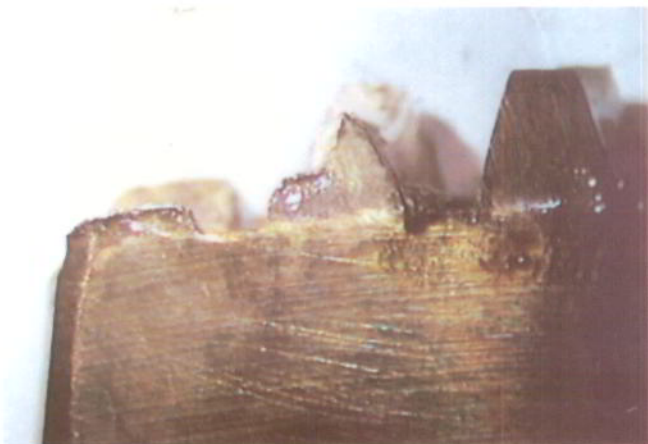
Secondly, the last two teeth of the quadrant had been worn away and the end of the worm drive thread had broken off. Close inspection of this damage suggested that the worm drive thread had been rotating, in a gear down sense, out of engagement but pressed against the end of the quadrant. At this position the quadrant had travelled past the point, by several gear teeth pitches, at which it would have contacted the overtravel stop.

Quadrant position with gear teeth just out of engagement from worm drive. Wear on last two teeth caused by rotating worm drive shown in lower picture.
