No: 7/86

Aircraft type and registration: Piper PA 18—150 Super Cub G-PULL

Date and time (GMT): 13 June 1986 at 1920 hrs

Location: Eaglescott Aerodrome, Barnstable, N Devon

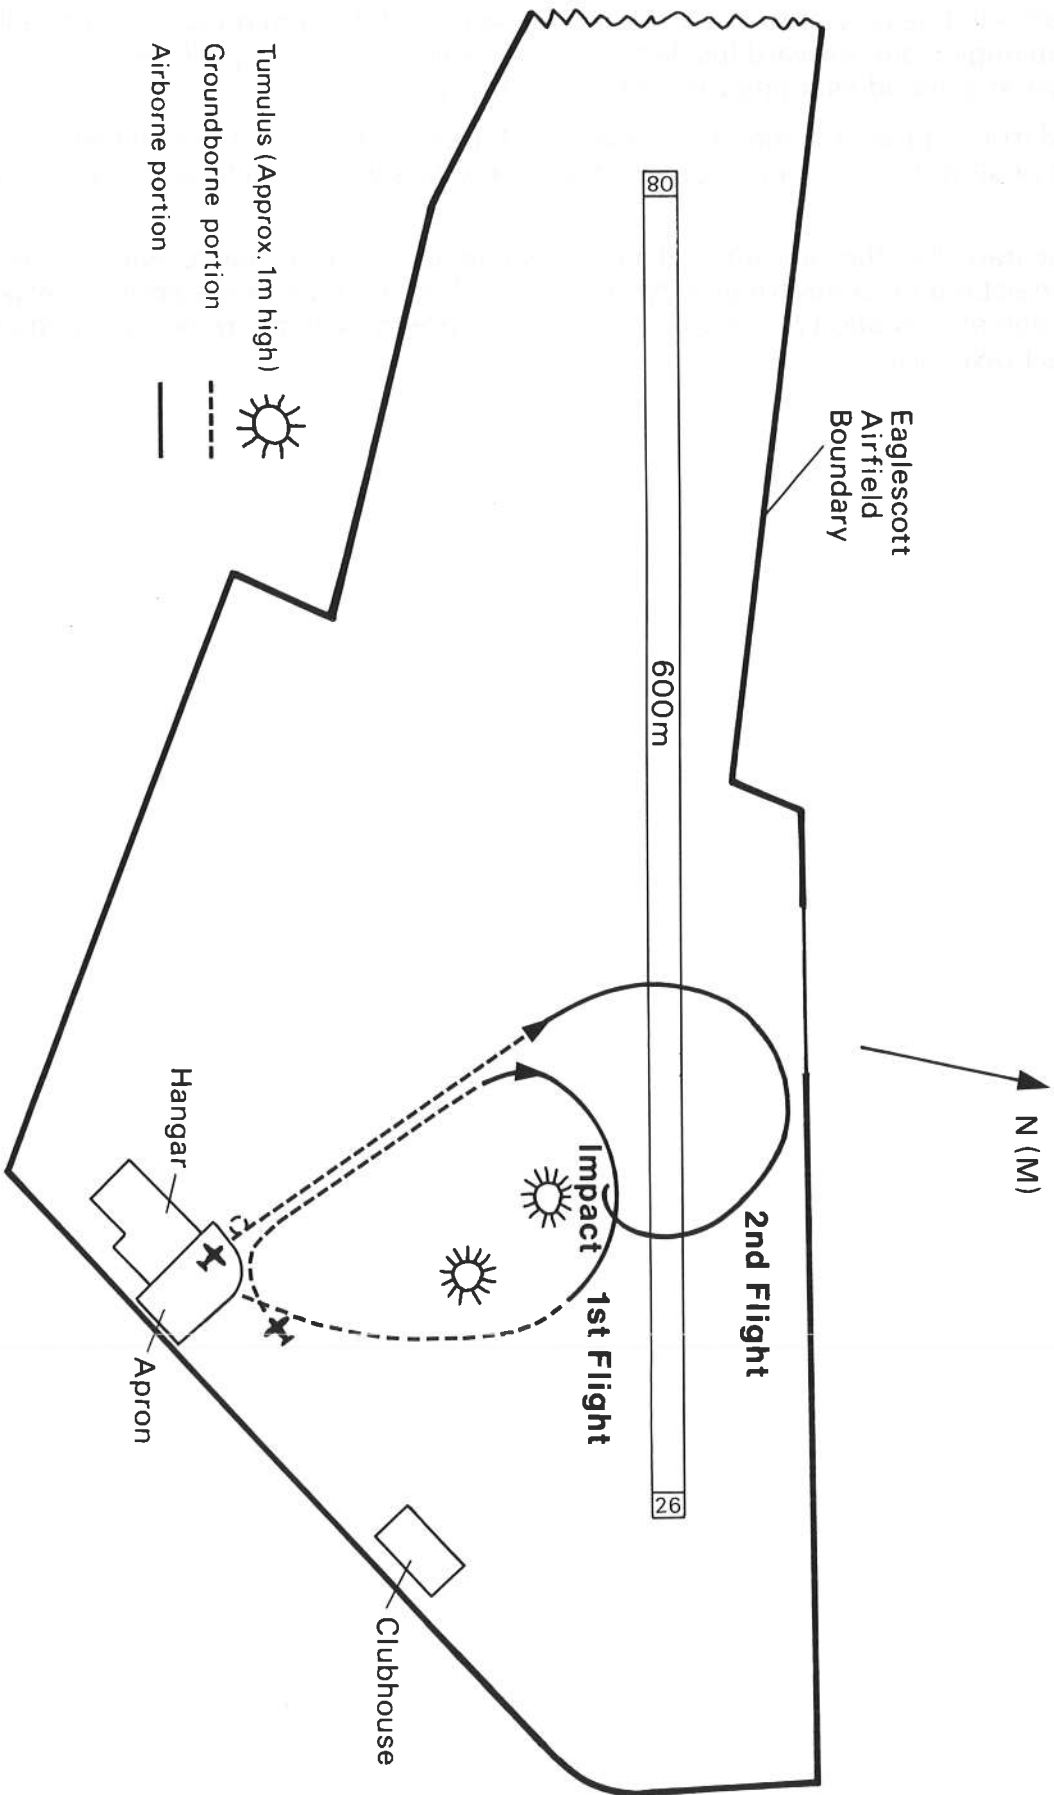
RECONSTRUCTION OF FLIGHT PATHS

Shortly before 1840 hrs the pilot hurried from the clubhouse to the Super Cub, climbed in, started up and immediately took off in a northerly direction with a glider tow rope attached. The reported wind was northerly at 5 knots. On becoming airborne the aircraft was seen to bank steeply to the right, with the wing tip 2 or 3 feet above the ground, pass between the active Runway 26 and the tumuli on the airfield and make a very heavy downwind landing on the right main wheel. The pilot taxied the aircraft back to the hangar, shut down the engine and removed the tow rope.

At 1919 hrs the pilot was again seen to board the aircraft, start up, execute a rapid 360° "clearing" turn and immediately take-off along the same path as previously. Once airborne, the aircraft again performed a very steeply banked right turn within the airfield boundary, climbing to a height estimated as less than 100 feet. As it passed through a north easterly heading the engine speed was heard to reduce somewhat and, a few seconds later, to reduce smoothly to somewhere near idle RPM. At this point the bank angle increased and the nose of the aircraft sliced downwards and the aircraft struck the ground.

The aircraft crashed in level grassed terrain 25 metres south of the centre line of Runway 26 while heading 310°M. Wreckage and ground mark examination indicated that at the time of impact the aircraft was approximately 45° nose down, was banked about 45° right wing down, and was yawing to the right whilst skidding to the left. The right wing tip hit the ground first, and the
