## Piper PA-28-161 Warrior II, G-BTSJ

| <b>AAIB Bulletin No:</b> 12/2004 | <b>Ref:</b> EW/G2004/09/02 | <b>Category:</b> 1.3 |

### Synopsis

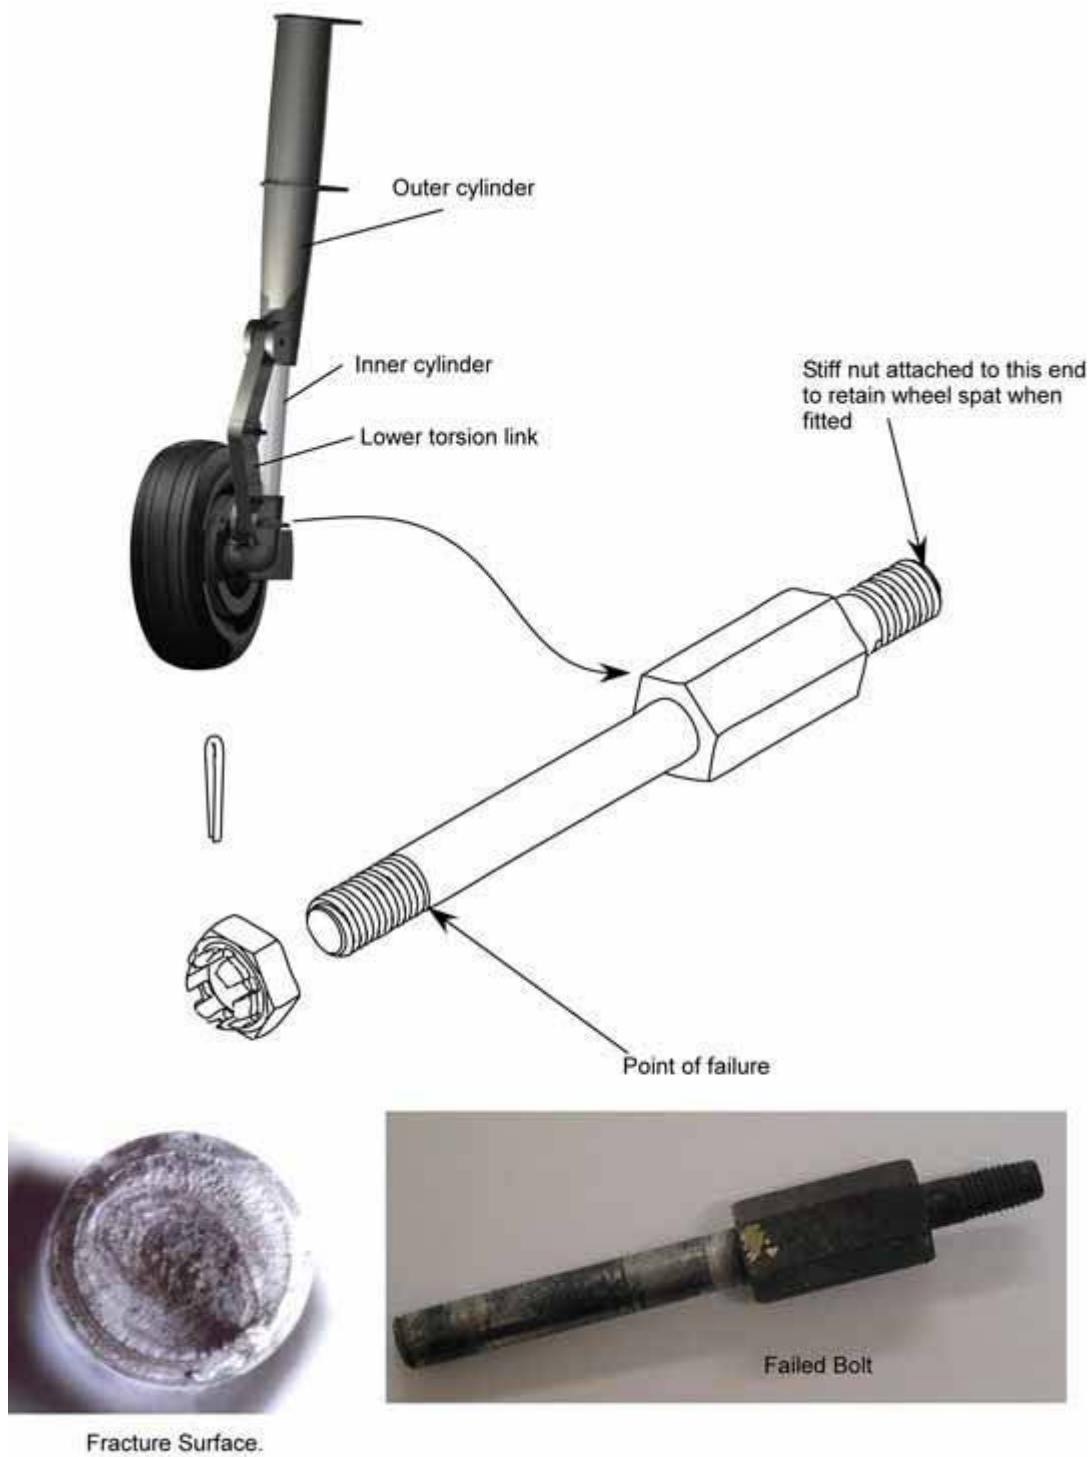
**Figure 1**

The lower torsion link attachment bolt on the PA-28-161 can be one of two designs. The simplest installation is an AN 5-22 hexagonal head bolt, castellated nut and split pin arrangement. However, on aircraft fitted with wheel spats, the bolt is manufactured with a small threaded section, a hexagonal spacer section, followed by the bolt shank and a final threaded portion, see Figure 1.

The small threaded portion is used to attach to the wheel spat using a stiff nut. The spacer portion provides clearance between the wheel spat and the torsion link and the bolt shank passes through a sleeve in the torsion link and inner cylinder assembly. All of this is fastened together using a castellated nut and split pin on the remaining threaded portion. G-BTSJ was not fitted with wheel

spats, but did have the latter bolt arrangement. This indicated that at some point in the past the aircraft had been fitted with wheel spats which were subsequently removed.

Metallurgic examination of the failed attachment bolt revealed that it had failed as a result of a rotational reverse bending fatigue mechanism with multiple crack initiation points. The shank of the bolt showed signs of corrosion and polishing of the surface due to rotation inside the sleeve, indicating that the bolt had become loose in its fitting. The castellated nut and split pin were recovered from the runway, with the split pin still inserted; however, this had been mislaid and was not available for examination.

Since this incident, the maintenance organisation responsible for this aircraft has undertaken to replace all torque link attachment bolts during the next maintenance input on any Piper PA-28-161 aircraft they maintain.
