**ACCIDENT**

<b>Aircraft Type and Registration:</b>	Airbus A320-214, G-MRJK	
<b>No &amp; Type of Engines:</b>	2 CFM 56-5B4/2P turbofan engines	
<b>Year of Manufacture:</b>	1999 (Serial no: 1081)	
<b>Date &amp; Time (UTC):</b>	30 May 2012 at 0624 hrs	
<b>Location:</b>	London Luton Airport	
<b>Type of Flight:</b>	Commercial Air Transport (Passenger)	
<b>Persons on Board:</b>	Crew - 6	Passengers - 180
<b>Injuries:</b>	Crew - None	Passengers - None
<b>Nature of Damage:</b>	G-MRJK - Right stabilizer G-OZBM - APU tail cone	
<b>Commander's Licence:</b>	Airline Transport Pilot's Licence	
<b>Commander's Age:</b>	48 years	
<b>Commander's Flying Experience:</b>	10,512 hours (of which 6,317 were on type) Last 90 days - 26 hours Last 28 days - 16 hours	
<b>Information Source:</b>	Aircraft Accident Report Form submitted by the pilot and further enquiries by the AAIB

**Synopsis**

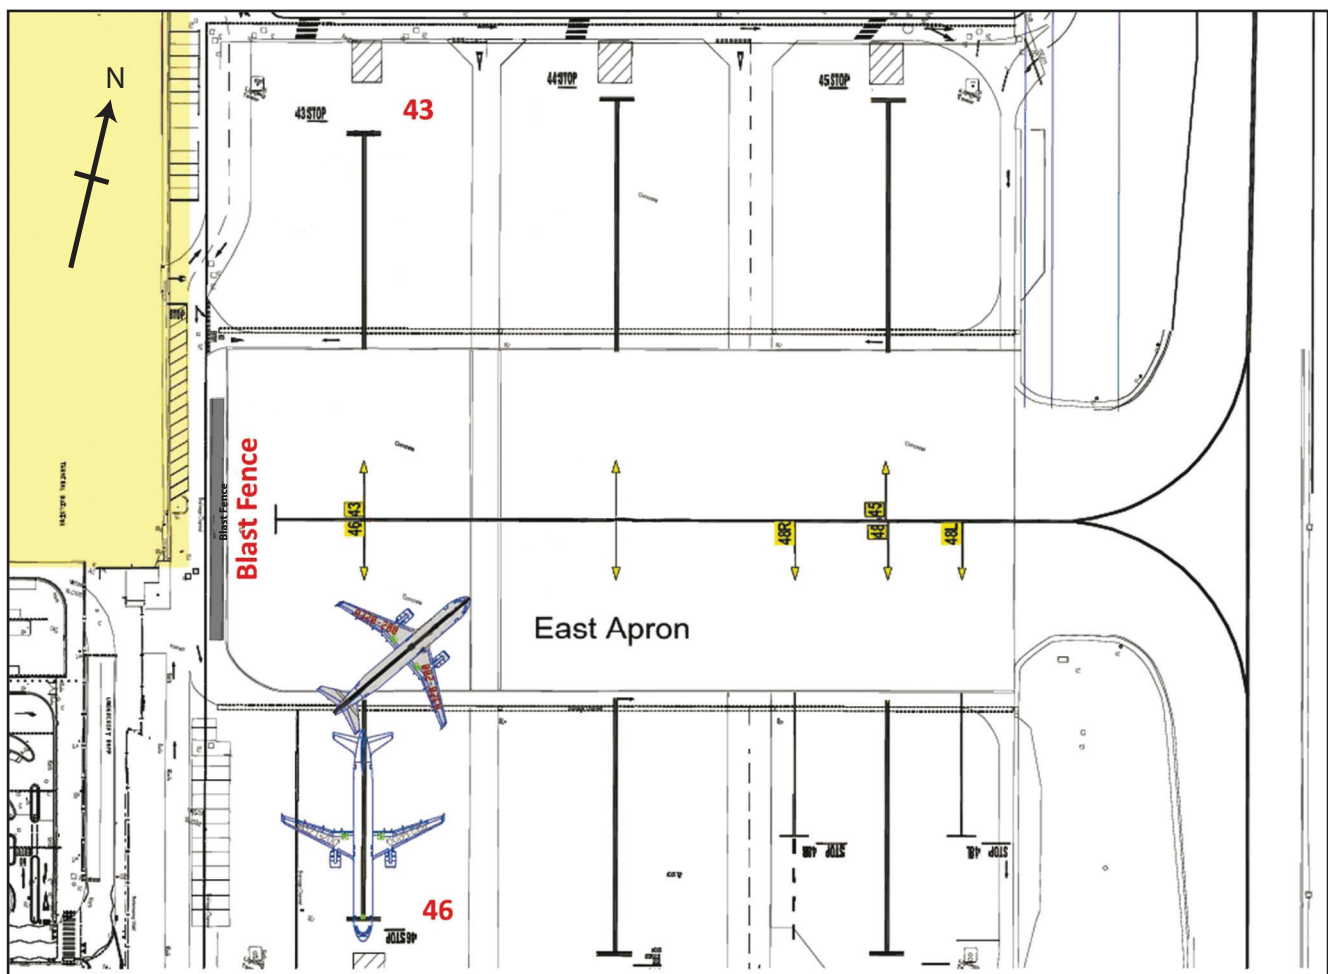
unoccupied G-OZBM, which was on Stand 46 directly behind Stand 43. Figure 1 shows layout of the East Apron and the approximate position of each aircraft at the point of collision.

Approximate position of the aircraft at the time of the collision.
