**Aircraft type and registration:** Stampe SV4C/G G-ATKC

**Date and time (UTC):** 2 August 1987 at 0952 hrs

**Location:** Shingay, near Royston, Hertfordshire

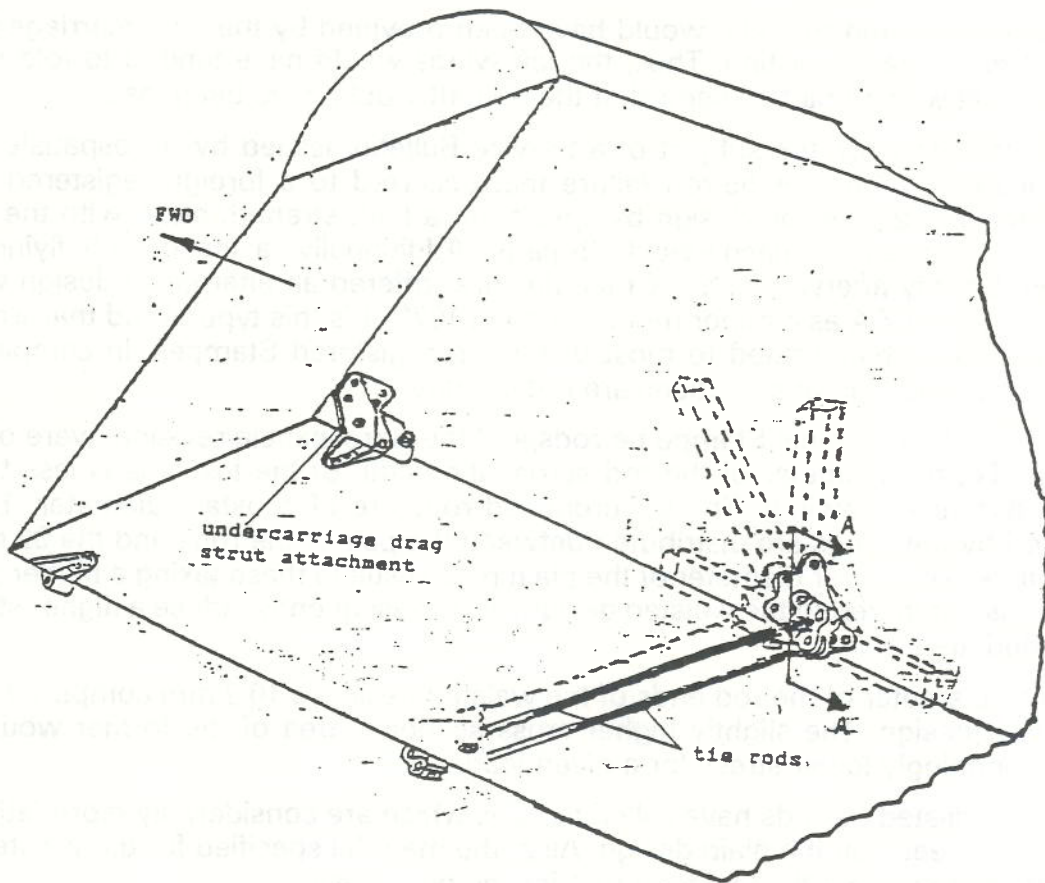
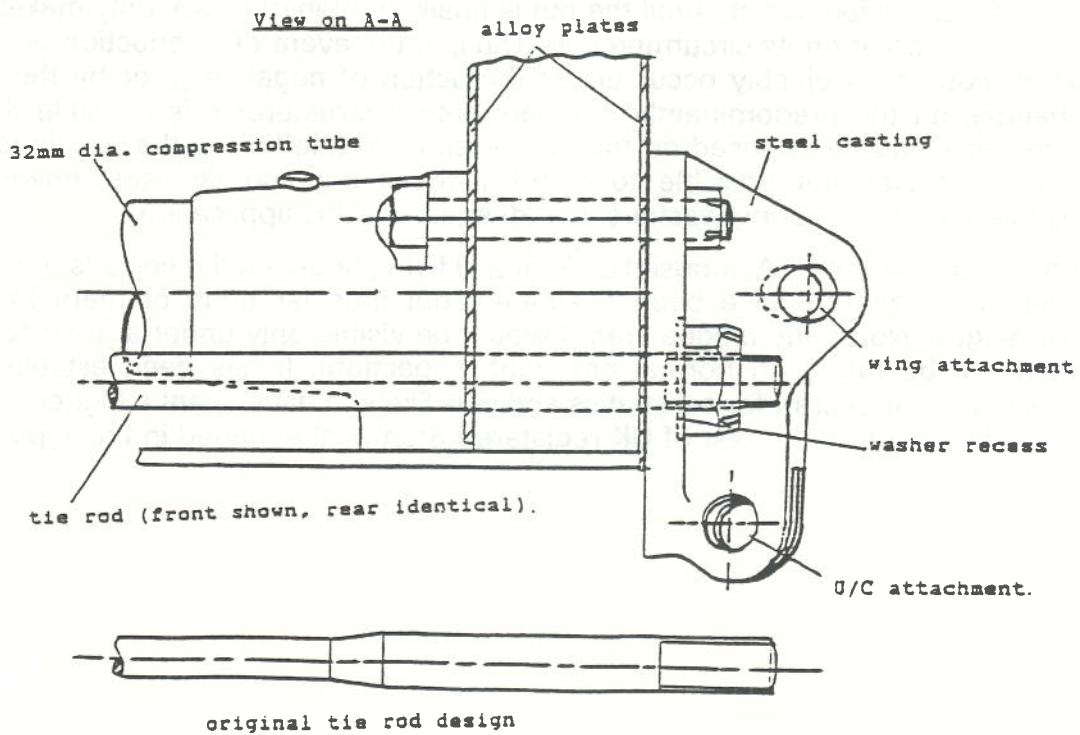
Stampe Wing Attachment Details

It was found that there had been a fatigue failure in each of the two steel tie-rods that effectively link together the main spars of the lower mainplanes across the fuselage, (see attached drawing). The rods lie alongside a 32 mm diameter steel tube which reacts compressive forces imparted by the undercarriage during landing. However, this tube is placed in tension when the aircraft is airborne. The tube terminates at the inside face of each fuselage sidewall, and two short bolts attach it, via flanges on the upper arc of the tube ends, to a steel casting on the outside of the fuselage sidewall. The tie-rods pass through both the sidewalls and the castings, and are retained by nuts on the threaded ends of the rods. The design of the aircraft is such that the effect of aerodynamic lift and drag on the wings is to apply predominantly tensile forces on the tie-rods. The CAA had set a 500 hour life on these components, and the aircraft log books showed that they had been replaced in May 1986 prior to the renewal of the Certificate of Airworthiness. Subsequently the aircraft had flown approximately 365 hours up until the time of the accident. It was noted that neither of these tie-rods, nor any of those subsequently examined during the course of the investigation, bore any serial or part numbers.

The failures had occurred within the threaded areas of the left-hand ends of each tie-rod. The rod-ends and nuts were not recovered. A metallurgical examination revealed that the fatigue in the rear rod had started from multiple origins in the thread root on the underside (relative to the aircraft axes) and had progressed upwards until complete failure had occurred. The forward rod fatigue origins were on the forward/underside quadrant of a thread root, and the crack progressed rearwards and upwards until the rod failed in overload over the last 25% of the section. The "smoother" nature of the fatigued surface on the rear rod implied that this had been a comparatively high cycle fatigue (i.e. low stress, large number of load applications). This in turn suggested that the rear rod had started to fatigue before the forward one. When complete failure of the rear rod had occurred, additional stress would have been placed on the forward rod, resulting in a faster rate of crack propagation. Ultimately the effective cross-sectional area of the rod would have been reduced to the stage where a comparatively small load application would have resulted in complete failure. It was not possible to assess the length of time the entire process took, although it is considered that a large number of flights was involved.

Additional metallurgical examination revealed the presence of a small fatigue crack in the thread root of the right-hand end of the rear tie-rod. The crack was in the upper quadrant of the rod and had progressed through some 10% of the section. The material was checked against its specification of S96 steel and it was found to conform. Furthermore, there were no stress-raising features, such as corrosion pits, in the areas of the fatigue origins.

- (i) Most of the original Stampe tie-rods, and the Aerospatiale revision, were of a "waisted" design, i.e. the diameter of the rod across the width of the fuselage is less than the end-diameters (see drawing). The UK-produced rods are of constant diameter. Tensile forces exerted by the wings are distributed between the pair of the rods and the 32 mm diameter steel tube. The larger diameter of the plain rods result in these taking a higher proportion of the loads compared to the waisted design, and consequently induce a higher stress over the threaded area.

- (ii) The diameter of the rod ends of the waisted design is 10.2 mm compared to 10 mm for the plain design. The slightly higher cross sectional area of the former would result in a correspondingly lower stress for a given load.

- (iii) The waisted tie-rods have rolled threads which are considerably more fatigue-resistant than the threads on the plain design. Also, the material specified for the waisted design is a slightly higher strength steel than that for the plain design.

Finally, it was observed that the tie-rods from G-ATKC had been assembled with spring washers instead of the plain washers called for in the relevant drawings. The spring washer is effectively a helical section, which, until the nut is finally tightened down, only makes contact with the nut at one point on its circumference. Thus, in the event of a reduction of assembly torque (which could conceivably occur under the action of negative g, or by the effect of climatic changes on the predominantly wooden aircraft structure) it is possible that small bending stresses could be imposed on the tie-rod ends, in addition to the tensile loads that normally occur. It was not possible to quantify these bending stresses, however it is considered that the use of spring washers is undesirable in this application.

Stampe tie-rods were the subject of a Service Bulletin, issued by Aerospatiale of France in 1971, following an earlier tie-rod failure that occurred to a foreign registered aircraft. The Bulletin revised the tie-rod design by specifying a high strength steel, with the ends having rolled (as opposed to machine-cut) threads. Additionally, a life of 500 flying hours was imposed. Shortly afterwards, a UK manufacturer offered an alternative design which gained approval by the CAA as a minor modification in 1972. It is this type of rod that was fitted to G-ATKC, and is probably fitted to most of the UK registered Stampes. In comparing the two designs, the following observations are noteworthy.

Following the accident, the CAA imposed a life of 250 flying hours on the tie-rods. A number of tie-rods from other aircraft have been examined, but thus far none of them has shown evidence of fatigue (Note: any fatigue cracks would be visible only under a microscope, and hence would not be found on normal pre-flight inspection). It has been established that G-ATKC was a popular aircraft for aerobatics and was likely to have spent a higher proportion of its life (in comparison to the rest of UK registered Stampes) engaged in this type of flying.
