EC-FXI Flight Recorder Data

MD-80 Series main landing gear oleo strut

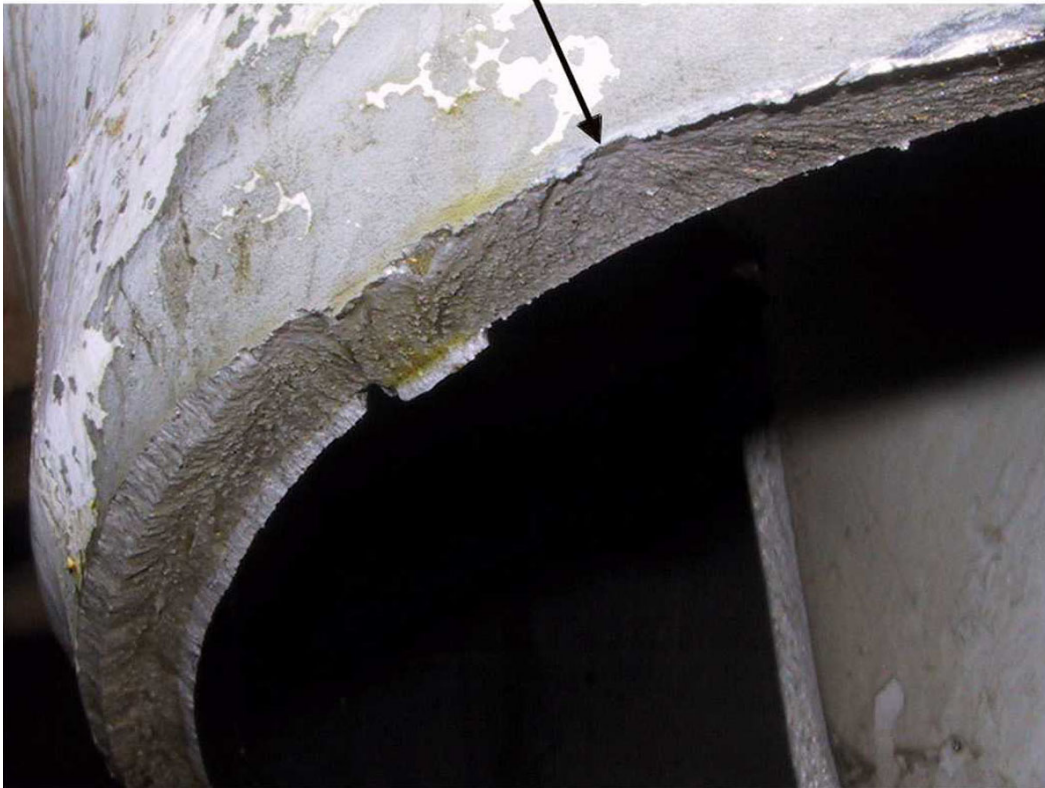
Fatigue origin

'As found' picture of upper half of fractured MLG cylinder showing the major fatigue crack (arrowed)

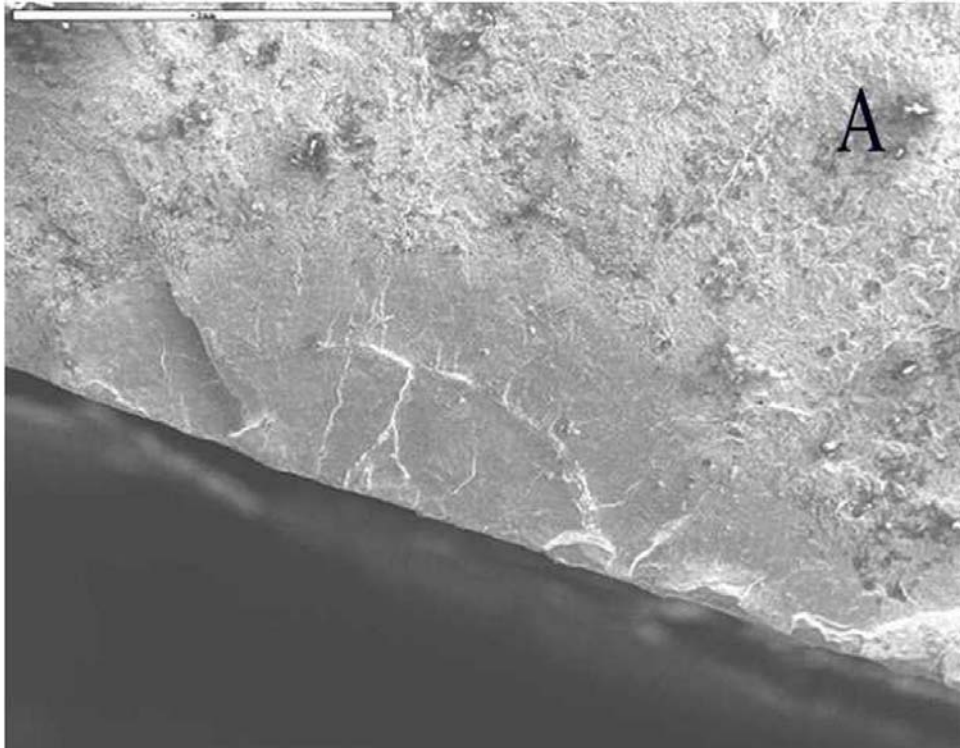
Scanning electron microscope secondary image of major fatigue crack

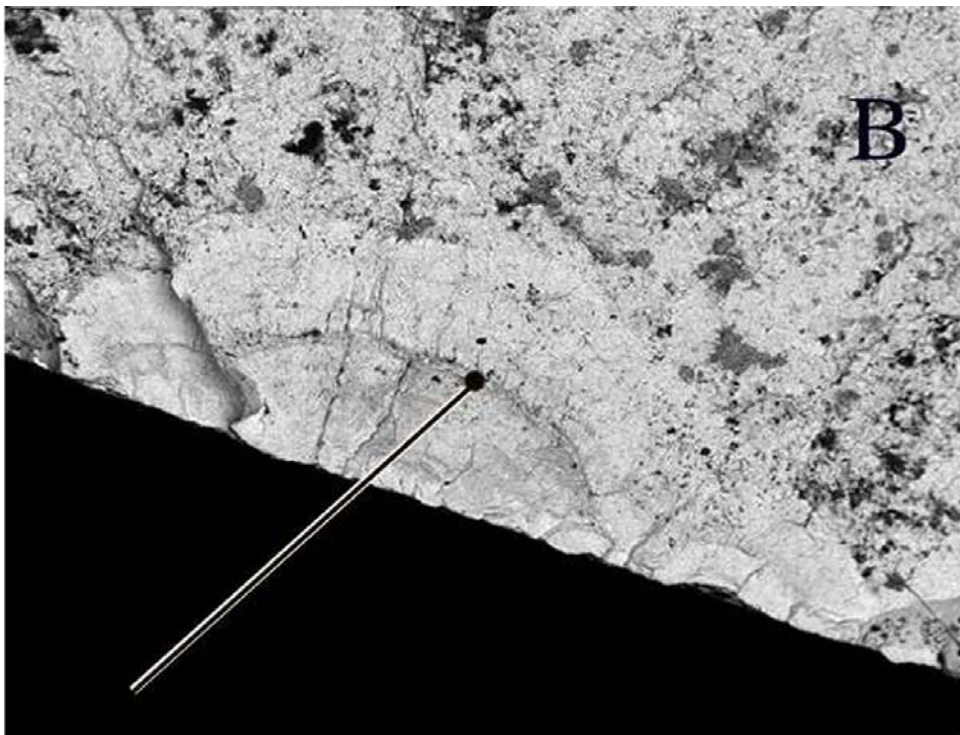
Scanning electron microscope backscatter image of major fatigue crack

Note clearly visible growth band (arrowed)
within which high levels of Cadmium were found

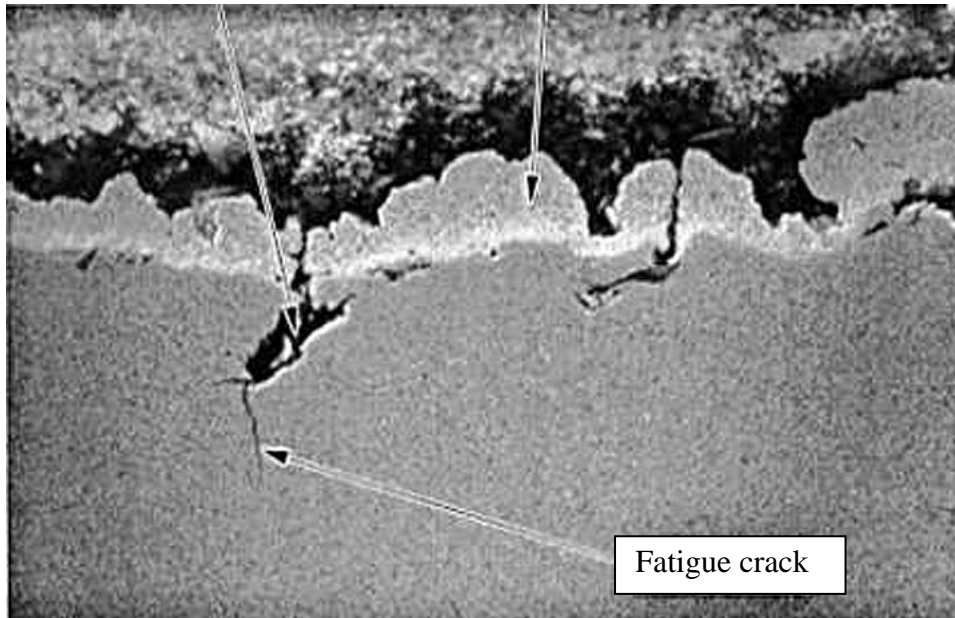
Void induced in steel surface
by grit blasting

Cadmium
plating

SEM photograph of the surface finish of the failed cylinder from G-DEVR

Note embryonic fatigue crack growing from imperfection

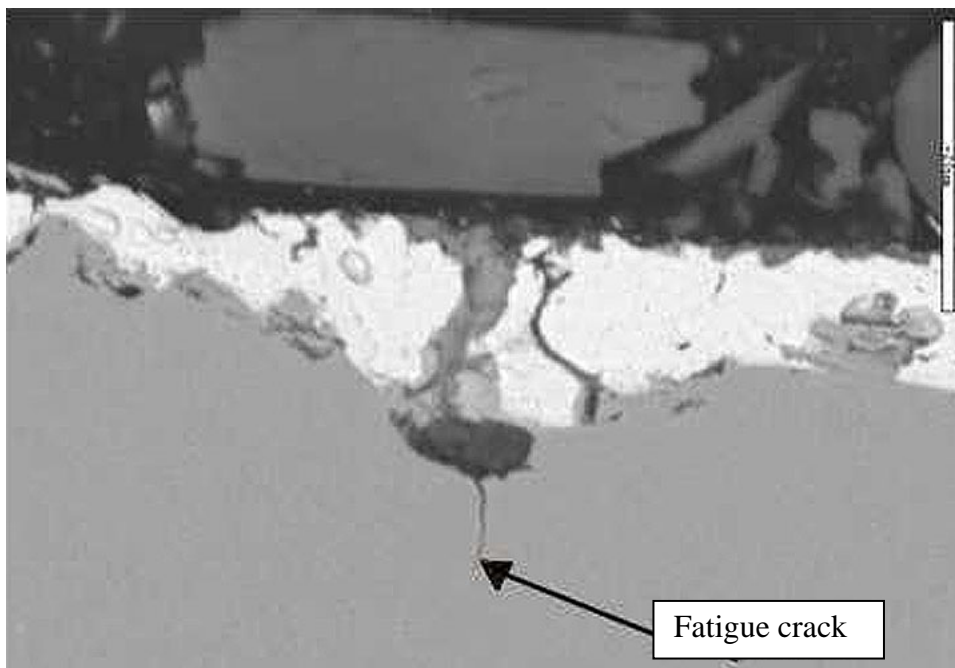
SEM photograph of the surface finish of the failed cylinder from EC-FXI

Note embryonic fatigue crack growing from imperfection
which is an embedded particle of Alumina grit
