ACCIDENT

Aircraft Type and Registration:	Piper PA-38-112 Tomahawk, G-BGBN	
No & Type of Engines:	1 Lycoming O-235-L2C piston engine	
Year of Manufacture:	1978 (Serial no: 38-78A0511)	
Date & Time (UTC):	5 June 2013 at 1239 hrs	
Location:	Cranfield Aerodrome, Bedfordshire	
Type of Flight:	Training	
Persons on Board:	Crew - 2	Passengers - None
Injuries:	Crew - 2 (Serious)	Passengers - N/A
Nature of Damage:	Aircraft destroyed	
Commander's Licence:	Commercial Pilot's Licence	
Commander's Age:	21 years	
Commander's Flying Experience:	390 hours (of which 145 hours were on type) Last 90 days - 77 hours Last 28 days - 15 hours	
Information Source:	AAIB Field Investigation

Synopsis

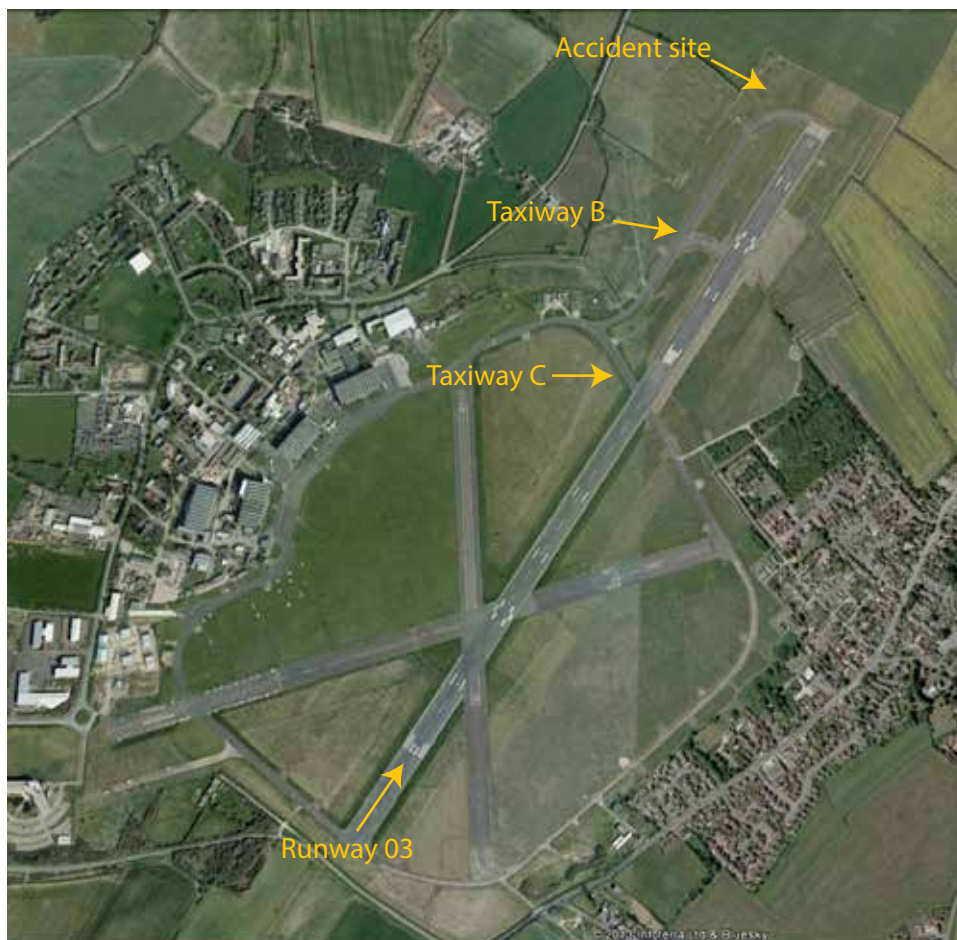
Figure 1
Cranfield Aerodrome

G-BGBN was seen to touch down near the touchdown zone markers, power was applied and it lifted off near the intersection of the runway and taxiway C (see Figure 1). Approximately two seconds later, the instructor transmitted "GOLF BRAVO NOVEMBER ROUGH RUNNING ENGINE TURNING AROUND FOR RUNWAY 21". The aircraft was in a gentle right turn as it passed the intersection of the runway and taxiway B but it then reversed its turn abruptly to the left. As the aircraft passed the upwind end of the runway in the left turn, the nose began to drop. The aircraft descended and crashed within the aerodrome boundary 100 m north-west of the threshold of Runway 21.

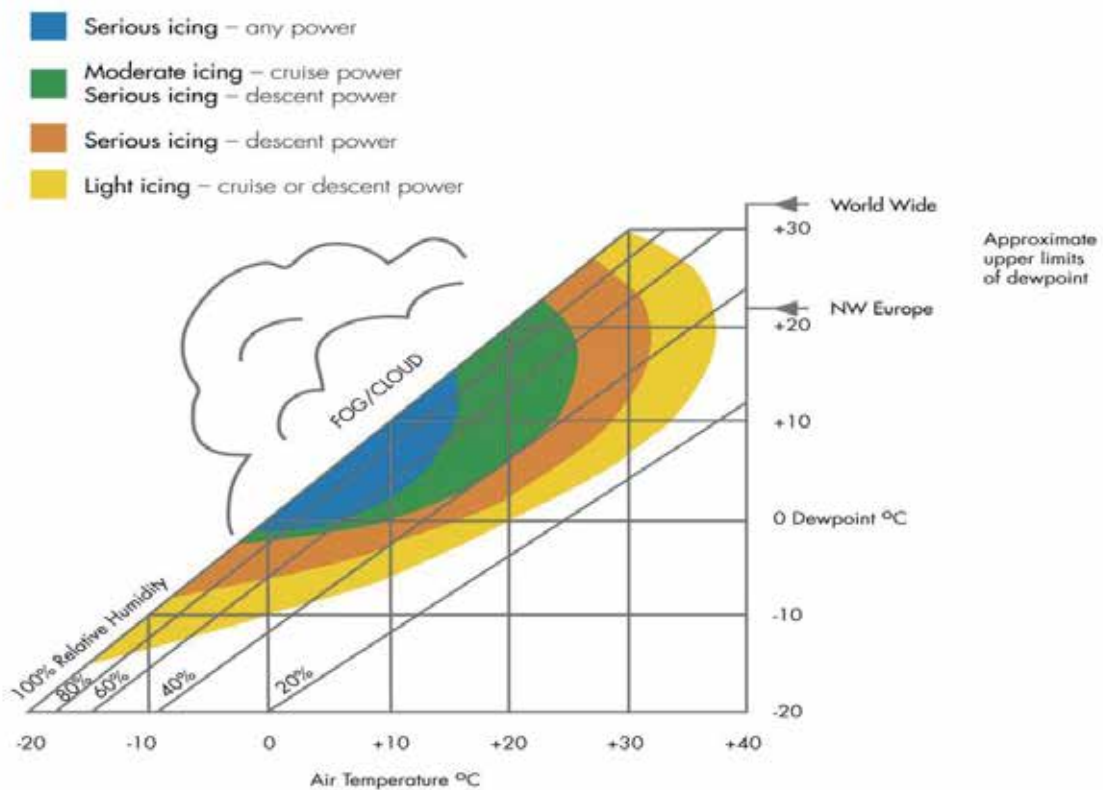
Figure 3

Carburettor icing occurs as a result of vaporisation of fuel and a reduction in pressure as the fuel / air mixture passes through the venturi in the carburettor. These effects cause a drop in the temperature which, if it falls below the dew or freezing point of water, will result in ice forming on the sidewalls and the butterfly valve in the carburettor. As the ice builds up, it gradually blocks the venturi and alters the fuel / air balance which causes the engine to run roughly and lose power. Figure 3² shows combinations of atmospheric temperatures and dew points where there is a risk of carburettor icing. At the time of the accident, the temperature was 13°C and the dew point was 10°C. In these conditions, there was a risk of serious carburettor icing at any power setting.

In the absence of evidence of alternative causes, carburettor icing appears to be the most likely cause of the rough running.
