**AAIB Bulletin No: 8/95**

**Ref: EW/G95/04/03**

**Aircraft Type and Registration:** Jetstream 4112, C-FTVN

**Location:** Prestwick Airport

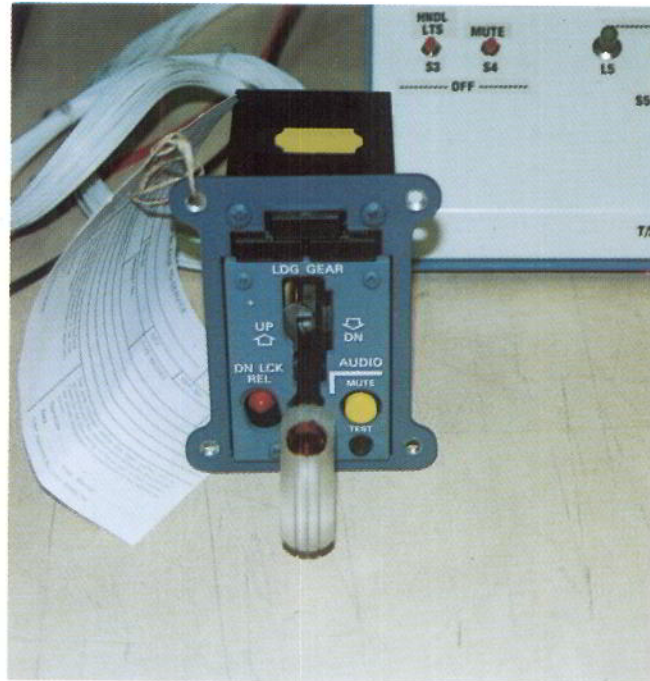
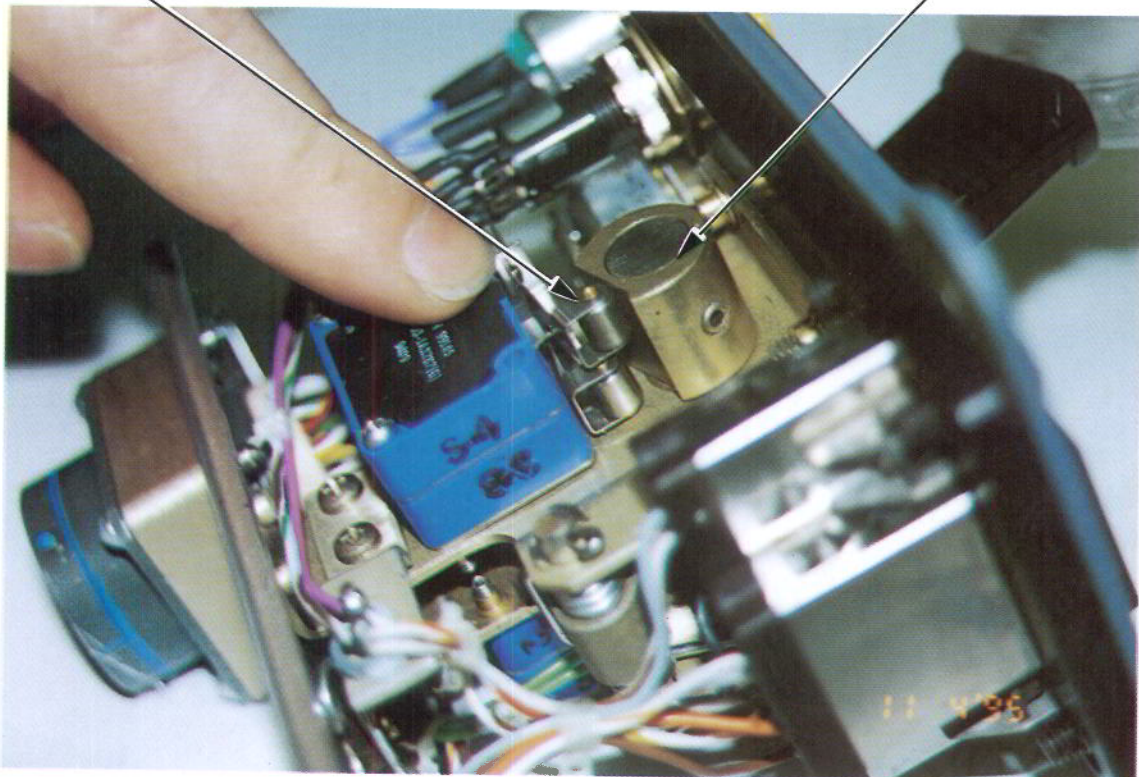
FIG 1 Landing gear control unit

The landing gear selector lever is connected to a cammed shaft within the control unit. This in turn operates on a bank of four identical microswitches which provide the landing gear operating and signalling functions. These are: the gear warning horn; the 'position disagreement' light in the selector handle; the baulk solenoid in the control unit (signalled by the left gear 'weight on wheels' switch when the aircraft is on the ground, and which prevents movement of the selector lever to 'UP', unless the solenoid is manually overridden); and finally, the 'UP' or 'DOWN' signal to the hydraulic selector valve solenoid. Each switch is operated by means of a spring loaded plunger emerging from the switch body, and which is in contact with the cam. Upon opening the control unit, it was apparent that no spring loading was present on the plunger of the gear up/down signalling microswitch. The latter was removed from the unit and X-rayed, which revealed that a moving contactor within the switch was apparently lying loose. At this stage it was decided to take the control unit, together with the microswitches, to the DRA Structural Materials Centre at Farnborough for detailed examination and metallographic analysis of the contactor. Two photographs of the landing gear control unit are presented at Fig 1.

View of front of unit

Microswitch plunger operated by roller & lever

Camshaft

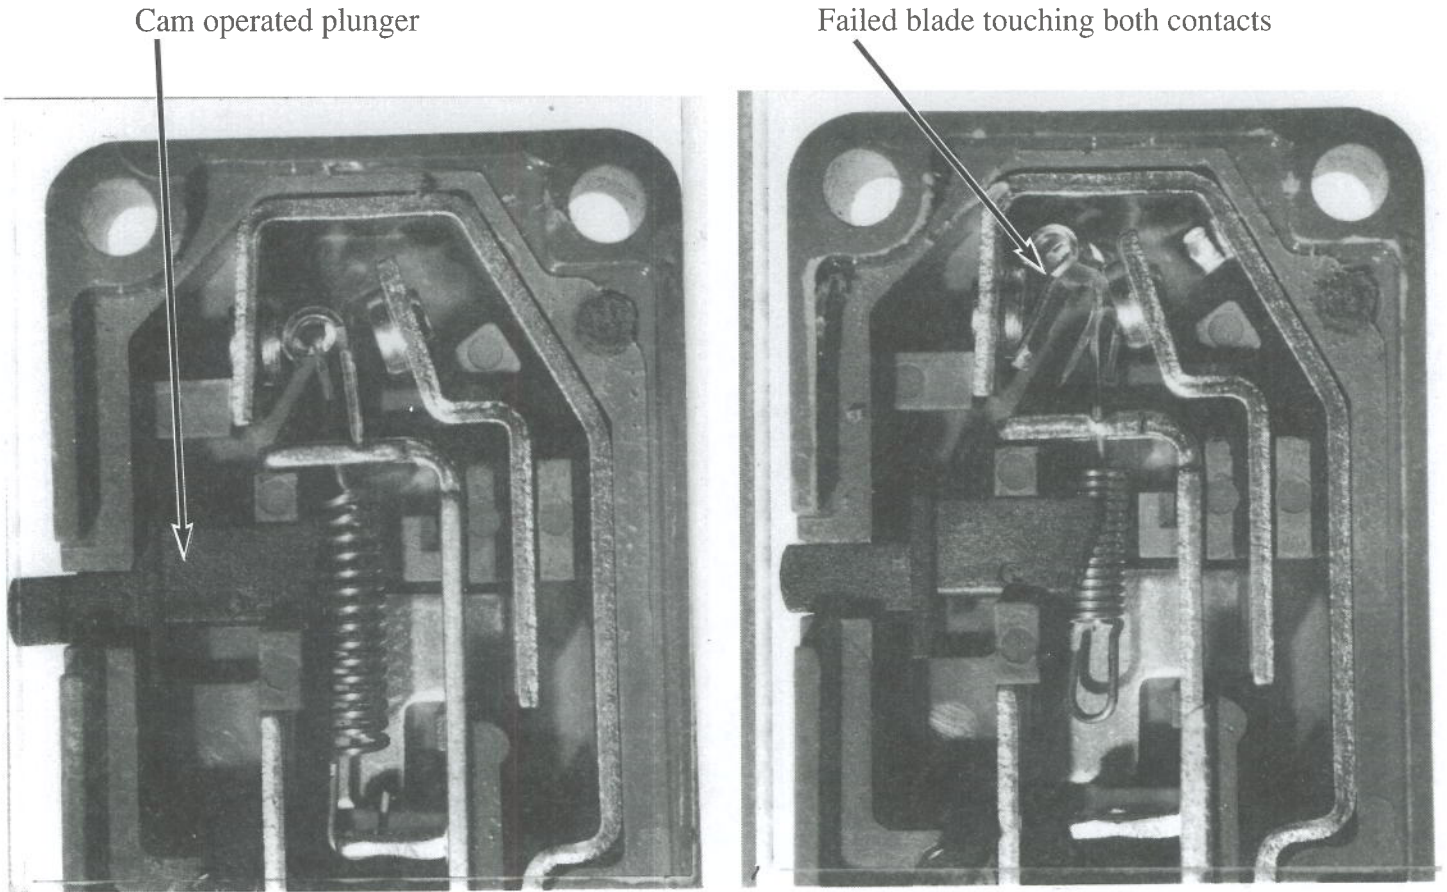
The conductive elements, including the moving contact blade, within the microswitch were made from gold plated 0.015 inch thick silver-magnesium-nickel alloy strip. A photograph of the switch is shown at Fig 2, together with a photograph of the failed unit from C-FTVN after the cover had been removed. Operation of the switch occurs when the cam-operated plunger applies a lateral force to the tensioning spring. This causes the blade, the lower end of which is pivoted on a platform on the central ('common') contactor, to 'flip' to its alternate position. Upon opening the switch, it was apparent that the integral loop on the moving contact blade, to which the upper end of the tensioning spring was attached, had failed. This had resulted in disconnection of the spring, which therefore

removed the loading on the plunger. It had also liberated the remaining portion of the blade, which was thus free to make random contact with the 'normally open' and 'normally closed' contacts. A sketch is included at Figure 3 which is a representation of how the moving contact blade, with its integral loop, is stamped out of one piece of alloy strip.

The failed contact blade from C-FTVN, together with the other failed unit obtained directly from the vendor, were examined under a scanning electron microscope. Both failures were similar in that the fracture faces were intergranular, with no evidence of crack growth prior to failure, and were thus characteristic of mechanical overload imposed by the spring. Certainly one of the failed loops was deformed on its inner edges in a manner indicative of considerable pressure from the spring.

Following their own metallurgical examinations, the manufacturers of the control units and the microswitches have concluded that the failures could be attributed to "the presence of pre-existing cracks, folds, etc resulting from the forming process caused by the condition of the material prior to the forming operation".

Other information included the fact that switches are assembled manually, as opposed to an automated process. It is thus possible that there is a variation in the forces applied to the loops in the contact blades by different assembly personnel. Higher forces would result in an attendant risk of overstressing the loops. Furthermore, shorter springs and/or higher spring rates would require slightly higher forces to stretch them enough to attach them to the contacts. There is thus a suggestion that the observed failures were of the 'infant mortality' type, ie only applicable to new units.

**FIG 2** Comparison of intact (left) and failed microswitches. Note disconnected spring on failed unit (*Photographs: DRA*)

Following the accident, the aircraft manufacturer issued an Alert Mandatory Service Bulletin (J41-A32-042) to implement a solution to the problem, which does not affect other Jetstream models. The modification re-routes the 'UP' signal wire from the landing gear control unit via a spare set of contacts in the flight idle baulk time delay relay. The function of the baulk is to prevent power lever movement below flight idle unless at least one of the weight on wheels switches is in the 'ground' position. When these switches attain the 'flight' condition, the time delay relay inserts a three second delay before the baulk is reinstated. Thus in the modified configuration, a spurious 'UP' signal would not, as a result of this modification, reach the hydraulic selector valve unless the weight-on-wheels switches, and hence the time delay relay, were in the 'flight' condition. However, in view of the remote possibility of this modification causing a critical delay in gear retraction in the event of an engine failure on takeoff, a further Service Bulletin will be issued which installs a modified landing gear control unit. This modifies the unit so that two microswitches are used to control gear operation. This results in the system having dedicated 'UP' and 'DOWN' microswitches connected to opposite ends of the double acting solenoid in the selector valve. This is effected by re-assigning the functions of the current UP/DOWN microswitch and the microswitch currently connected to the handle baulk solenoid. A rearrangement of the switch locations has resulted in the UP and DOWN switches being located on separate cams. A failure within either switch causing an uncommanded (and therefore opposing) signal would simply result in a hydraulic lock, ie no change in gear position. This feature has been confirmed by the aircraft manufacturer, using the J41 hydraulic systems rig. The emergency gear extension system is not affected by this modification.

As part of a product improvement exercise, the switch manufacturer has redesigned the switch and changed the process specification for the contactor material. A lighter spring has also been incorporated. In addition, improved quality control procedures have been implemented, including a blade loop pull-out test on production samples. Prior to delivery, each switch will be subjected to 15,000 operating cycles. No failures have been reported with the new switch following an intensive test programme. Pending full production of the new switch, the old type will continue to be delivered to the landing gear control unit manufacturer, but only after the 15,000 operating cycle qualification.

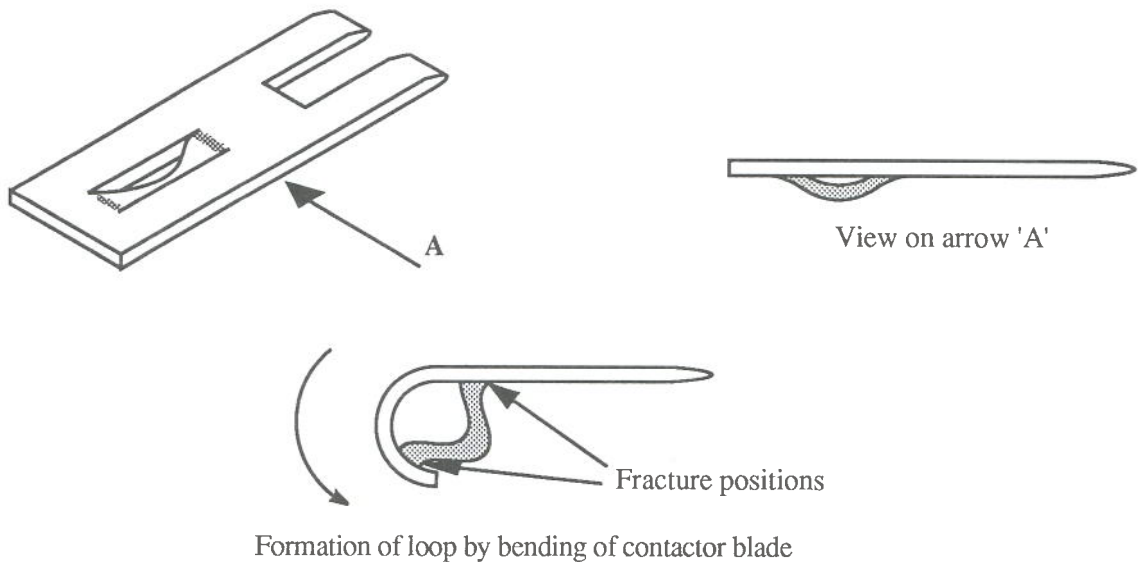
**FIG 3** Representation of how contactor blade and integral loop is formed from single piece of alloy strip
