**Report on the accident between
Cessna 402C, G-EYES and
Rand KR-2, G-BOLZ
near Coventry Airport
on 17 August 2008**

Aircraft Accident Report No: 8/2010 (EW/C2008/08/05)

Aircraft Types: 1) Cessna 402C
2) Rand KR-2

Registrations: 1) G-EYES
2) G-BOLZ

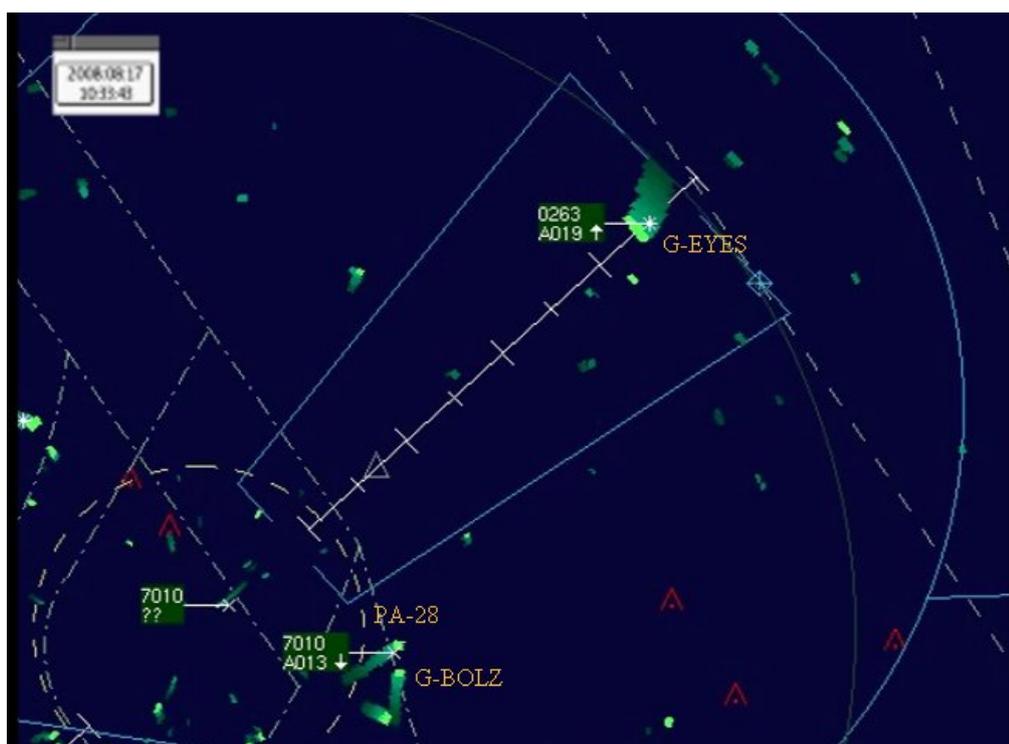
Figure 1

The ATM at 1033:43 hrs:
PA-28 about to turn onto base leg,
with G-BOLZ following

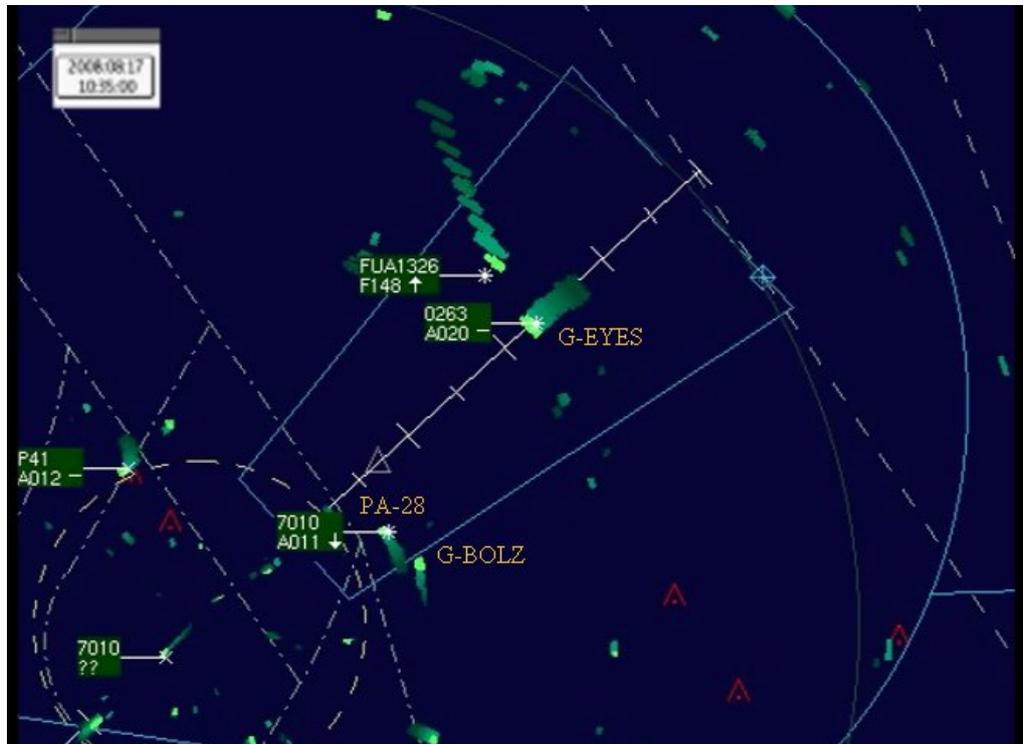
Figure 2

The ATM at 1035:00 hrs:
PA-28 and G-BOLZ on base leg

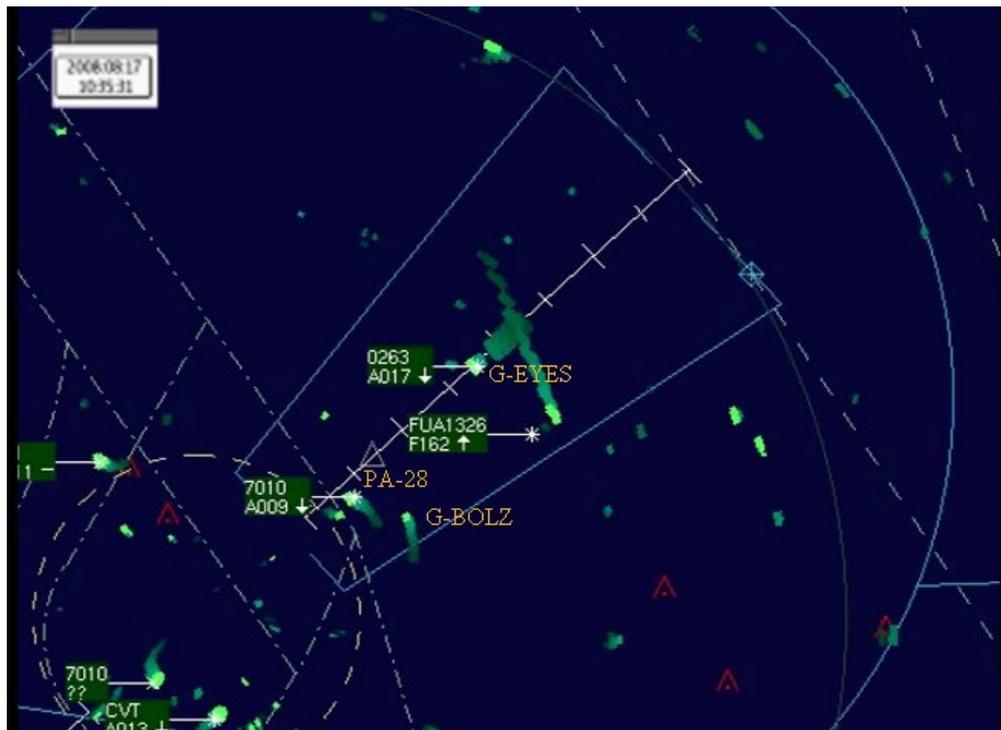
Figure 3

The ATM at 1035:31 hrs:
PA-28 turning onto final, G-BOLZ on left base,
G-EYES on 5.5 nm final

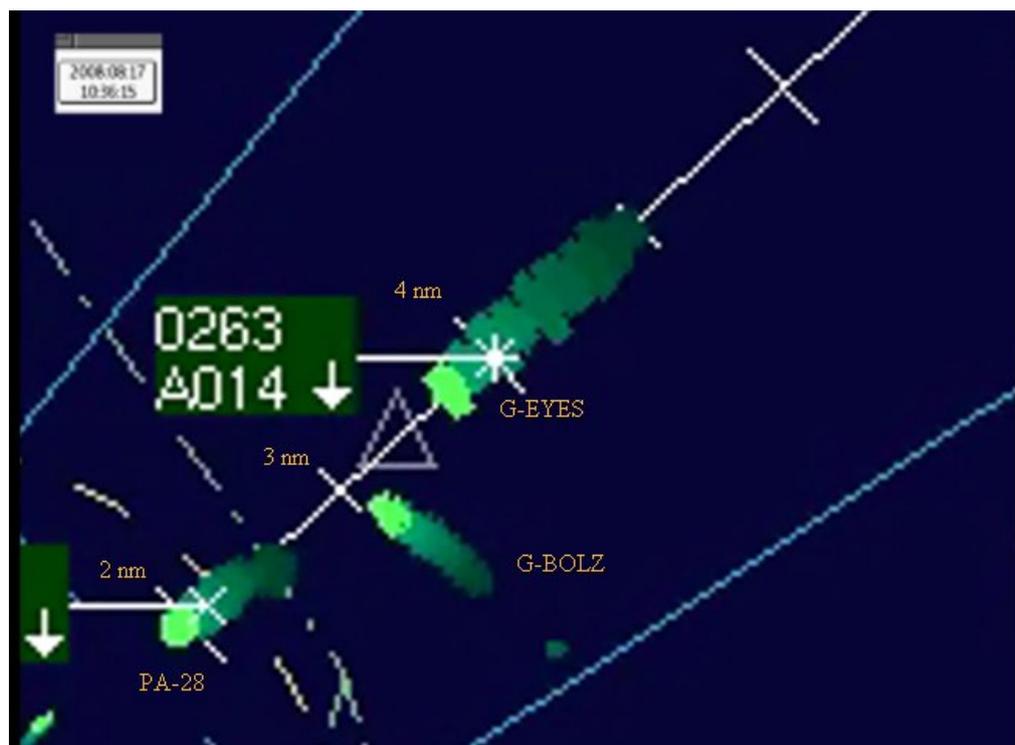
At 1036:20 hrs, the ADC transmitted “GOLF LIMA ZULU COVENTRY IF YOU CONTINUE FLYING THROUGH THE FINAL APPROACH ROUTE TOWARDS ER RIGHT BASE PLEASE”. The pilot of G-BOLZ replied “GOLF LIMA ZULU”; this was his last transmission. It was estimated from timing of radio transmissions that G-BOLZ and G-EYES collided at or around 1036:32 hrs. Figure 4 shows their relative positions on the ATM display at 1036:15 hrs.

The ATM at 1036:15 hrs:
showing the relative positions of G-EYES and G-BOLZ
shortly before the collision

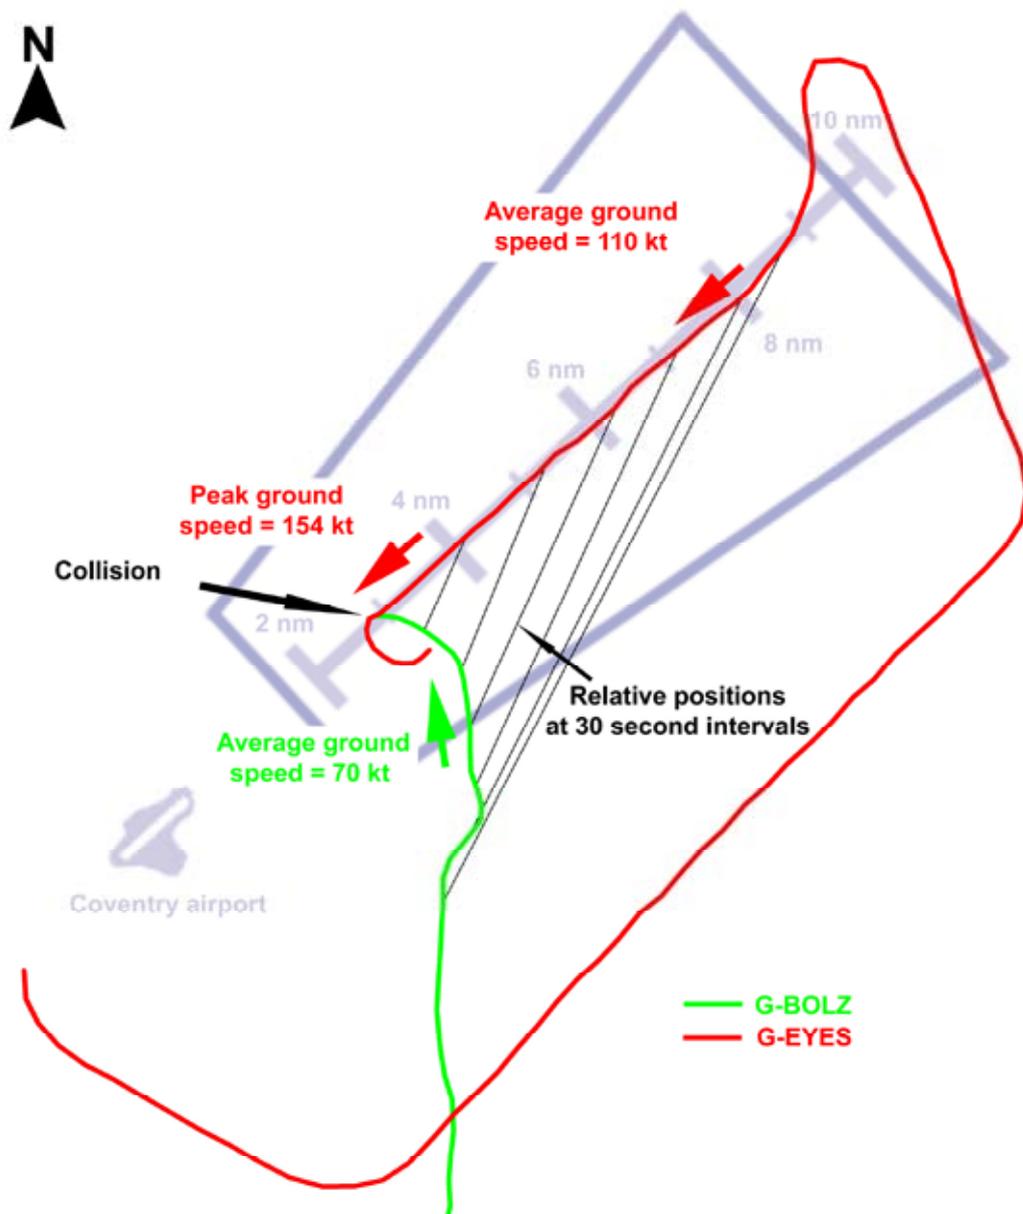
Figures 9 and 10 were generated from the amalgamation of the recorded data discussed above and show the tracks of G-BOLZ, G-EYES and the PA-28. Figure 10 shows that the bearing of G-BOLZ relative to the nose of G-EYES remained almost constant for approximately three minutes before the collision.

Tracks and speeds of G-BOLZ and G-EYES

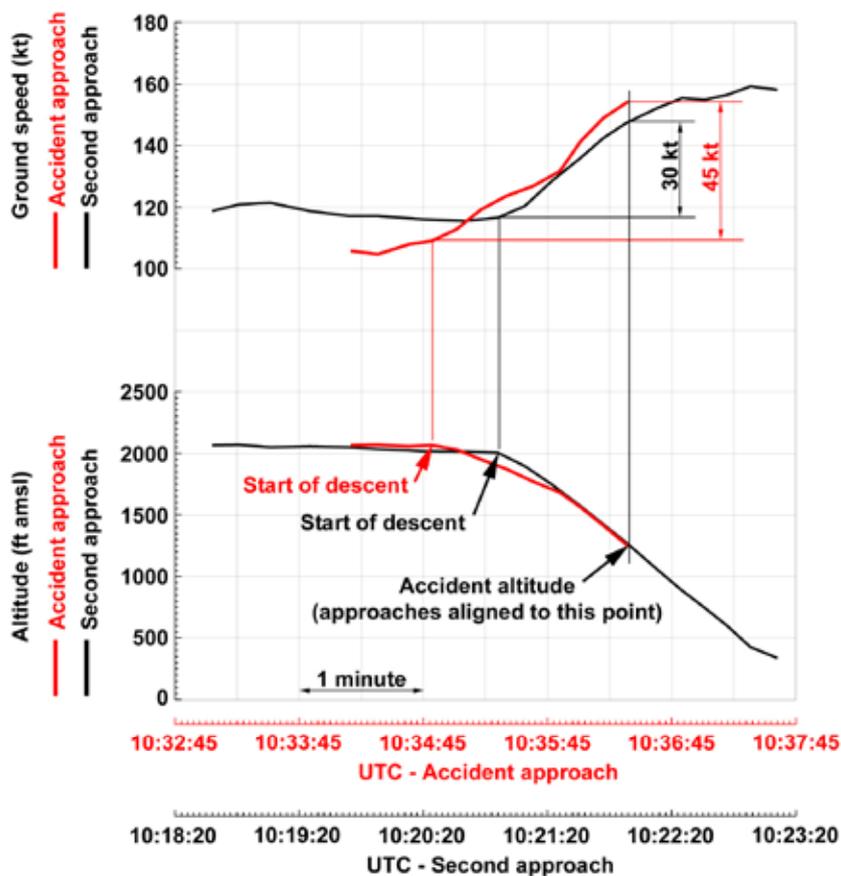
Figure 11 shows a comparison between the altitude and groundspeed of G-EYES on its second and third approaches. The aircraft began its third approach approximately 8 kt slower than its second approach but accelerated and achieved the same speed just as it began to descend. During the descent on the third approach, G-EYES was faster than on the second approach by up to 6 kt. G-EYES gained approximately 30 kt during the descent of the second approach and approximately 45 kt during the descent preceding the accident.

Note: the airspeeds would have been higher than the ground speeds shown due to the wind, which may have varied slightly between the approaches.

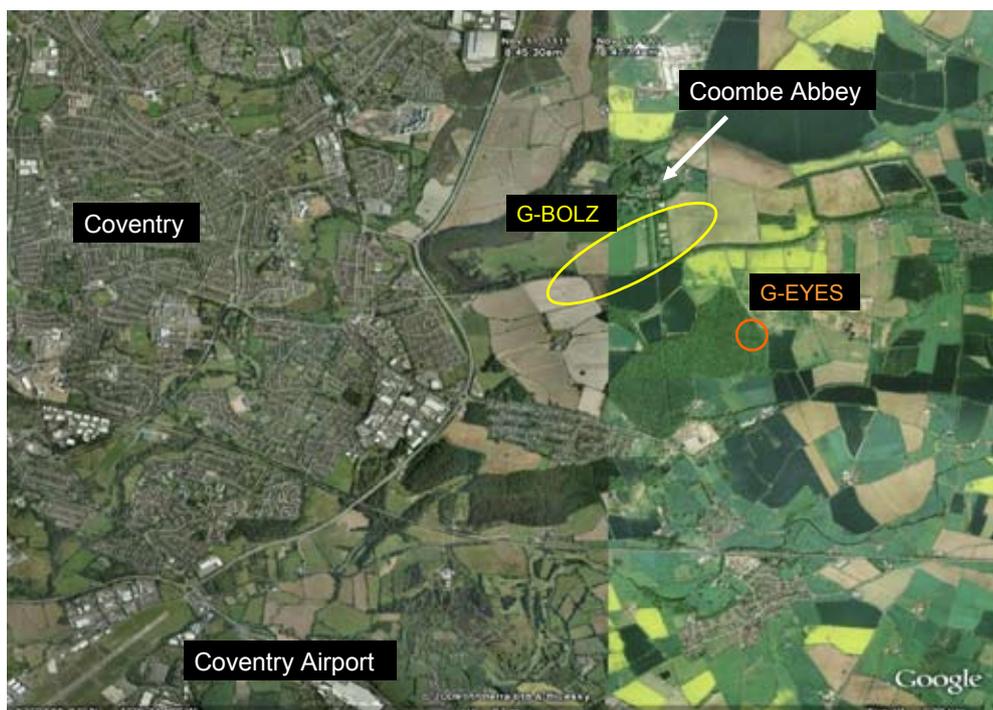
Figure 12

The wreckage of G-BOLZ was located in fields to the south of Coombe Abbey, on the eastern outskirts of the city of Coventry. The engine, fin, rudder, left tailplane and left wing were the only parts of the aircraft found largely intact. Most of the remaining smaller and lighter parts were found along a trail approximately 1 km long and 100 m wide, aligned with the wind direction (Figure 12).

Wreckage locations

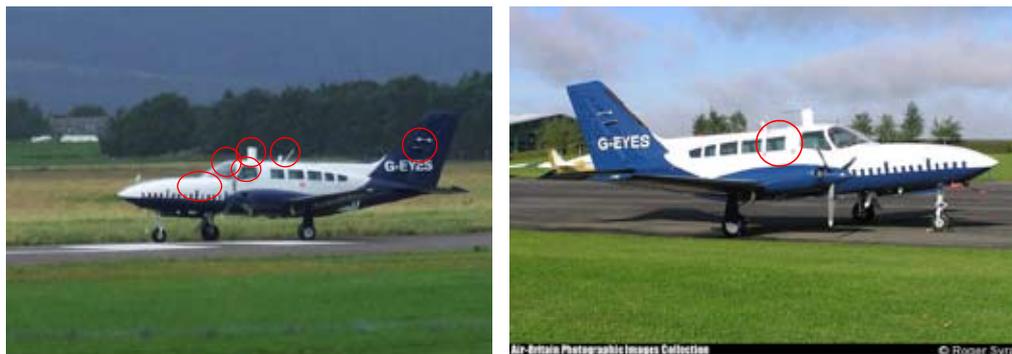
Figure 13

A number of parts from G-EYES were found amongst the wreckage of G-BOLZ (Figure 13). These consisted of: the left rear nose baggage bay door, a large portion of the pilot's escape hatch and its frame, parts of the windscreen and side window transparencies, the sun visors from both windscreens, the ILS calibration monitor screen from the left side of the instrument panel, aerials from the top of the fuselage and the left side of the fin, and most of the passenger escape hatch from the right side of the fuselage. Various papers, charts and pieces of interior trim from G-EYES were also found in the vicinity.

Parts of G-EYES found with the wreckage of G-BOLZ

Significant collision damage was visible on the left side of the forward fuselage. The parts found with the wreckage of G-BOLZ were indicative of the extent of this damage. A number of pieces of wreckage from G-BOLZ were found amongst the wreckage of G-EYES; some were inside the cabin. These consisted of a substantial number of parts of the leading edge of G-BOLZ's right wing and small parts of forward fuselage structure.

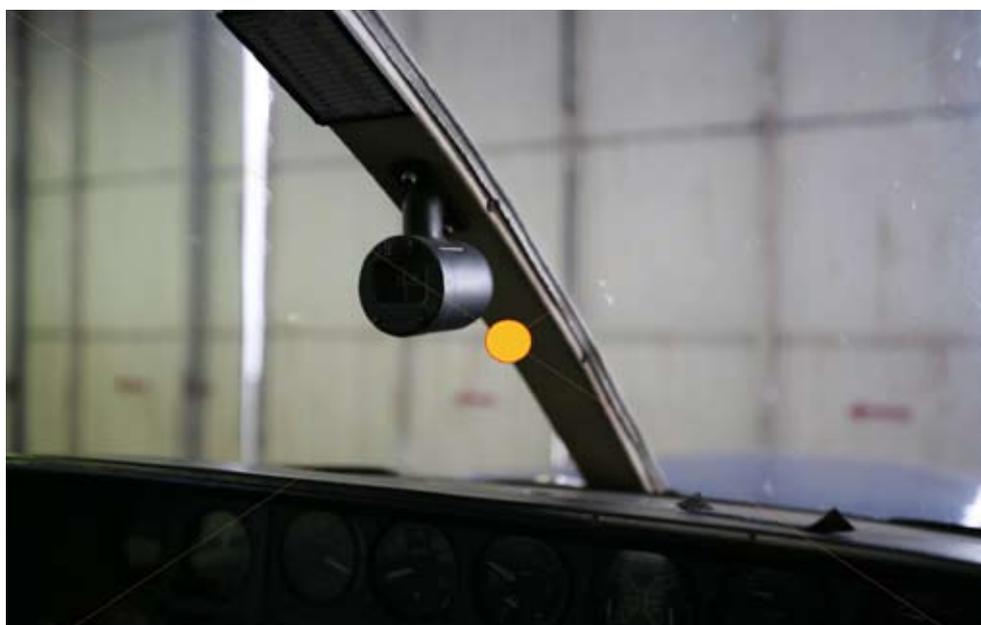
Figure 14

The AAIB undertook an investigation of the field of view from the cockpit of an aircraft similar to G-EYES. An assessment was made from each pilot's seat to find where G-BOLZ would have appeared on the windscreen at the data points in Table 2. The assessment used representative eye positions which could not take account of the actual orientation and level of the pilots' heads, and thus the results are only best estimates. The results suggested that the view towards G-BOLZ from the left seat was probably unobstructed. However, when viewed from the right seat, G-BOLZ would probably have been located behind, or slightly to the left of, the windscreen central pillar in the area between the compass mounting and the coaming (Figure 14). (Note that the size of the circle is not intended to be representative of the size of G-BOLZ.)

The estimated location of G-BOLZ when viewed from the right seat of G-EYES
