**ACCIDENT**

<b>Aircraft Type and Registration:</b>	Fokker F27 Mk 500 Friendship, TC-MBG
<b>No &amp; Type of Engines:</b>	2 Rolls-Royce Dart 532-7 turboprop engines
<b>Year of Manufacture:</b>	1971
<b>Date &amp; Time (UTC):</b>	1 February 2008 at 2115 hrs
<b>Location:</b>	Stand 201, Edinburgh Airport
<b>Type of Flight:</b>	Commercial Air Transport (Cargo)
<b>Persons on Board:</b>	Crew - 3                      Passengers - None
<b>Injuries:</b>	Crew - None                      Passengers - N/A
<b>Nature of Damage:</b>	Propeller, engine and ground power unit severely damaged
<b>Commander's Licence:</b>	Airline Transport Pilot's Licence
<b>Commander's Age:</b>	56 years
<b>Commander's Flying Experience:</b>	4,080 hours (of which 2,745 were on type) Last 90 days - 74 hours Last 28 days - 26 hours
<b>Information Source:</b>	AAIB Field Investigation

**Synopsis**

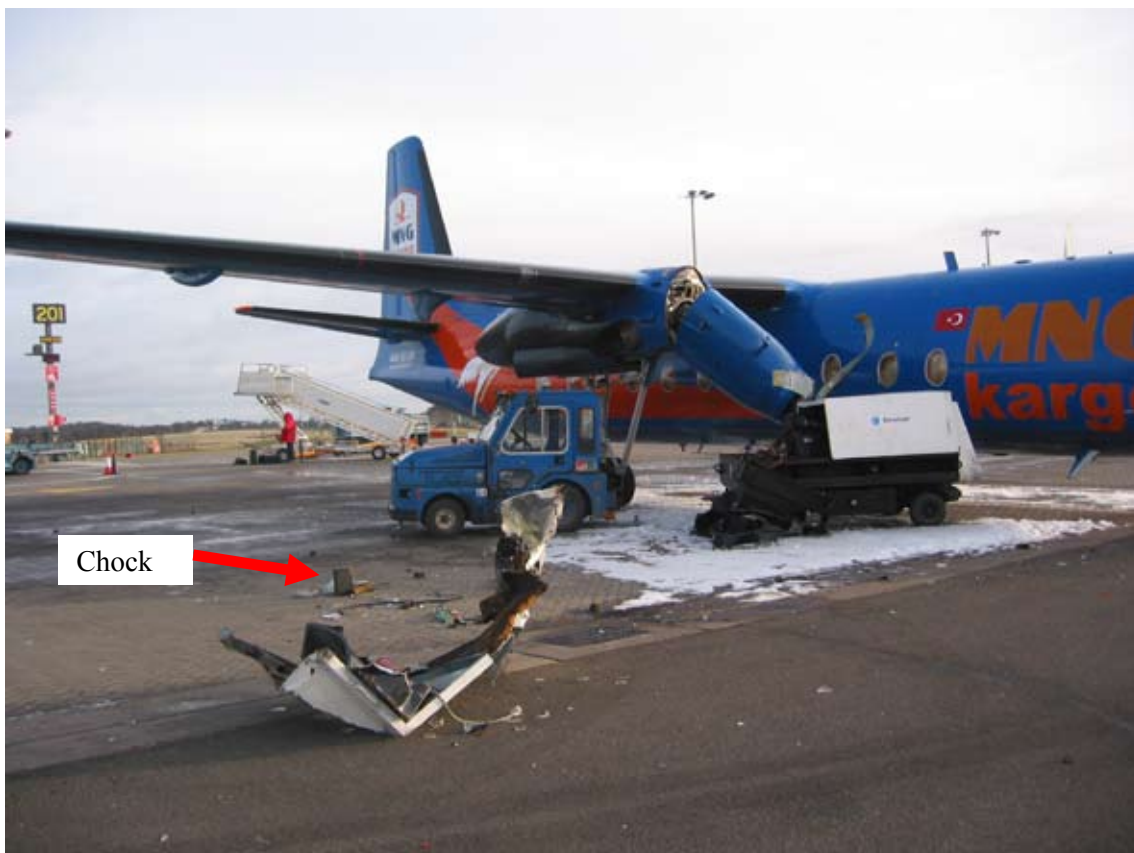
**Figure 1**

A photograph of the accident scene, taken on the morning after the event, is shown at Figure 1. Chocks had been placed at all the wheels at this stage. According to the AFRS, no chocks were found in the vicinity of any of the wheels on their arrival and they chocked the wheels as a precaution, prior to applying foam. Two chocks were found in the wreckage of the GPU, with one of them being visible in Figure 1.

View of the accident site. Position of chock is indicated. The other is located within GPU debris in foreground

The GPU had sustained substantial damage as a result of being struck by the right propeller. The sliding portion of the cover, which was made from steel, had been torn from the chassis and thrown some 7-8 metres, landing in front of the outboard section of the aircraft's right wing. The control panel had also been removed from its mountings but had remained attached to the GPU by electrical cables. The roof of the tractor had suffered a glancing blow from a propeller blade and the rear window had received a number of impacts from flying debris.

As can be seen in the photograph, the aircraft's right engine nacelle had almost separated from the wing, remaining attached only by the exhaust duct and some conduits. The instability of the nacelle during the accident sequence and the close proximity of the fuselage had resulted in the propeller striking and breaking an adjacent window transparency.

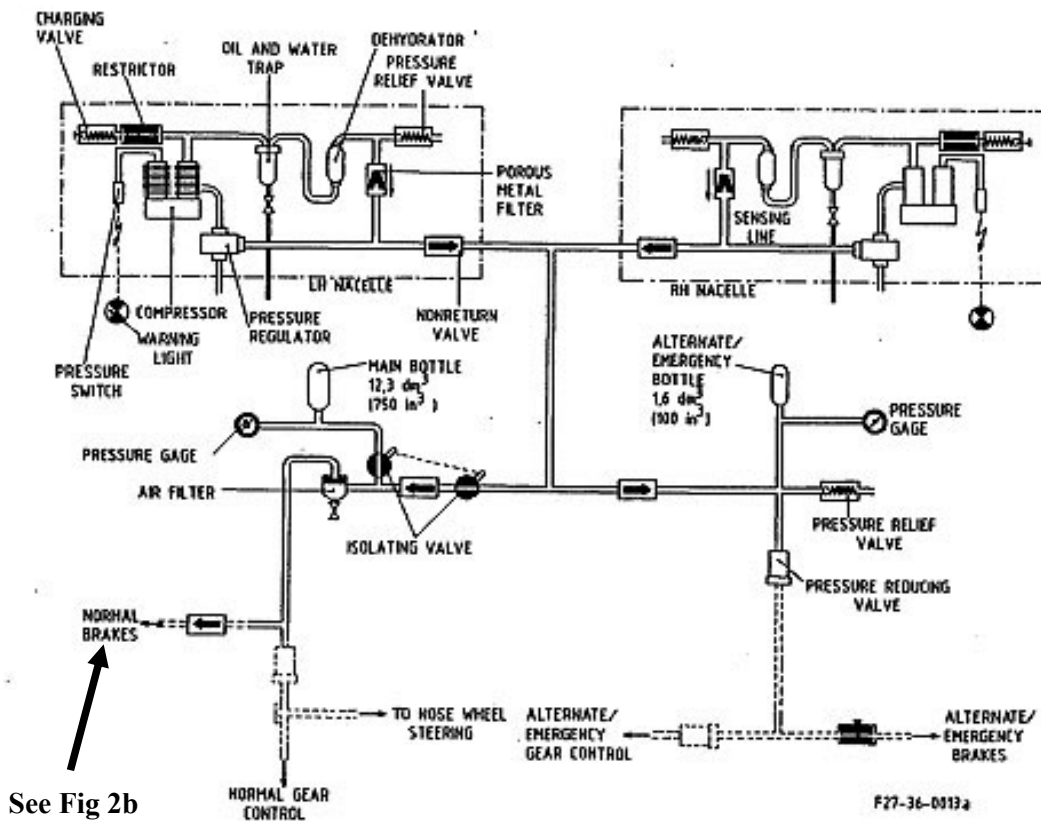
Figure 2a

An isolating valve is incorporated within the system, which, as can be seen in Figure 2a, actually consists of two valves, both operated by a single control rod. The purpose of the valve is to preserve stored pressure in the event of a leak elsewhere in the system.

Pneumatic system schematic diagram

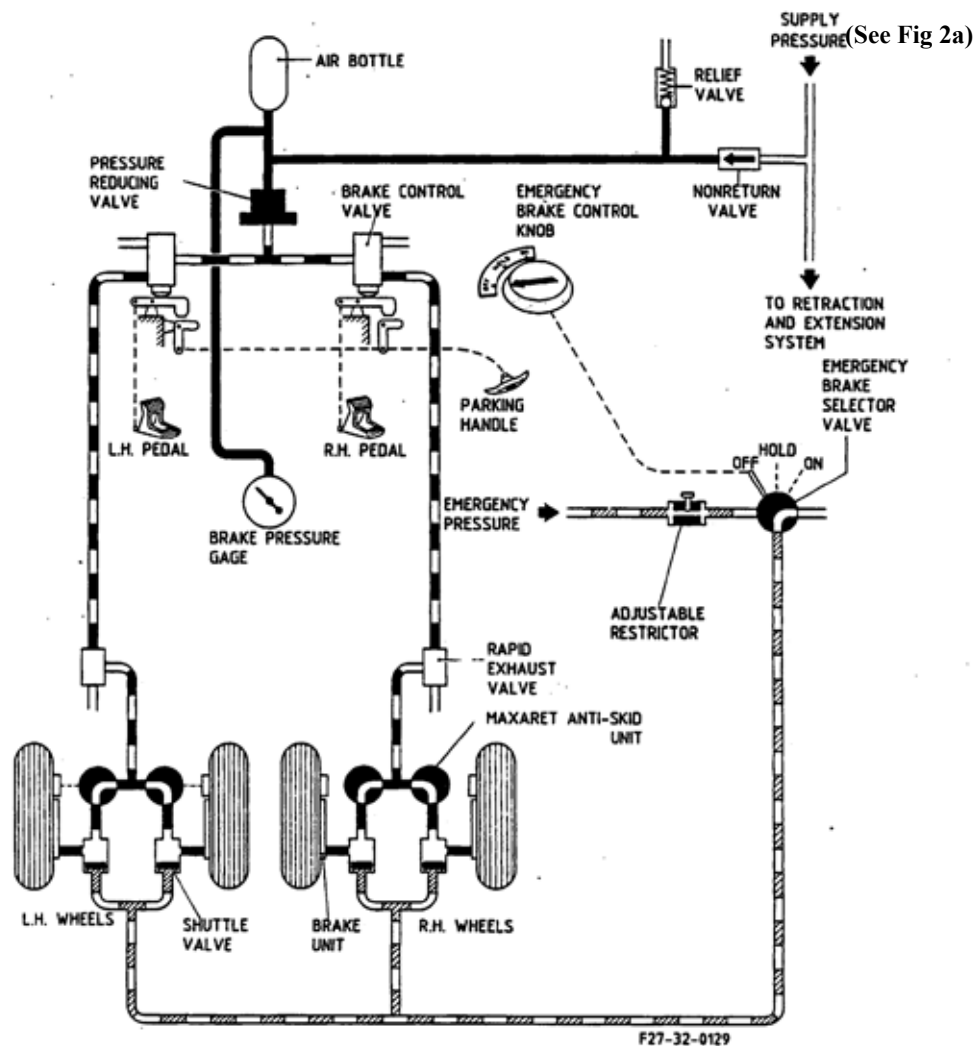
**Figure 2b**

Brake system schematic diagram
