INCIDENT

Aircraft Type and Registration:	Dornier 328-110, D-CPRW	
No & Type of Engines:	2 Pratt & Whitney PW 119B turboprop engines	
Year of Manufacture:	1998	
Date & Time (UTC):	28 November 2005 at 0923 hrs	
Location:	Isle of Man (Ronaldsway) Airport	
Type of Flight:	Public Transport (Passenger)	
Persons on Board:	Crew - 3	Passengers - 16
Injuries:	Crew - None	Passengers - None
Nature of Damage:	None	
Commander's Licence:	Airline Transport Pilot's Licence	
Commander's Age:	53 years	
Commander's Flying Experience:	5,575 hours (of which 310 were on type) Last 90 days - 150 hours Last 28 days - 30 hours	
Information Source:	AAIB Field Investigation

Synopsis

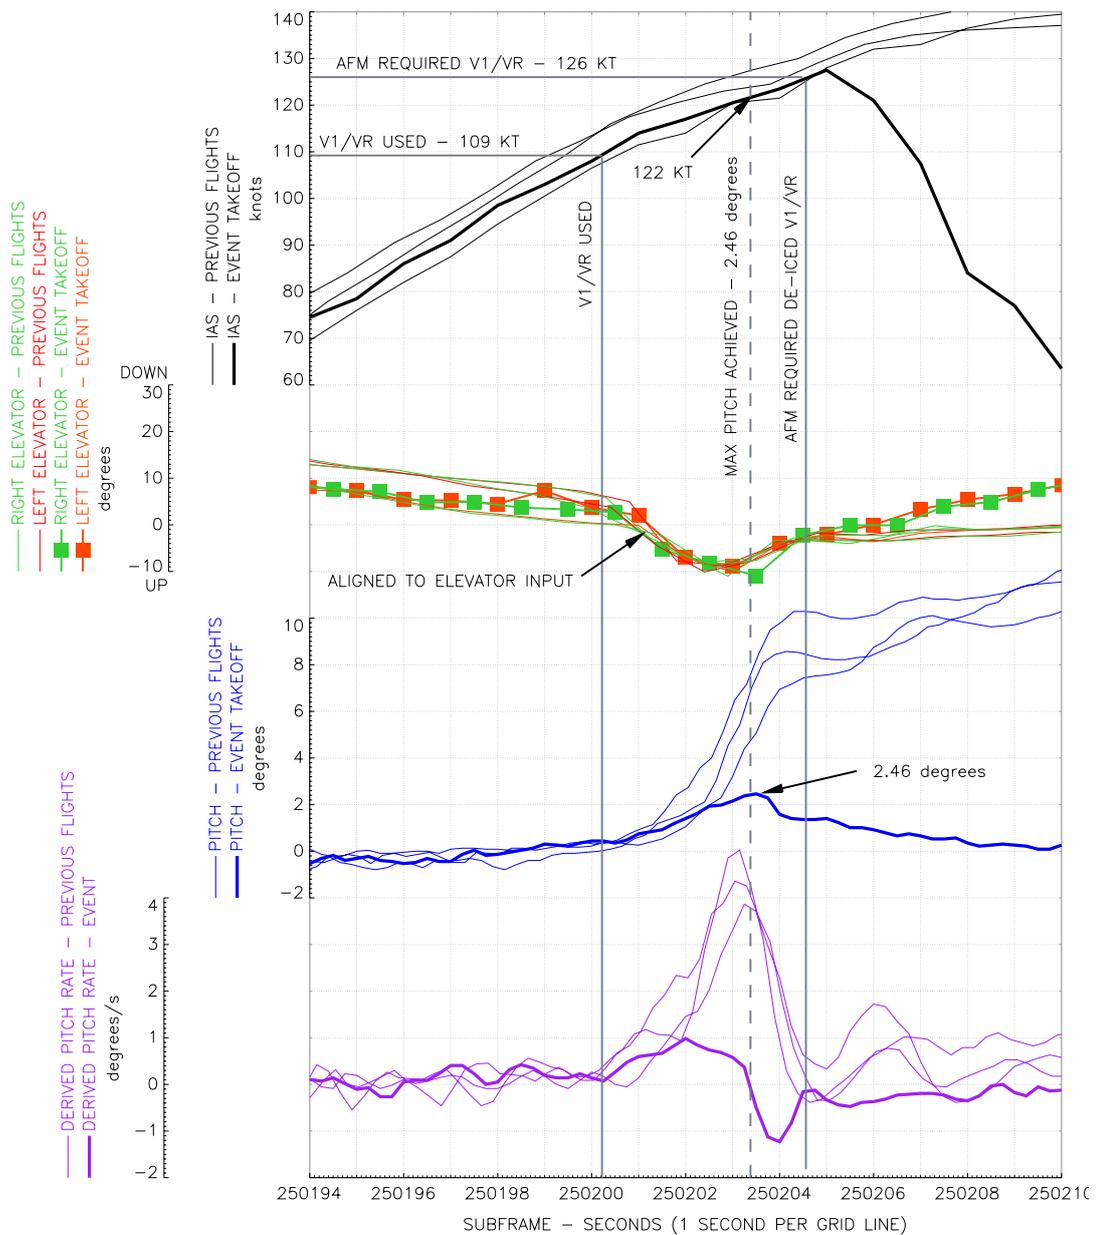
Figure 2
Comparison of Speed, Elevator Input, Pitch & Pitch Rate With 3 Other Flights

A comparison of speed, elevator input, pitch and pitch rate with three other flights is shown in Figure 2. The recordings are aligned to elevator movement at the point of rotation. This diagram further illustrates the abnormality of the aircraft's pitch response to elevator movement during the incident takeoff.

The FDR data showed that the aircraft was rotated significantly before the AFM stated rotation speed for the given weight and conditions. A comparison with previous flights indicates that the effect of the given elevator input did not result in the normal aircraft pitch behaviour. The comparison flights did not match the event flight with regards to the speed at which the elevator input was initiated so a comparison of elevator effectiveness at a given speed cannot be made from this limited data.
