SERIOUS INCIDENT

Aircraft Type and Registration:	Dornier 328-100, DO328, G-BWWT
No & Type of Engines:	2 Pratt & Whitney Canada PW119B turboprop engines
Year of Manufacture:	1995 (Serial No: 3022)
Date & Time (UTC):	22 March 2012 at 0955 hrs
Location:	Norwich International Airport
Type of Flight:	Commercial Air Transport (Passenger)
Persons on Board:	Crew - 3 Passengers - 24
Injuries:	Crew - None Passengers - None
Nature of Damage:	Runway edge light broken
Commander's Licence:	Airline Transport Pilot's Licence
Commander's Age:	59 years
Commander's Flying Experience:	20,175 hours (of which 2,800 were on type) Last 90 days - 24 hours Last 28 days - 14 hours
Information Source:	AAIB Field Investigation

Synopsis

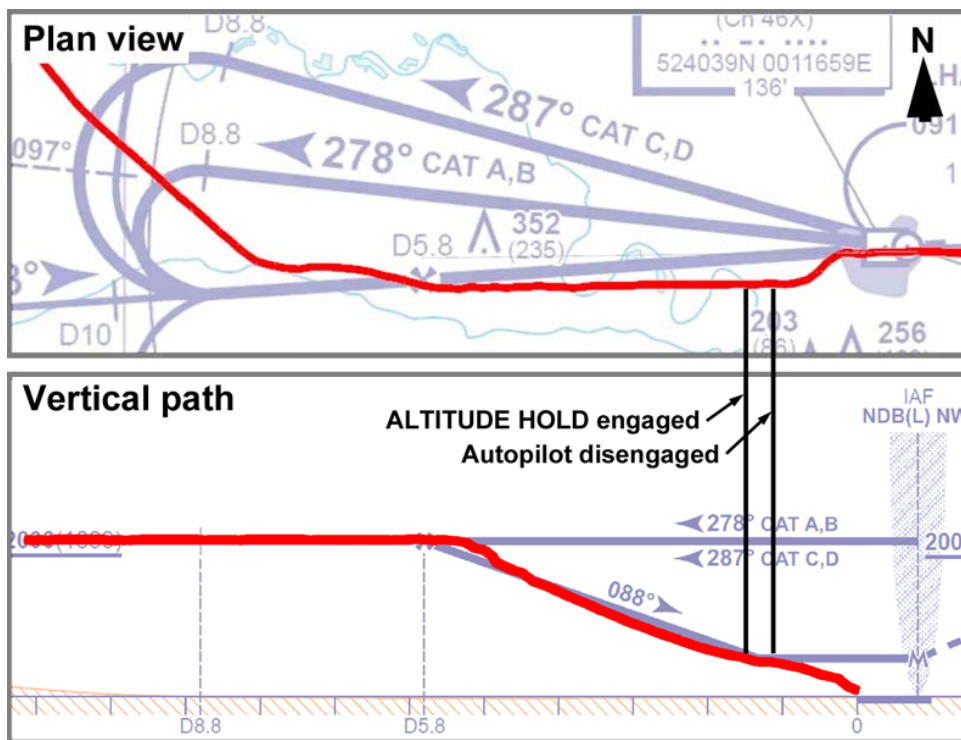
the wind was from 110° at 07 kt. The commander, who was pilot flying (PF), subsequently briefed for radar vectors to the final approach for an NDB/DME approach to Runway 09. The co-pilot, who had gained his captaincy seven months before the incident, was the pilot monitoring (PM). Figure 1 shows the NDB/DME approach plate to Runway 09, with flight path overlay.

Excerpt from NDB/DME approach plate, Runway 09 at Norwich, with flight path overlay

NATS Radar data provided good positional information of the event approach, down to the runway elevation. This showed that the final approach descent started in the vicinity of the final approach fix location for the NDB approach procedure. The vertical profile of the descent approximately matched that of the procedure. However, the aircraft track paralleled the runway centreline (with an offset of approximately 0.4 nm until about 1.1 nm from the threshold) rather than converging with it.

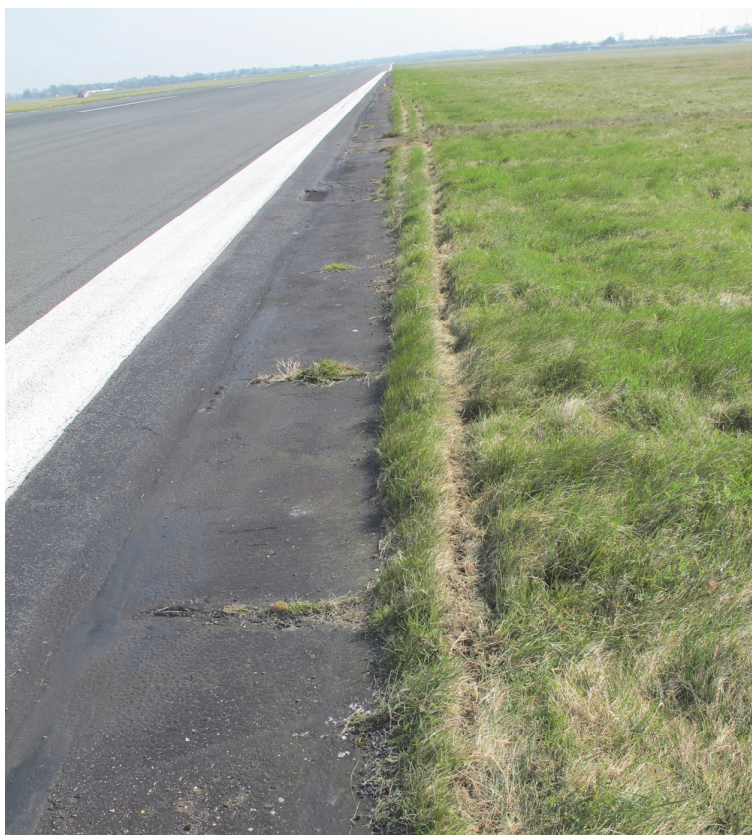
Figure 2

The pilot became visual with the runway at about 1 nm, with the aircraft about ½ nm south of the centreline after levelling at MDA from an NDB/DME approach to Runway 09 at Norwich. The aircraft subsequently touched down tracking towards the right edge of the runway. The aircraft's right main landing gear went onto the grass and broke a runway edge light but the subsequent go-around and landing were uneventful.

The airfield was inspected by the airport operator and the AAIB. Tyre marks from G-BWWT were found on the runway and grass, with a broken lens from a runway edge light. Tyre tracks from the right landing gear wheels are shown at Figure 2.

Photograph of runway excursion by right main landing gear

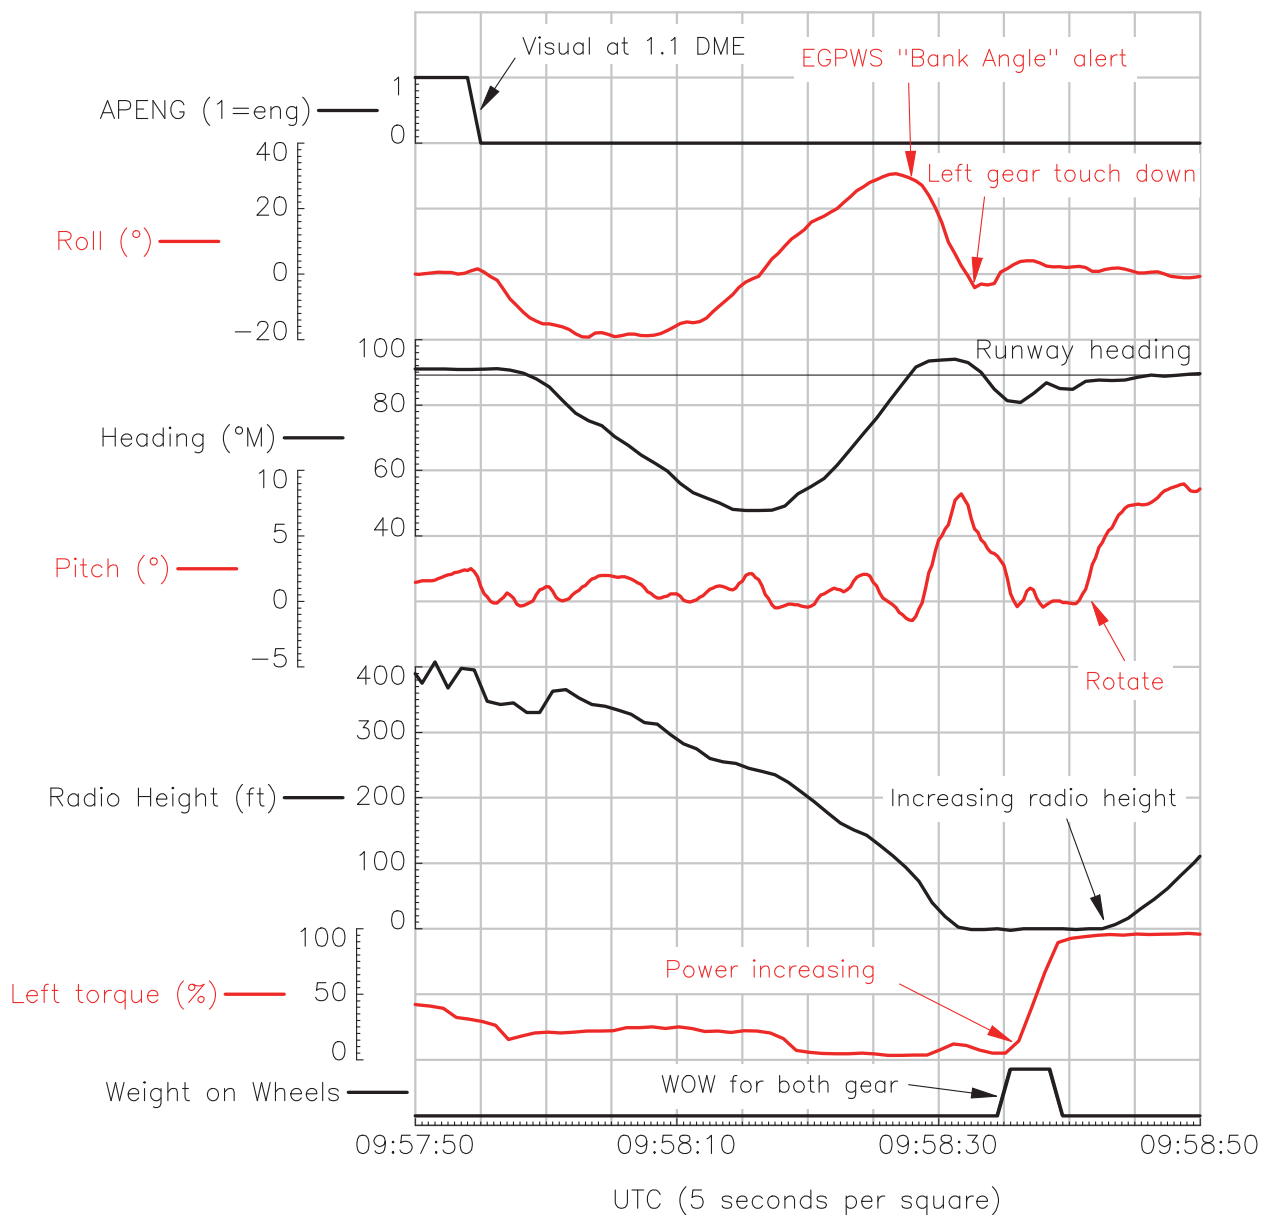
The aircraft was fitted with an FDR and a CVR but the CVR evidence was over-written before the AAIB had been notified of the incident. The FDR recording captured the event flight, including the first approach, shown in Figure 3.

The recordings showed that the A/P was engaged with a lateral mode of HEADING SELECT for the whole approach. The A/P pitch mode transitioned from ALT HOLD to VERTICAL SPEED for the descent but at approximately 460 ft aal switched back to ALT HOLD. After a further 10 seconds the autopilot was disengaged and control inputs to correct the aircraft's position were initiated. This is considered to be the point at which the crew became visual with the runway.

Figure 3
FDR plot of final approach

The aircraft then banked left 19°, at about 330 ft aal, followed by a right bank of 30°, at about 110 ft aal, which was transitioning to a left bank at the point of touchdown. The data indicated that the left gear touched down first with the aircraft on a heading of 093°M, to the right of the runway heading but turning towards it. Approximately two seconds later the right gear touched down and the heading was 081°M, to the left of the runway heading with the engine torque values starting to increase. Four seconds later the 'weight-on-wheels' parameter and pitch attitude indicated liftoff and the radio altimeter showed positive height after a further four seconds.
