AAIB Bulletin No: 7/94

Ref: EW/C94/3/2

**Aircraft Type and Registration:** Yak-52, RA 01337

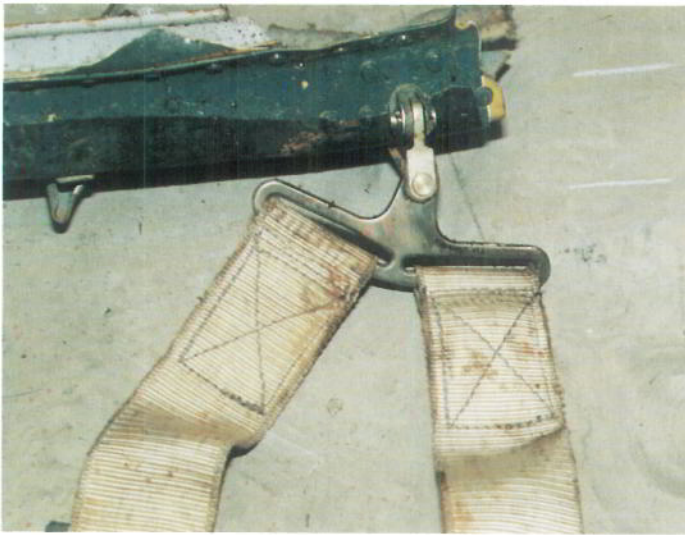
**FRONT COCKPIT**

This aircraft was fitted with a five point harness in each cockpit, and it was determined that all five straps were being worn by both occupants at the time of the accident. The crotch strap of these harnesses is connected to the floor of each cockpit by a metal link, which is free to pivot in the fore-and-aft direction from a point just aft of each control column. Any slackness in the crotch strap could allow this link to rotate either forward, to make contact with the rear of the column, or aft, under the base of the seat. In the rear cockpit this link had rotated aft and had failed in compression induced bending after being trapped by the downwards deformation of the seat, probably during the initial

Upper Torso Attachment  
Showing Crossbeam Failure

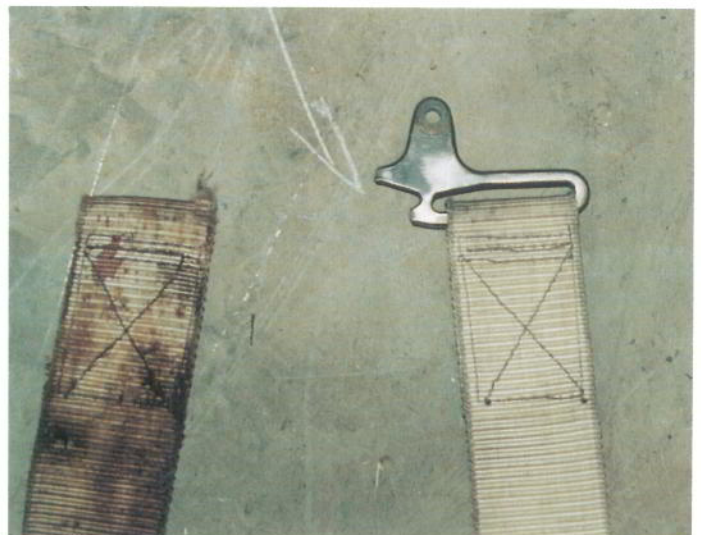
**REAR COCKPIT**

impact. Failures had also occurred in both upper torso restraints. The right strap had been released by failure of one side of the common attachment fitting (crank link), a fitting designed such that the loads from both straps are fed to a single attachment point on a crossbeam located at the top of, and behind, the seat. This crossbeam had remained intact and securely attached to the fuselage sides. The left strap itself had suffered a failure, probably as a result of additional loading following failure of the right strap, at a point where it passed around its adjustment buckle. These failures, the upper torso ones in particular, had allowed the rear seat pilot to jack-knife about the intact lap strap and strike his head on the coaming. In the front cockpit, the crossbeam had broken and become detached as a result of the general disruption of the forward fuselage, although the upper torso attachment fitting remained intact. In addition, the link attached to the crotch strap had pulled free from the fuselage complete with a section of floor structure, but the lap straps had remained intact. Figure 1 details the above failures. The post mortem examination revealed that both occupants received fatal injuries as a direct result of the accident and that their chances of survival, the rear seat pilot in particular, would have been greatly enhanced had the harnesses/attachments not failed and head protection been worn. Information from the manufacturer stated that 'all belts and crank links are calculated for a load of 1.5 tonnes'.

Upper Torso Attachment Showing  
Failure of Common Fitting

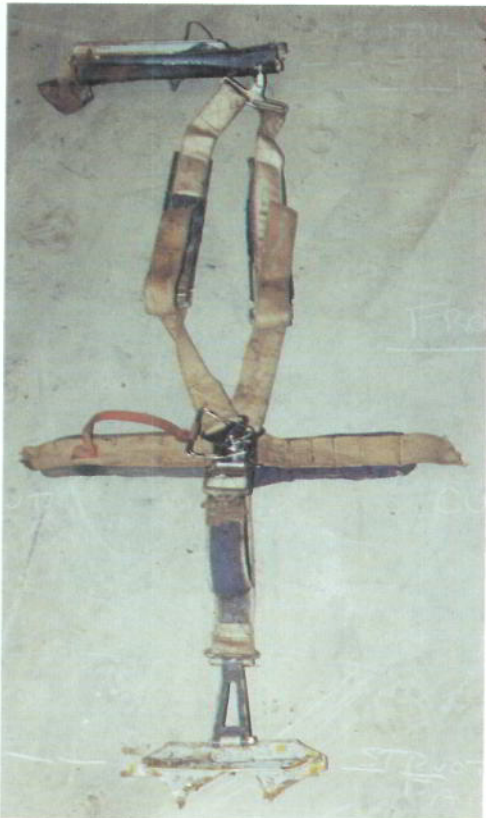
**Complete Harness Showing  
Failures of Structural Members**

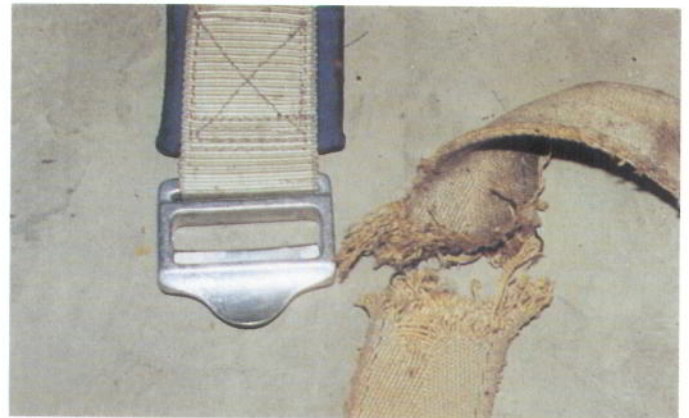
**Failure of Left Upper Torso Strap**

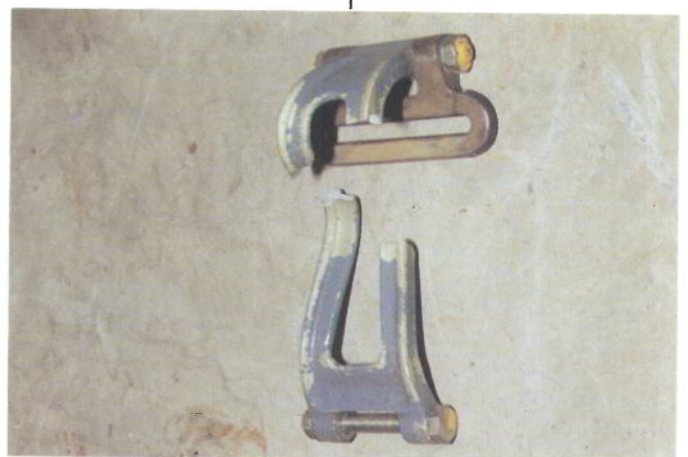
**Compression Failure of Crotch Strap Link**

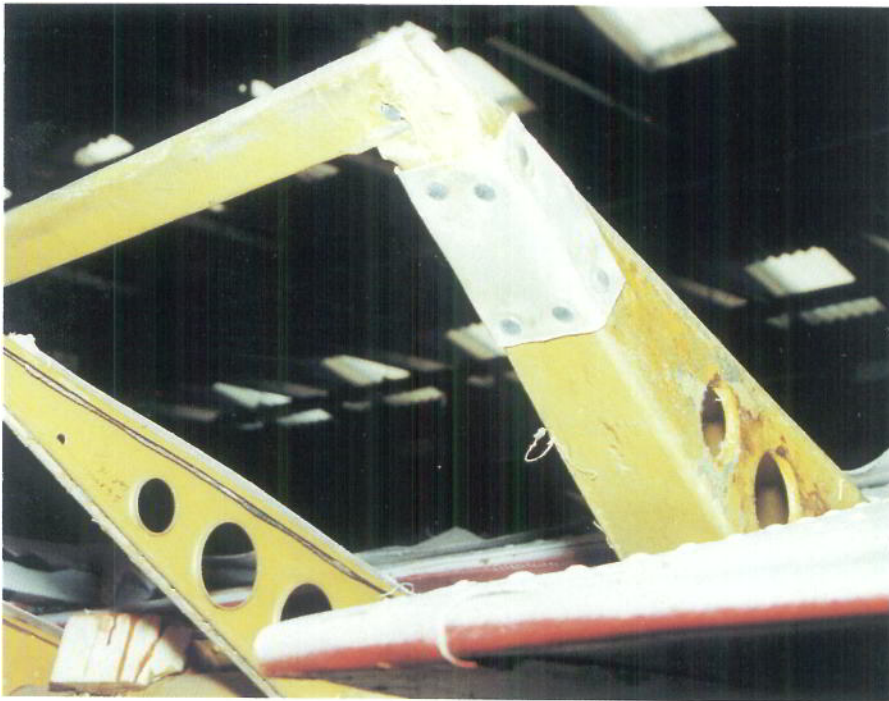
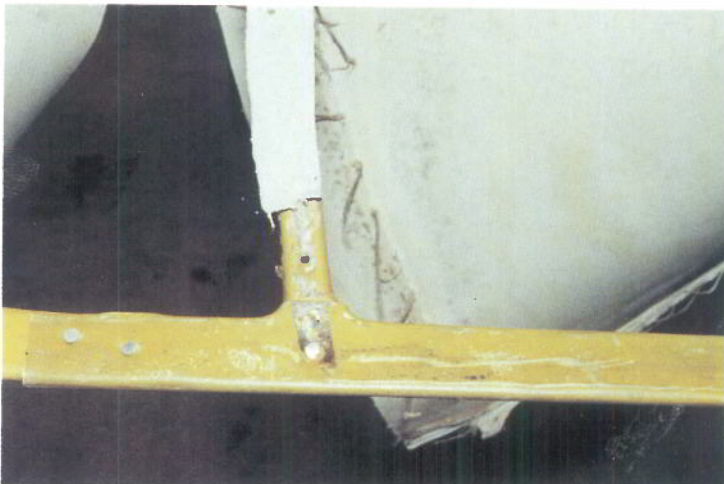
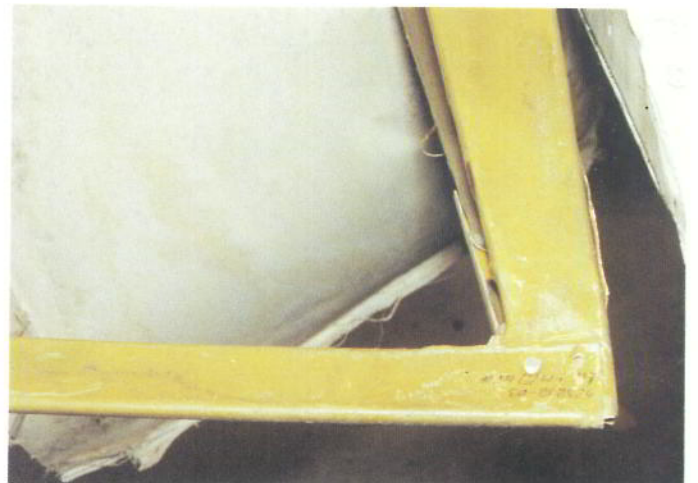
During the examination of the wreckage an area of crush damage, that had previously been repaired, was revealed at the inboard end of the left aileron. Although not a causal factor in this accident, the quality of this repair was extremely poor and was not detected without removal of the fabric covering the aileron structure. Photographs of this repair are shown at Figure 2.

Repaired area to inboard end of left aileron structure
