**ACCIDENT**

<b>Aircraft Type and Registration:</b>	Jabiru J400, G-CDLS	
<b>No &amp; Type of Engines:</b>	1 Jabiru Aircraft PTY 3300A piston engine	
<b>Year of Manufacture:</b>	2006	
<b>Date &amp; Time (UTC):</b>	19 May 2010 at 0944 hrs	
<b>Location:</b>	Hinderwell, Yorkshire	
<b>Type of Flight:</b>	Private	
<b>Persons on Board:</b>	Crew - 1	Passengers - 1
<b>Injuries:</b>	Crew - None	Passengers - None
<b>Nature of Damage:</b>	Propeller destroyed, lower fuselage, cowlings, engine attachment and landing gear damaged	
<b>Commander's Licence:</b>	National Private Pilot's Licence	
<b>Commander's Age:</b>	69 years	
<b>Commander's Flying Experience:</b>	776 hours (of which 88 were on type) Last 90 days - 4 hours Last 28 days - 4 hours	
<b>Information Source:</b>	Aircraft Accident Report Form submitted by the pilot

**Synopsis**

The aircraft was damaged during a forced landing following an engine malfunction. Carburettor icing may have been a factor.

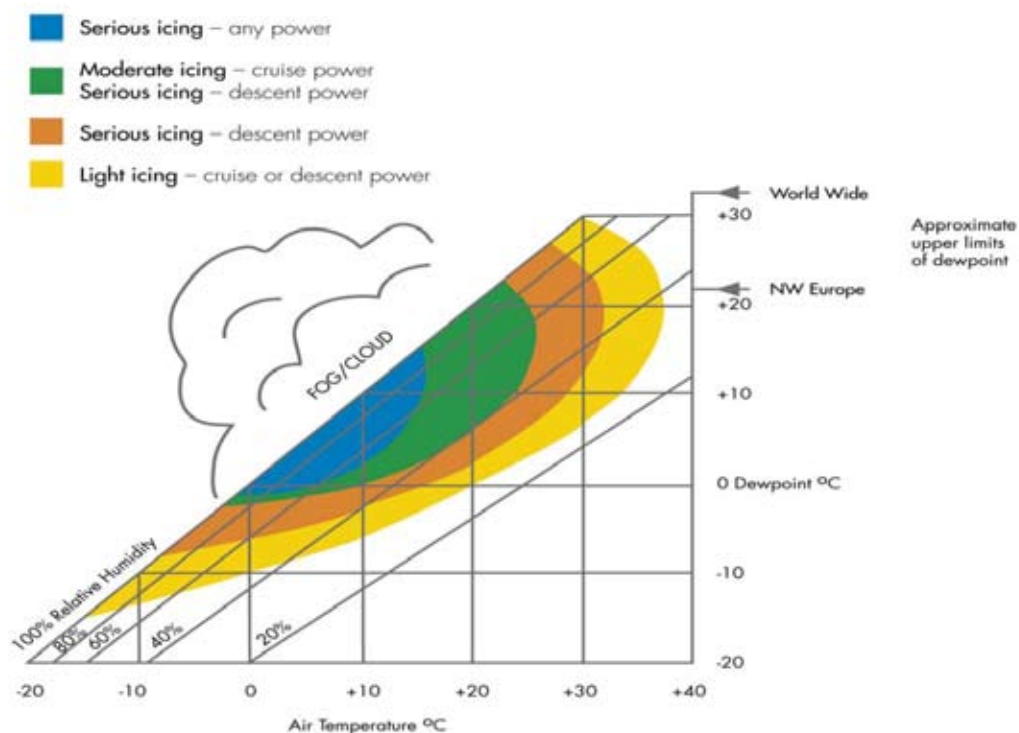
Figure 1

Carburettor icing as a function of temperature and dew point

The combination of temperature and dew point reported at Durham Tees Valley is conducive to moderate carburettor icing at cruise power and is close to combinations that might give rise to severe icing at any power.
